**Access Statement, Planning Statement and Heritage Statement**

Repair to the roof of a Grade II Listed Building within a Grade I Parkland setting

Queen Anne's Lodge  
Off Rockley Lane  
Worsbrough  
Barnsley  
S75 3DS

Date February 2018  
Project No 2013/05

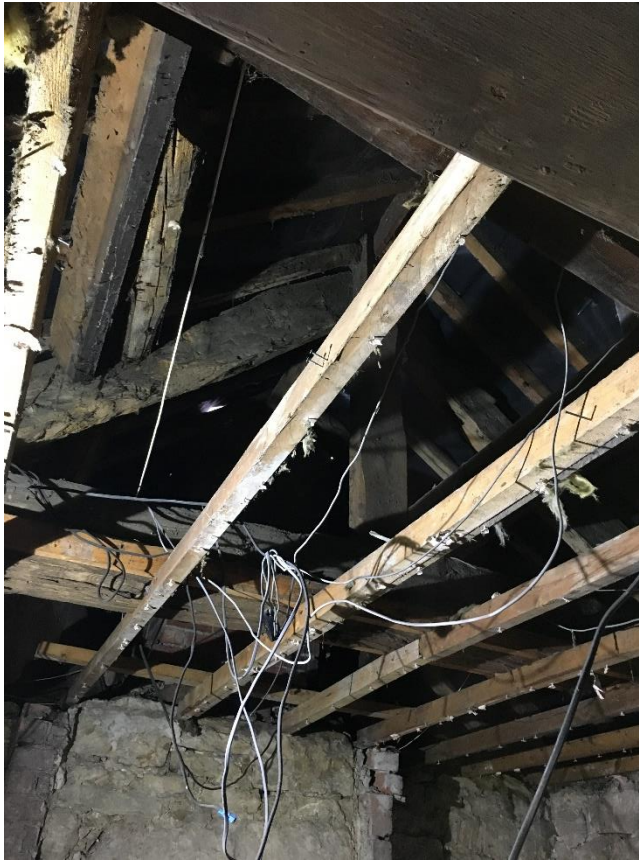
Photo 1

The historic oak truss (showing damage to the kingpost brace due to infestation) and the historic oak purlin. Note the later timber purlin below the oak purlin, installed to support the historic extension hip roof and the softwood rafters.

Modern ceiling joists to be removed and replaced.

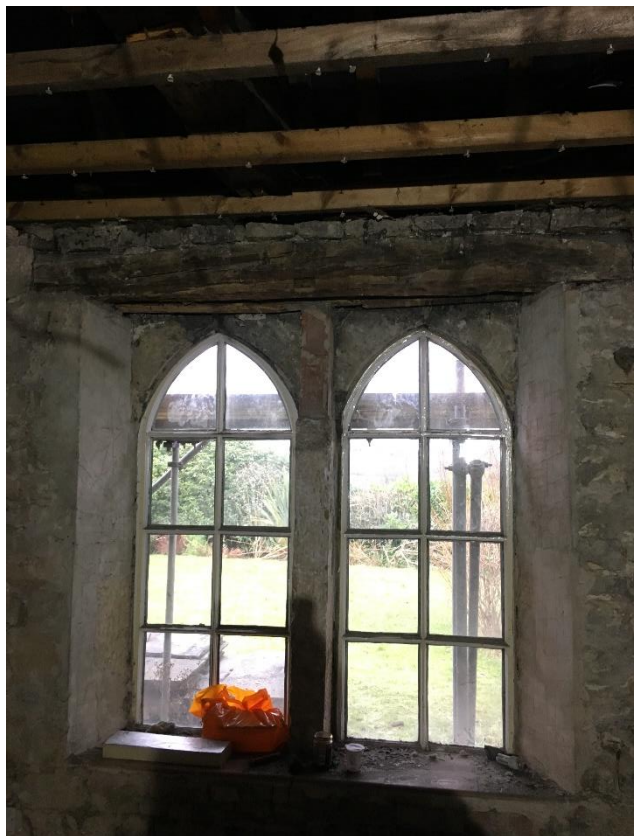
Photo 2

Oak lintel beneath historic oak truss. This lintel is sitting on a rubble filled stone wall. The oak truss is sitting on the rubble stone behind the truss. It is proposed that the oak lintel is carefully removed, a steel lintel is inserted behind it to support the existing truss and the new steel beams, and then the oak lintels is re fitted in the same location as before.

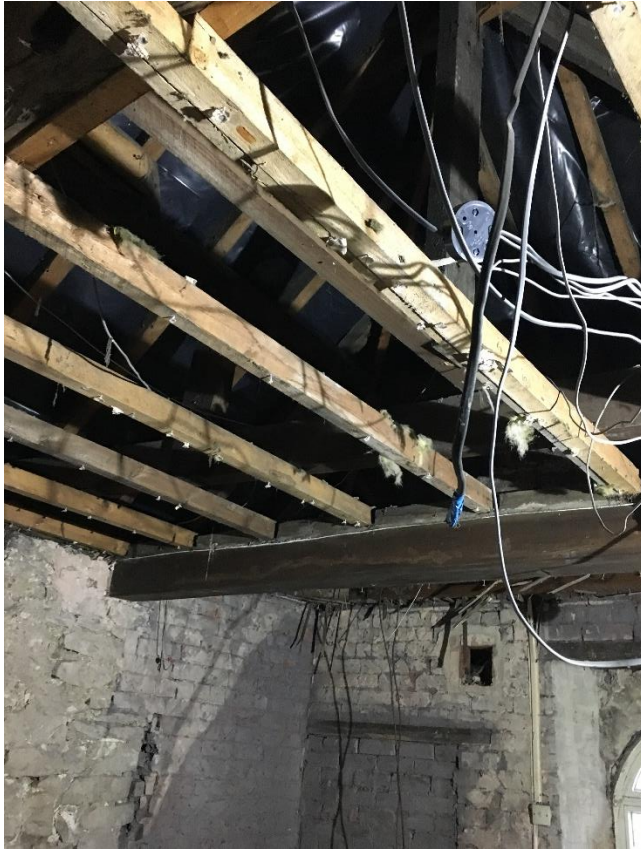
Photo 3

View towards the rear corner of the historic extension, showing the beam and the change in wall material (stone to brick) that indicates the extent of the extension. The lowest beam is the same as that shown in Photo 4.

The visible beam is to be removed and the roof structure is to be supported from below by props sitting on the new steel beam.

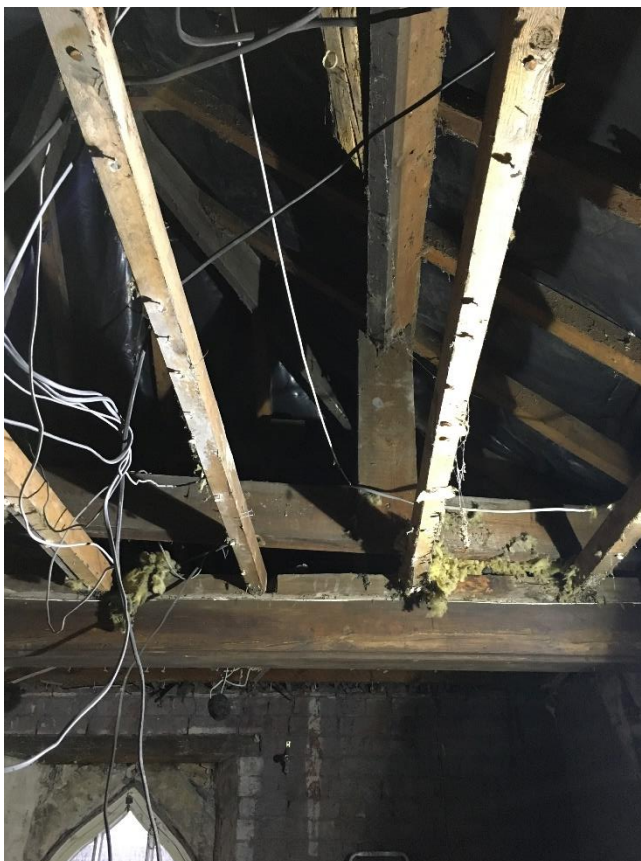
Photo 4

View to the side of the historic extension showing the existing beam arrangement used to prop the free end of the later softwood purlin (seen below the oak purlin in Photo 1). Refer to Architects drawings for additional information. The design is complicated due to the joiners need to prop the hip apex.

It is proposed that all the softwood beams in this location are removed, to be replaced with a single steel beam directly under the apex of the hip which will simplify the design and provide a location from which the purlins can all be propped.

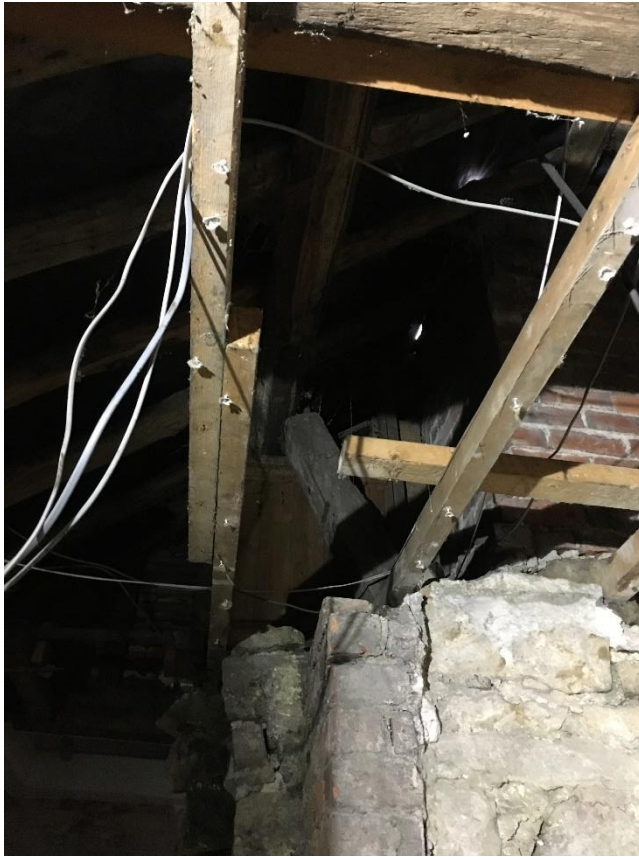
Photo 5

Historic oak prop, sitting on stone wall, supporting the historic purlin.

It is proposed that a new masonry wall is constructed behind the prop, which will support the existing purlins.

Modern rafters and ceiling joists to be removed and replaced with correctly sized members.

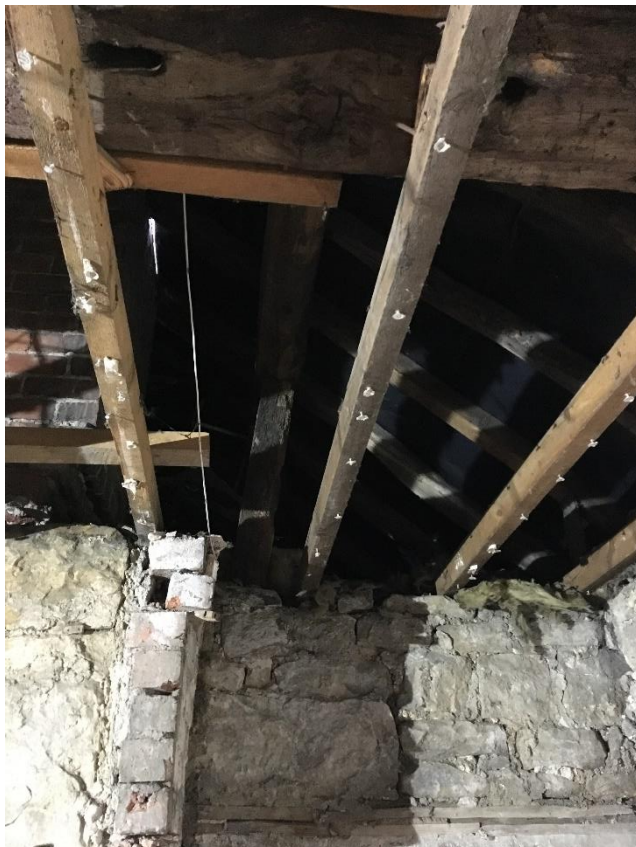
Photo 6

Historic oak prop, sitting on stone wall, to support the historic purlin.

It is proposed that a new masonry wall is constructed behind the prop, which will support the existing purlins.

Modern rafters and ceiling joists to be removed and replaced with correctly sized members.

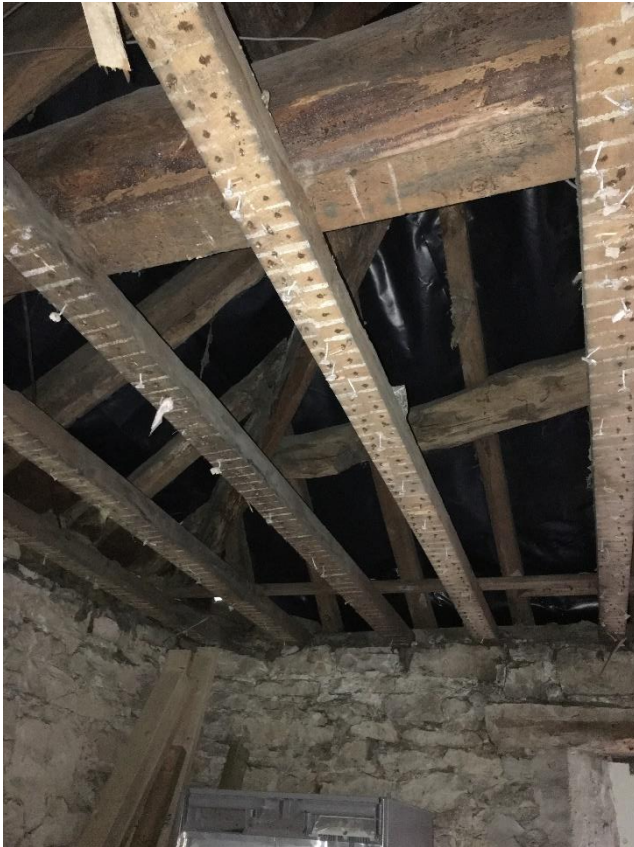
Photo 7

Bottom chord of softwood truss, with oak purlins and hip rafter creating the hip of the roof.

Historic truss, purlins and rafters to be retained, with new 150 x 50 rafters fixed along side them.

Modern rafters and ceiling joists to be removed and replaced with correctly sized members.

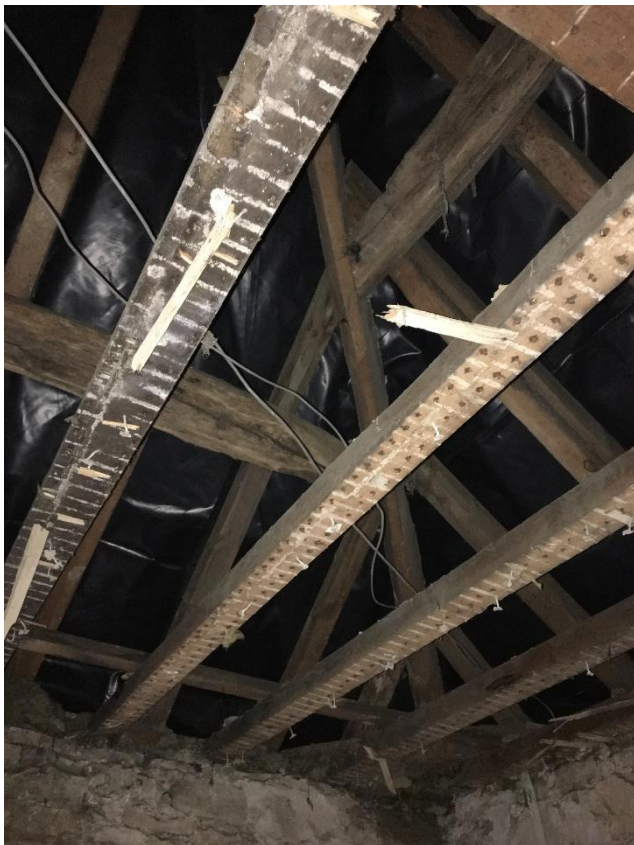
Photo 8

Showing oak purlins connecting to the hip rafter at different heights.

Historic purlins and rafters to be retained with new 150 x 50 rafters fixed alongside them.

Modern rafters and ceiling joists to be removed and replaced with correctly sized members.

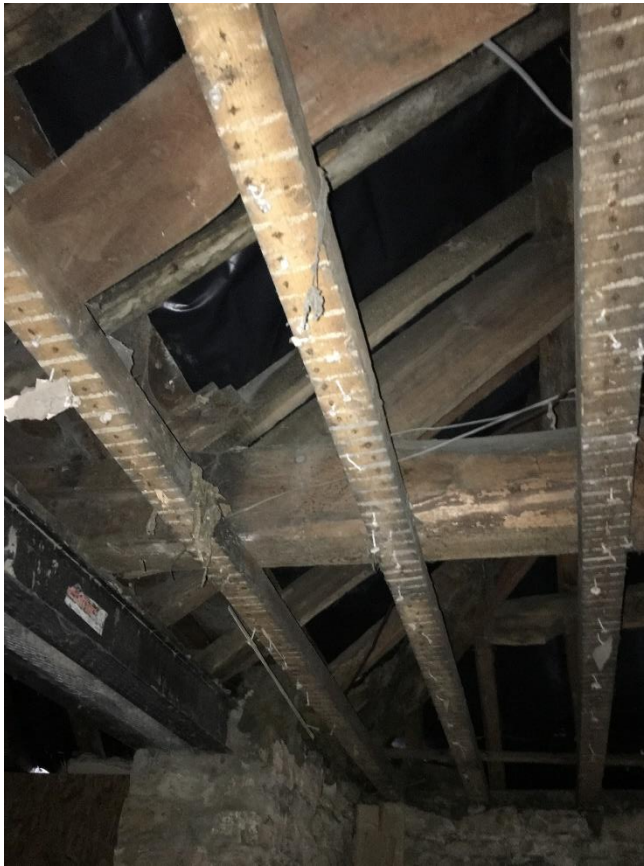
Photo 9

Softwood truss sitting on modern steel catnic lintel.

The truss is to be retained and new 150 x 50 rafters will be fitted to the side of the existing rafters. The lintels are to be replaced with suitable sized steel lintels.

Modern rafters and ceiling joists to be removed and replaced with correctly sized members.

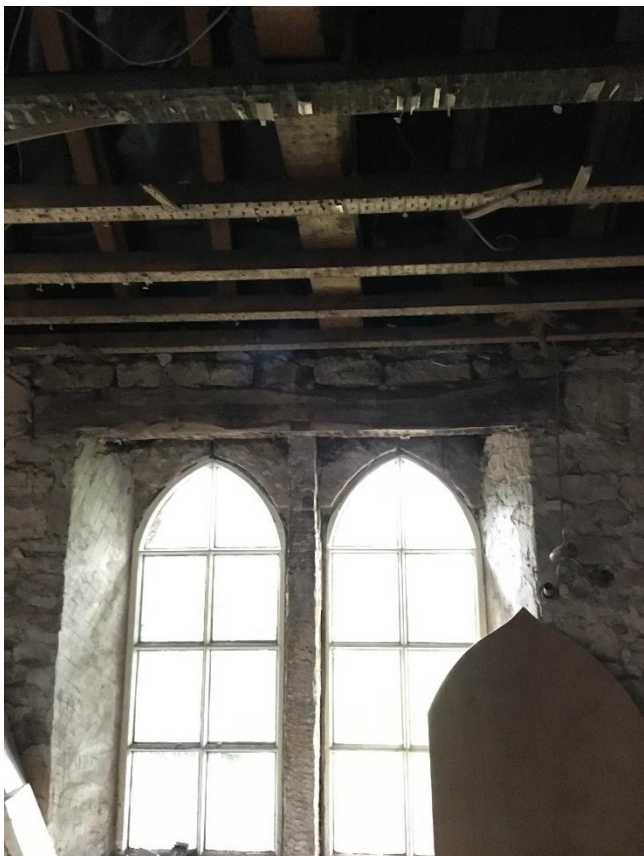
Photo 10

Softwood truss sitting on window with oak lintel.

This lintel is sitting on a rubble filled stone wall. The oak truss is sitting on the rubble stone behind the truss. It is proposed that the oak lintel is carefully removed, a steel lintel is inserted behind it to support the existing truss and the new steel beams, and then the oak lintels is re fitted in the same location as before.

Modern rafters and ceiling joists to be removed and replaced with correctly sized members.

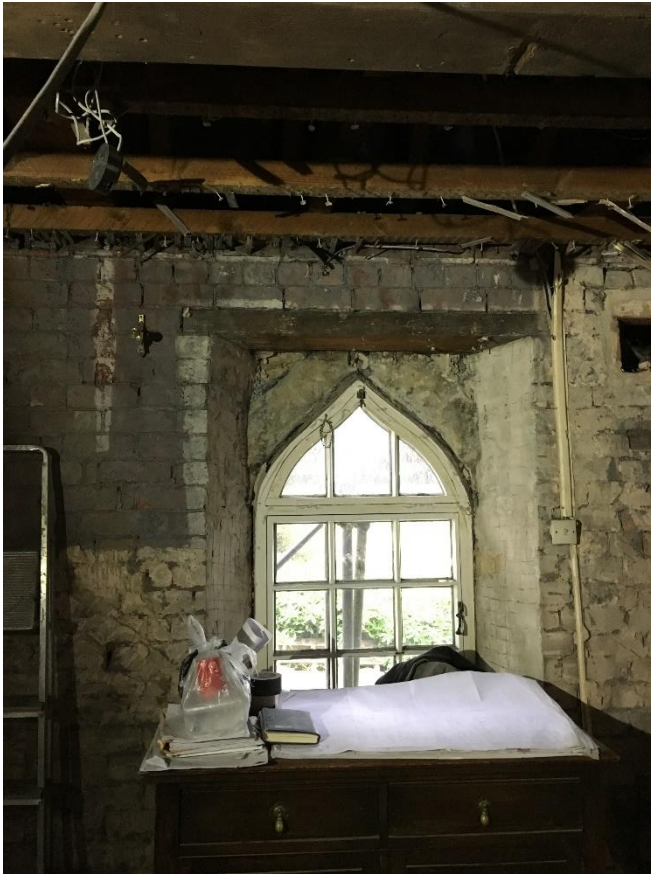
Photo 11

Example of timber lintel above window. The same detail occurs above the windows on the front elevation, onto which the roof sits.

It is proposed that these softwood lintels are replaced with concrete lintels.

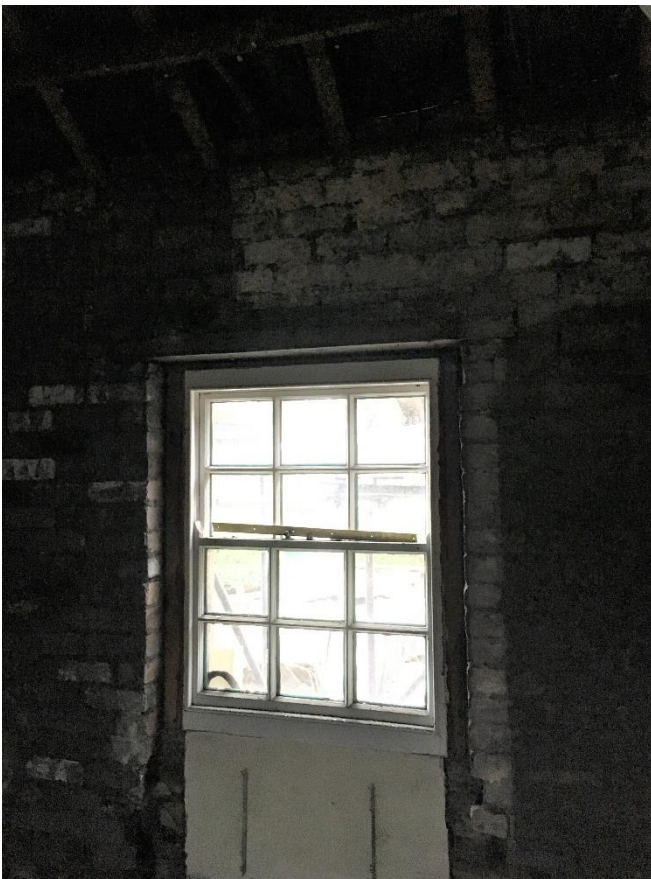
Photo 12

Poor quality photo (enhanced) showing timber lintel above front elevation window, similar to that shown in Photo 11.

It is proposed that these softwood lintels are replaced with concrete lintels.
