# **ARBORICULTURAL IMPACT ASSESSMENT & METHOD STATEMENT**

***Low Mill Farm,  
Fall Head Lane,  
Silkstone,  
Barnsley  
S75 4LB***

Date: *April 2023*

Reference: AWA5378

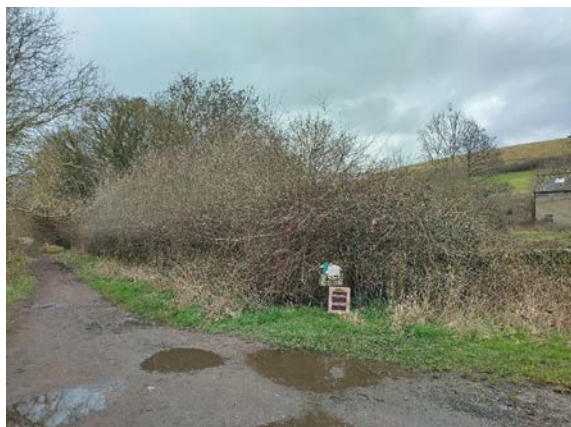
Photo 1: G1 from south west

| | Tree Species | | | Measurements | | | | Crown (m) | | | | Tree Condition | | | | | | | Value | | Management | |
|---|---|---|---|---|---|---|---|---|---|---|---|---|---|---|---|---|---|---|---|---|---|---|
| G1 | Hawthorn. Oak. | <i>Crataegus sp.</i><br><i>Quercus sp.</i> | Semi-mature | 4 | 10 | 30 | No | 0 | See plan | | | | Hedgerow. Hawthorn with occasional Oak sapling. Historically managed, recently unmanaged. | | | | Fair | Fair | >40 yrs | Low | C | No works required |

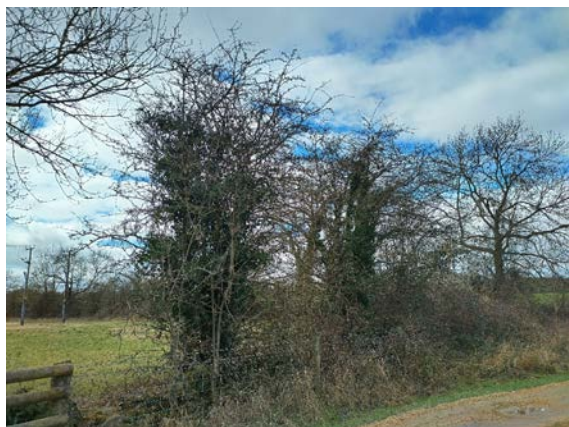
Photo 2: T2 and T3 from north east

| | Tree Species | | | Measurements | | | | Crown (m) | | | | Tree Condition | | | | | | | Value | | Management | |
|---|---|---|---|---|---|---|---|---|---|---|---|---|---|---|---|---|---|---|---|---|---|---|
| T2 | Hawthorn | <i>Crataegus monogyna</i> | Semi-mature | 7 | 10 | 70 | Yes | 1.5 | 3.5 | 3.5 | 3.5 | 4 | Limited access around base | Multiple stemmed at base. Vertical. Stubs. Bark damage. Epicormic growths. Minor cavities. Minor decay. Ivy covered. Tight unions. Partially included bark | Minor deadwood. Minor snapouts. Ivy covered | Delapidated low dry stone wall to immediate north. Limited access. | Fair | Fair | >40 yrs | Low | C | No works required |
| T3 | Hawthorn | <i>Crataegus monogyna</i> | Semi-mature | 7 | 10 | 60 | Yes | 0.5 | 2.5 | 2.5 | 2.5 | 2.5 | Limited access around base | Multiple stemmed at base. Vertical. Epicormic growths. Ivy covered. Tight unions. Partially included bark. Bark damage | Minor deadwood. Minor snapouts. Ivy covered | Delapidated low dry stone wall to immediate north. Limited access. | Fair | Fair | >40 yrs | Low | C | No works required |

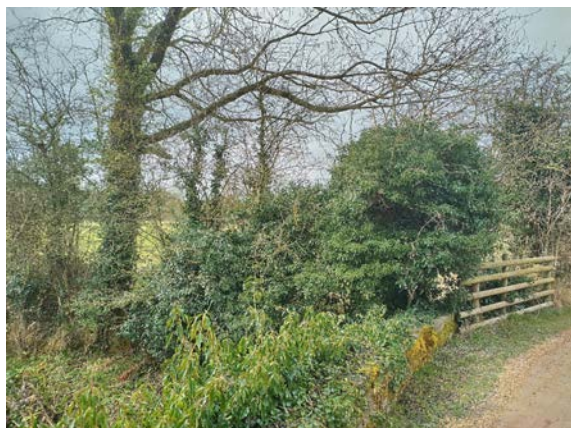
Photo 3: G4 from north east

| | Tree Species | | | Measurements | | | | Crown (m) | | | | Tree Condition | | | | | | | Value | | Management | |
|---|---|---|---|---|---|---|---|---|---|---|---|---|---|---|---|---|---|---|---|---|---|---|
| G4 | Hawthorn | <i>Crataegus monogyna</i> | Early-mature | 5 | 10 | 60 | Yes | 0.5 | See plan | | | | Linear shrubby group of Hawthorn. Situated on beck banking on western side of beck. Limited access. | | | | Fair | Fair | >40 yrs | Low | C | No works required |

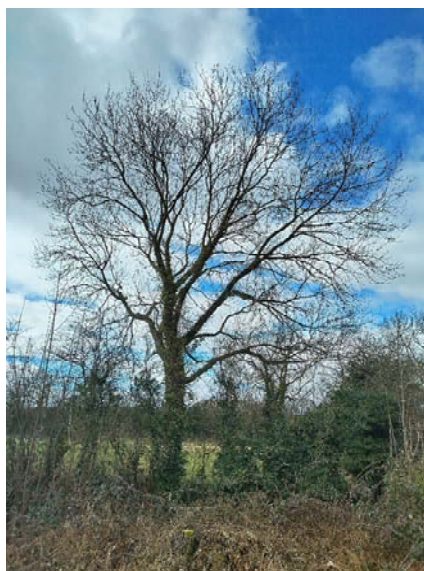
- 2.2.4 Construction access will pass through the RPAs of retained Ash T5 and Alder T11, however the access will be along an existing compacted access track within the RPAs of the trees, so there should be little negative impact on the trees.

Photo 4: T5 from north east

| Tree ID | Tree Species | | Maturity | Measurements | | | | Crown (m) | | | | Tree Condition | | | | | | | | Value | | Management |
|---|---|---|---|---|---|---|---|---|---|---|---|---|---|---|---|---|---|---|---|---|---|---|
| T5 | Ash | <i>Fraxinus excelsior</i> | Mature | 19 | 1 | 700 | Yes | 5 | 7 | 7 | 7 | 7 | Limited access around base. Soil erosion. Exposed roots | Single stemmed. Vertical. Ivy covered. Stubs | Minor deadwood. Minor snapouts | Situated on beck banking on western side of beck. Limited access. Very Ivy covered. | Good | Fair | 10 to 20 yrs | Moderate | C | No works required |

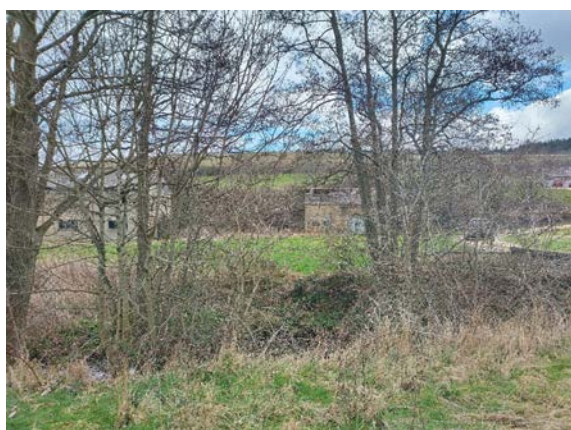
Photo 5: G6 and G7 from west

| Tree ID | Tree Species | | Maturity | Measurements | | | | Crown (m) | | | | Tree Condition | | | | | | | | Value | | Management |
|---|---|---|---|---|---|---|---|---|---|---|---|---|---|---|---|---|---|---|---|---|---|---|
| G6 | Hawthorn. Elder. | <i>Crataegus sp.</i><br><i>Sambucus sp.</i> | Young | 5 | 10 | 50 | Yes | 0.5 | See plan | | | | Linear group of young Hawthorn and Elder. Situated on beck banking on western side of beck. Limited access. Elder in poor condition. | | | | Fair | Fair | 20 to 40 yrs | Low | C | No works required |
| G7 | Sycamore | <i>Acer pseudoplatanus</i> | Young | 7 | 10 | 70 | Yes | 0.5 | 2 | 2.5 | 2.5 | 2.5 | Limited access around base. Soil erosion. Exposed roots | Multiple stemmed at base. Vertical. Old pruning wounds. Tight unions. Rubbing stems | Minor deadwood | Group of young Sycamore forming one crown. Situated on beck banking on western side of beck. Limited access. | Fair | Fair | 10 to 20 yrs | Low | C | No works required |

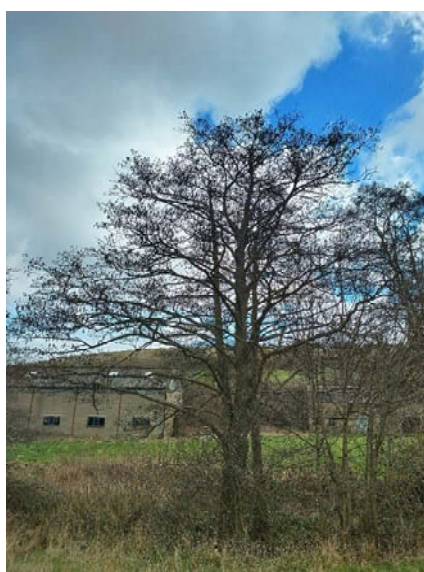
Photo 6: T8 from west

| Tree ID | Tree Species | | Maturity | Measurements | | | | Crown (m) | | | | Tree Condition | | | | | | | | Value | | Management |
|---|---|---|---|---|---|---|---|---|---|---|---|---|---|---|---|---|---|---|---|---|---|---|
| T8 | Alder | <i>Alnus glutinosa</i> | Early-mature | 13 | 1 | 600 | Yes | 2 | 5 | 4 | 4.5 | 6 | Limited access around base. Soil erosion. Exposed roots | Single stemmed. Vertical. Tight union. Partially included bark. Bark damage. Stubs | Minor deadwood. Minor snapouts. Minor dieback | Twin stemmed at 2.5m with included bark union. Situated on beck banking on western side of beck. Limited access. | Fair | Fair | 20 to 40 yrs | Moderate | B | No works required |

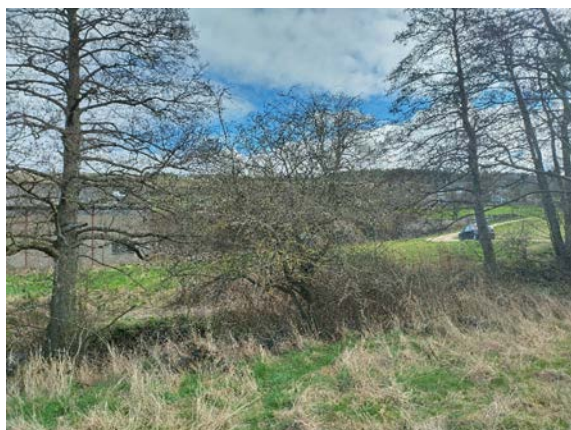
Photo 7: T9 from west

| Tree ID | Tree Species | | Maturity | Measurements | | | | Crown (m) | | | | Tree Condition | | | | | | | | Value | | Management |
|---|---|---|---|---|---|---|---|---|---|---|---|---|---|---|---|---|---|---|---|---|---|---|
| T9 | Hawthorn | <i>Crataegus monogyna</i> | Early-mature | 5.5 | 10 | 60 | Yes | 0.5 | 2 | 2 | 2 | 2 | Limited access around base. Soil erosion. Exposed roots | Multiple stemmed at 1m. Slight lean north east. Tight unions | Minor deadwood. Minor snapouts | Situated on beck banking on western side of beck. Limited access. | Good | Fair | >40 yrs | Low | C | No works required |

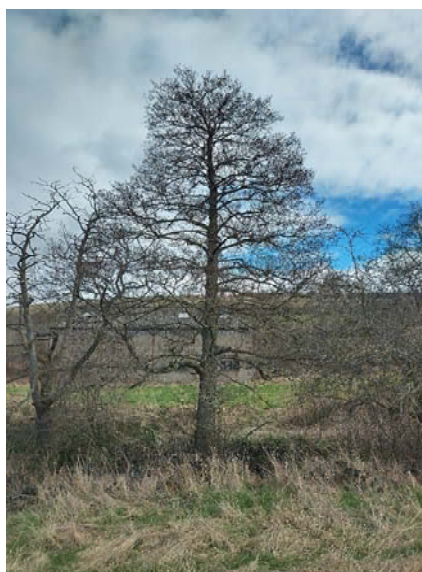
- 2.2.2 The proposed new parking is situated within the detailed RPA of retained Alder T10, however, T10 is situated on the opposite side of the beck and the detailed RPA for the tree is likely to be an exaggerated representation of the tree's actual rooting area. As such, it is unlikely that significant roots will be within the area of the proposed new parking and T10 should remain largely unaffected by the works.

Photo 8: T10 from west

| | Tree Species | | | Measurements | | | | Crown (m) | | | | Tree Condition | | | | | | | Value | | Management | |
|---|---|---|---|---|---|---|---|---|---|---|---|---|---|---|---|---|---|---|---|---|---|---|
| T10 | Alder | <i>Alnus glutinosa</i> | Early-mature | 13 | 1 | 600 | Yes | 2 | 4.5 | 4.5 | 4.5 | 6.5 | Soil erosion. Exposed roots | Single stemmed. Vertical. Epicormic growths | Minor deadwood. Minor snapouts | Situated on beck banking on western side of beck. Limited access. | Good | Fair | 20 to 40 yrs | Moderate | B | No works required |

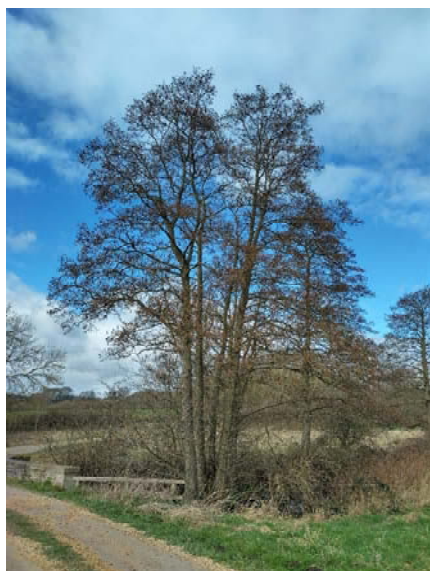
- 2.2.3 The proposed new driveway encroaches into the RPA of retained Alder T11, however, the encroachment into the RPA is minor and the retained tree should remain largely unaffected by the works provided care is taken during construction.

Photo 9: T11 from south east

| | Tree Species | | | Measurements | | | | Crown (m) | | | | Tree Condition | | | | | | | Value | | Management | |
|---|---|---|---|---|---|---|---|---|---|---|---|---|---|---|---|---|---|---|---|---|---|---|
| T11 | Alder | <i>Alnus glutinosa</i> | Early-mature | 17 | 6 | 300 | Yes | 3 | 5.5 | 5.5 | 5 | 4.5 | Limited access around base. Soil erosion. Exposed roots | Multiple stemmed at base. Vertical. Epicormic growths. Tight unions. Partially included bark | Minor deadwood. Minor snapouts | Situated on beck banking on eastern side of beck. Limited access. | Good | Fair | 20 to 40 yrs | Moderate | B | No works required |

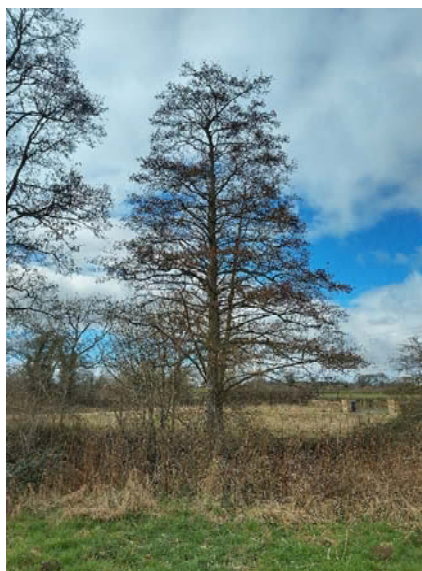
Photo 10: T12 from east

| | Tree Species | | | Measurements | | | | Crown (m) | | | | Tree Condition | | | | | | | Value | | Management | |
|---|---|---|---|---|---|---|---|---|---|---|---|---|---|---|---|---|---|---|---|---|---|---|
| T12 | Alder | <i>Alnus glutinosa</i> | Early-mature | 16 | 1 | 450 | Yes | 2 | 5 | 5 | 4.5 | 3 | Soil erosion. Exposed roots. Limited access around base | Single stemmed. Vertical. Epicormic growths | Minor deadwood. Minor snapouts | Situated on beck banking on eastern side of beck. Limited access. | Good | Fair | 20 to 40 yrs | Moderate | B | No works required |

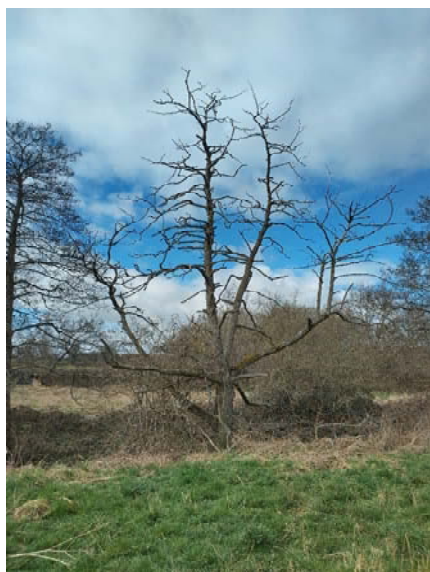
Photo 11: T13 and T14 from east

| | Tree Species | | | Measurements | | | | Crown (m) | | | | Tree Condition | | | | | | | Value | | Management | |
|---|---|---|---|---|---|---|---|---|---|---|---|---|---|---|---|---|---|---|---|---|---|---|
| T13 | Elder | <i>Sambucus nigra</i> | Semi-mature | 5.5 | 10 | 50 | Yes | 0.5 | 2 | 3.5 | 3 | 2.5 | Limited access around base. Soil erosion. Exposed roots | Multiple stemmed at base. Vertical. Stubs. Tight unions. Partially included bark | Minor dieback. Minor deadwood. Minor snapouts | Situated on beck banking on eastern side of beck. Limited access. | Fair | Fair | 10 to 20 yrs | Low | C | Removal required to facilitate development |
| T14 | Alder | <i>Alnus glutinosa</i> | Dead | 14 | 2 | 250, 450 | Yes | 1.5 | 6 | 4 | 5 | 4.5 | Limited access around base. Soil erosion. Exposed roots | Twin stemmed at 1m. Vertical. Moderate cavities. Moderate decay | Major dieback. Minor deadwood. Moderate deadwood. Major deadwood. Minor snapouts. Moderate snapouts. Major snapouts | Dead. Situated on beck banking on eastern side of beck. Limited access. | Dead | Dead | n/a | Dead | U | Removal required regardless of development |

- 4.1.1 The trees requiring removal are T13, T14, T15, T17 and T18.
- 4.1.2 These trees requiring removal have been identified in red on the Tree Protection Plan at Appendix 5.
- 4.1.3 All tree work should be carried out according to British Standard 3998:2010 Tree Work - Recommendations.
- 4.1.4 When appointing a tree surgeon, only properly qualified and experienced companies should be used, who have adequate Public Liability and Employer's Liability Insurance.

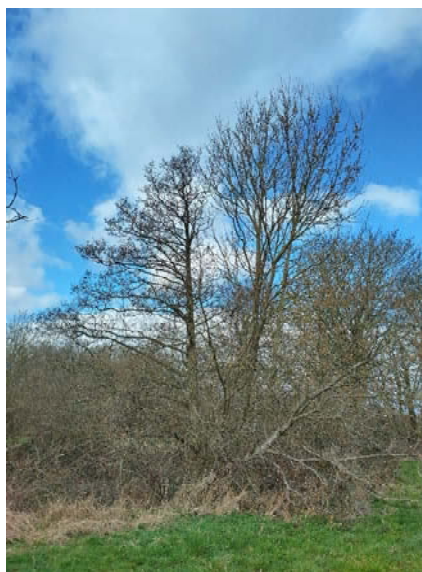
Photo 12: T15 and T16 from south east

| Tree ID | Tree Species | | Maturity | Measurements | | | | Crown (m) | | | | Tree Condition | | | | | | | | Value | | Management |
|---|---|---|---|---|---|---|---|---|---|---|---|---|---|---|---|---|---|---|---|---|---|---|
| T15 | Alder | <i>Alnus glutinosa</i> | Early-mature | 6 | 1 | 350 | No | 0 | 5.5 | 5 | 0.5 | 0.5 | Soil erosion. Exposed roots. Failed at roots | Single stemmed. Significant lean north east. Failed | Minor dieback. Minor deadwood. Minor snapouts | Failed and leaning to north east | Fair | Poor | <10 yrs | Low | U | Removal required regardless of development |
| G16 | Alder. Ash. Hawthorn. Elder. | <i>Alnus sp.</i><br><i>Fraxinus sp.</i><br><i>Crataegus sp.</i><br><i>Sambucus sp.</i> | Early-mature | 15 | 10 | 300 | Yes | 1 | See plan | | | | Linear group. Taller Alder and Ash with shrubby understorey of Elder and Hawthorn. Situated on beck banking on eastern side of beck. Limited access. | | | | Fair | Fair | 20 to 40 yrs | Moderate | C | No works required |

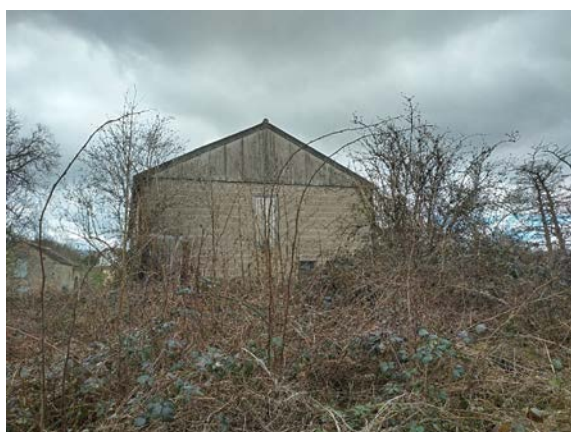
- 2.1.1 From assessing the new development proposals, 2 trees will require removal to facilitate the development as they are situated in the footprint of the development or their retention and protection throughout the development is not suitable.
- 2.1.2 The trees that require removal to facilitate the development are Elders T13 and T17. T13 and T17 are of very low value and their removal will have little negative impact.
- 2.1.3 Alders T14 and T15 and Elder T18 require removal regardless of development at the site. T14 is dead, T15 has failed, and T18 is growing up against and in contact with the existing barn at the site.

Photo 13: T17 and T18 from north west

| Tree ID | Tree Species | | Maturity | Measurements | | | | Crown (m) | | | | Tree Condition | | | | | | | | Value | | Management |
|---|---|---|---|---|---|---|---|---|---|---|---|---|---|---|---|---|---|---|---|---|---|---|
| T17 | Elder | <i>Sambucus nigra</i> | Semi-mature | 5 | 10 | 70 | Yes | 1 | 2.5 | 2.5 | 2.5 | 2.5 | Limited access around base | Multiple stemmed at base. Vertical. Tight unions. Partially included bark. Minor cavities. Minor decay | Minor dieback. Minor deadwood. Minor snapouts | Limited access due to dense undergrowth | Fair | Fair | 10 to 20 yrs | Low | C | Removal required to facilitate development |
| T18 | Elder | <i>Sambucus nigra</i> | Semi-mature | 5.5 | 6 | 60 | Yes | 1 | 2 | 2 | 2 | 2 | Limited access around base | Multiple stemmed at base. Vertical. Tight unions. Partially included bark. Minor cavities. Minor decay | Minor dieback. Minor deadwood. Minor snapouts | Growing up against and in contact with barn. Limited access due to dense undergrowth. | Fair | Fair | 10 to 20 yrs | Low | U | Removal required regardless of development |

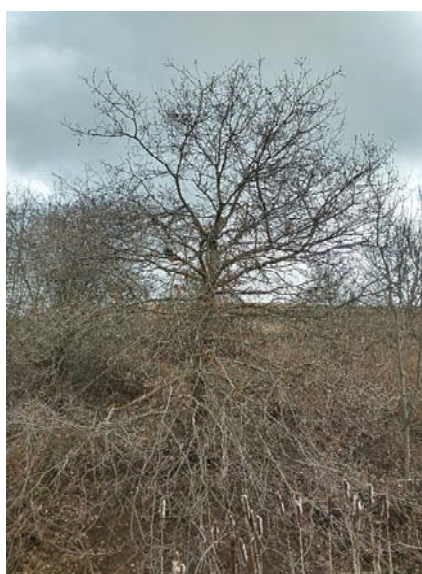
Photo 14: T19 from west

| Tree ID | Tree Species | | Maturity | Measurements | | | | Crown (m) | | | | Tree Condition | | | | | | | | Value | | Management |
|---|---|---|---|---|---|---|---|---|---|---|---|---|---|---|---|---|---|---|---|---|---|---|
| T19 | Oak | <i>Quercus robur</i> | Semi-mature | 7 | 1 | 200 | Yes | 0 | 3 | 3 | 3 | 3 | Limited access around base. Soil erosion. Exposed roots | Single stemmed. Vertical | Minor deadwood | Situated on opposite side of beck. Limited access. | Good | Fair | 20 to 40 yrs | | C | No works required |

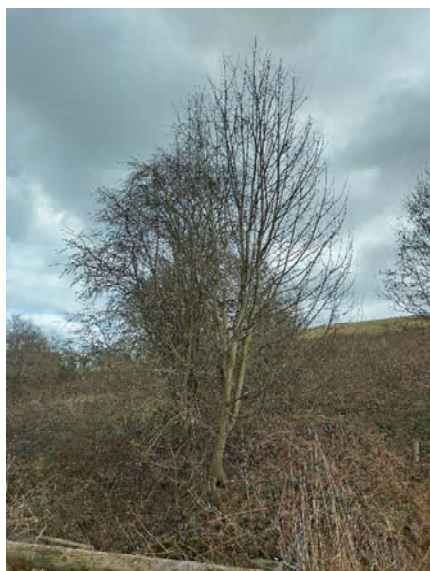
Photo 15: G20 from south west

| Tree ID | Tree Species | | Maturity | Measurements | | | | Crown (m) | | | | | Tree Condition | | | | | | | Value | | Management |
|---|---|---|---|---|---|---|---|---|---|---|---|---|---|---|---|---|---|---|---|---|---|---|
| G20 | Sycamore.<br>Hawthorn. | <i>Acer sp.</i><br><i>Crataegus sp.</i> | Semi-mature | 11 | 10 | 100 | Yes | 0.5 | 2.5 | 2.5 | 2.5 | 2.5 | Limited access around base. Soil erosion. Exposed roots | Multiple stemmed at base. Vertical. Tight unions. Partially included bark | Minor deadwood | Sycamore and Hawthorn forming one crown. Situated on opposite side of beck. Limited access. | Fair | Fair | 10 to 20 yrs | Low | C | No works required |
