**SOUTH YORKSHIRE MINING ADVISORY SERVICE**

**BUILDING REGULATIONS 2000  
APPROVED DOCUMENT A - STRUCTURE (2004 EDITION)  
REQUIREMENT A2(b) - SUBSIDENCE**

Description: DETACHED DWELLING

Location: LAND ADJACENT TO 12 CONE LANE SILKSTONE COMMON.

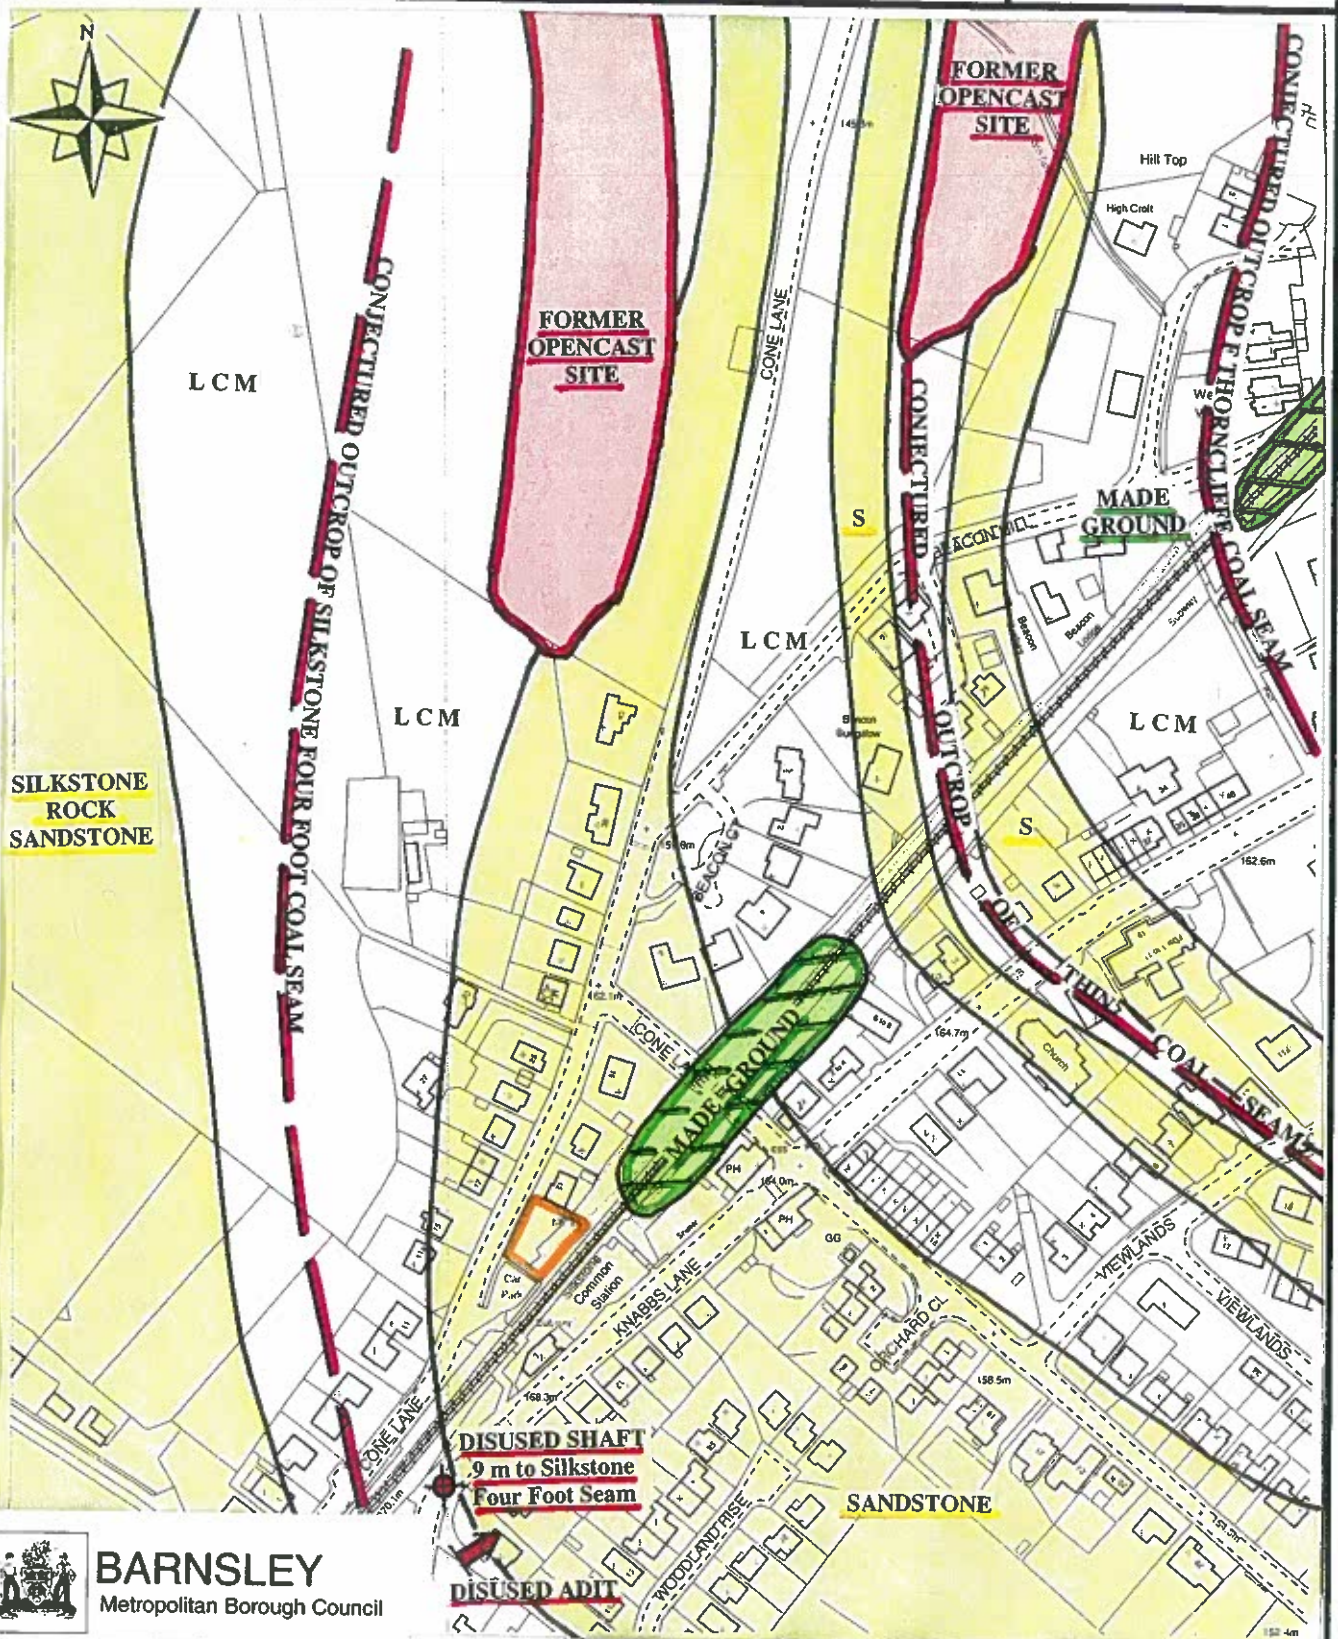
| Shallow mineworkings in the SILKSTONE FOUR FOOT coal seam marked on the attached plan may be present beneath the site. | A7<br>✓ |

| A site investigation should be carried out to check the possible presence of shallow workings/broken ground. Boreholes to a depth of 16m would be recommended in this instance. (Prior consultations with the Coal Authority would be required). | B4<br>✓ |
| Although it is not a consideration of the A2(b) requirement all the usual safety precautions and monitoring procedures in respect of fugitive gases (associated with shallow coals, mine entries, made ground or landfill) should be employed during future excavations. | B9<br>✓ |
