# **ARBORICULTURAL REPORT & Impact Assessment to BS5837:2012 at:**

***Lee Lane,  
Millhouse Green,  
Sheffield  
S36 9LN***

Prepared for:  
***White Agus Partnership***

Reference: AWA3917

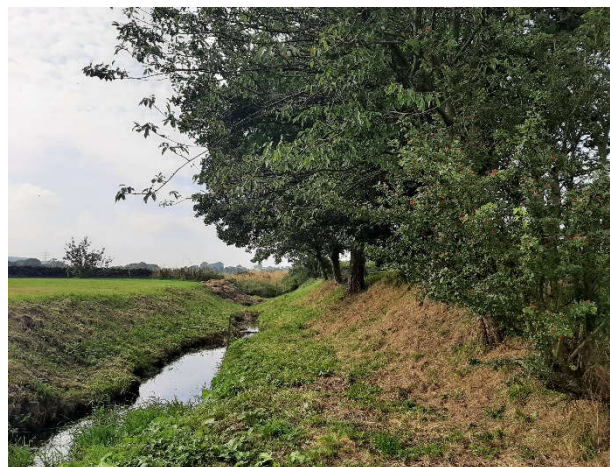
- 3.2.3 At the southern boundary of the garden are Hawthorn T1, Cherry T2, Alder T3 and T5 to T9, and Beech T4. These trees are situated on, or at the top of, a slight banking, and due to their exposed location a number of the trees are leaning with the prevailing wind. T3, T5, T6 and T7 appear to have been reduced in the past, with upper crowns typical of previously topped trees. T6 and T8 were previously twin-stemmed trees, however stems have previously been removed resulting in old pruning wounds with signs of decay at the base, which may limit long-term prospects. The trees at the southern boundary typically have low individual value, but collectively provide reasonable screening for the highway to the south.

Photo 2: Trees situated on the banking at the southern boundary

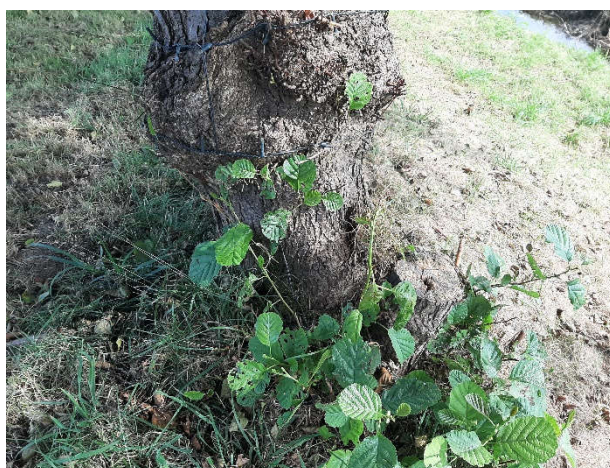
Photo 3: Occasional trees at the southern boundary with pruning wounds at the base, with decay

| Tree ID | Tree Species | | Maturity | Measurements | | | | Crown (m) | | | | | Tree Condition | | | | | | | Value | | Management |
|---|---|---|---|---|---|---|---|---|---|---|---|---|---|---|---|---|---|---|---|---|---|---|
| T6 | Alder | <i>Alnus incana</i> | Early-mature | 8.5 | 1 | 350 | No | 2.5 | 3.5 | 3 | 4.5 | 2.5 | Soil erosion, Exposed roots | Single stemmed, Slight lean east, Epicormic growths, Minor cavity, Minor decay, Old pruning wounds | Slightly unbalanced, Previously pollarded | Situated top of banking. Previously twin stemmed with one stem removed at .5m, now decayed | Fair | Fair | 10 to 20 yrs | Low | C | No works required |
| T8 | Alder | <i>Alnus glutinosa</i> | Semi-mature | 8 | 1 | 270 | No | 2 | 3 | 2.5 | 3.5 | 2 | Soil erosion, Exposed roots | Single stemmed, Vertical, Epicormic growths, Old pruning wounds at base, Minor decay | Normal | Situated on banking. Previously twin stemmed with one stem removed at .5m, now decayed | Good | Fair | 20 to 40 yrs | Low | C | No works required |

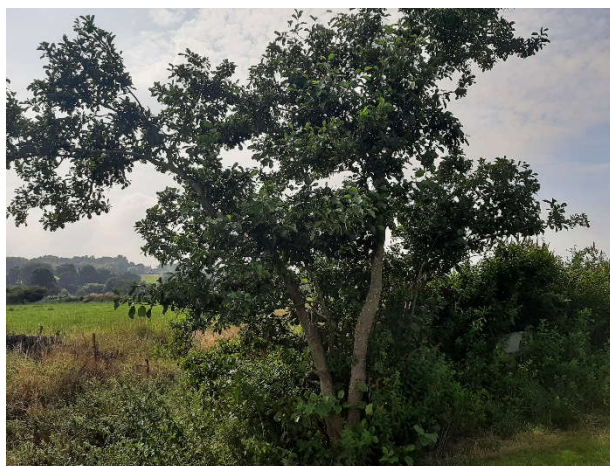
- 3.2.4 In the south-west corner of the garden is Alder T10, which has established among dense shrubs. T10 has negligible value in the wider landscape, with no significant contribution to boundary screening.

Photo 5: Alder T10, situated in boundary shrubs

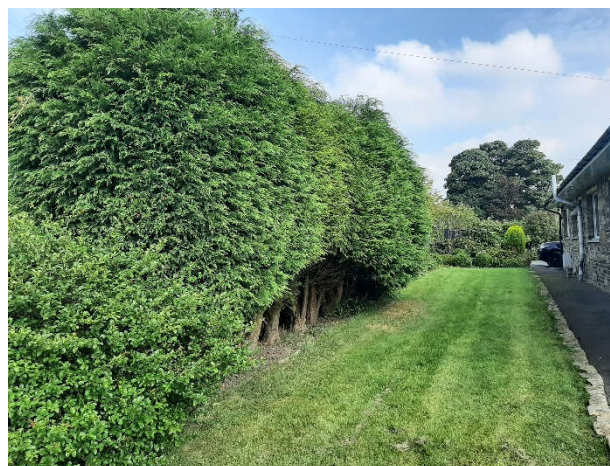
- 3.2.6 At the northern boundary is Cypress hedge G12. G12 is a dense, managed hedge that provides good boundary screening.
- 3.2.7 There are a number of smaller trees and shrubs throughout garden that fall outside the scope of a BS5837:2012 survey.

Photo 6: Cypress hedge G12, providing screening at the northern boundary

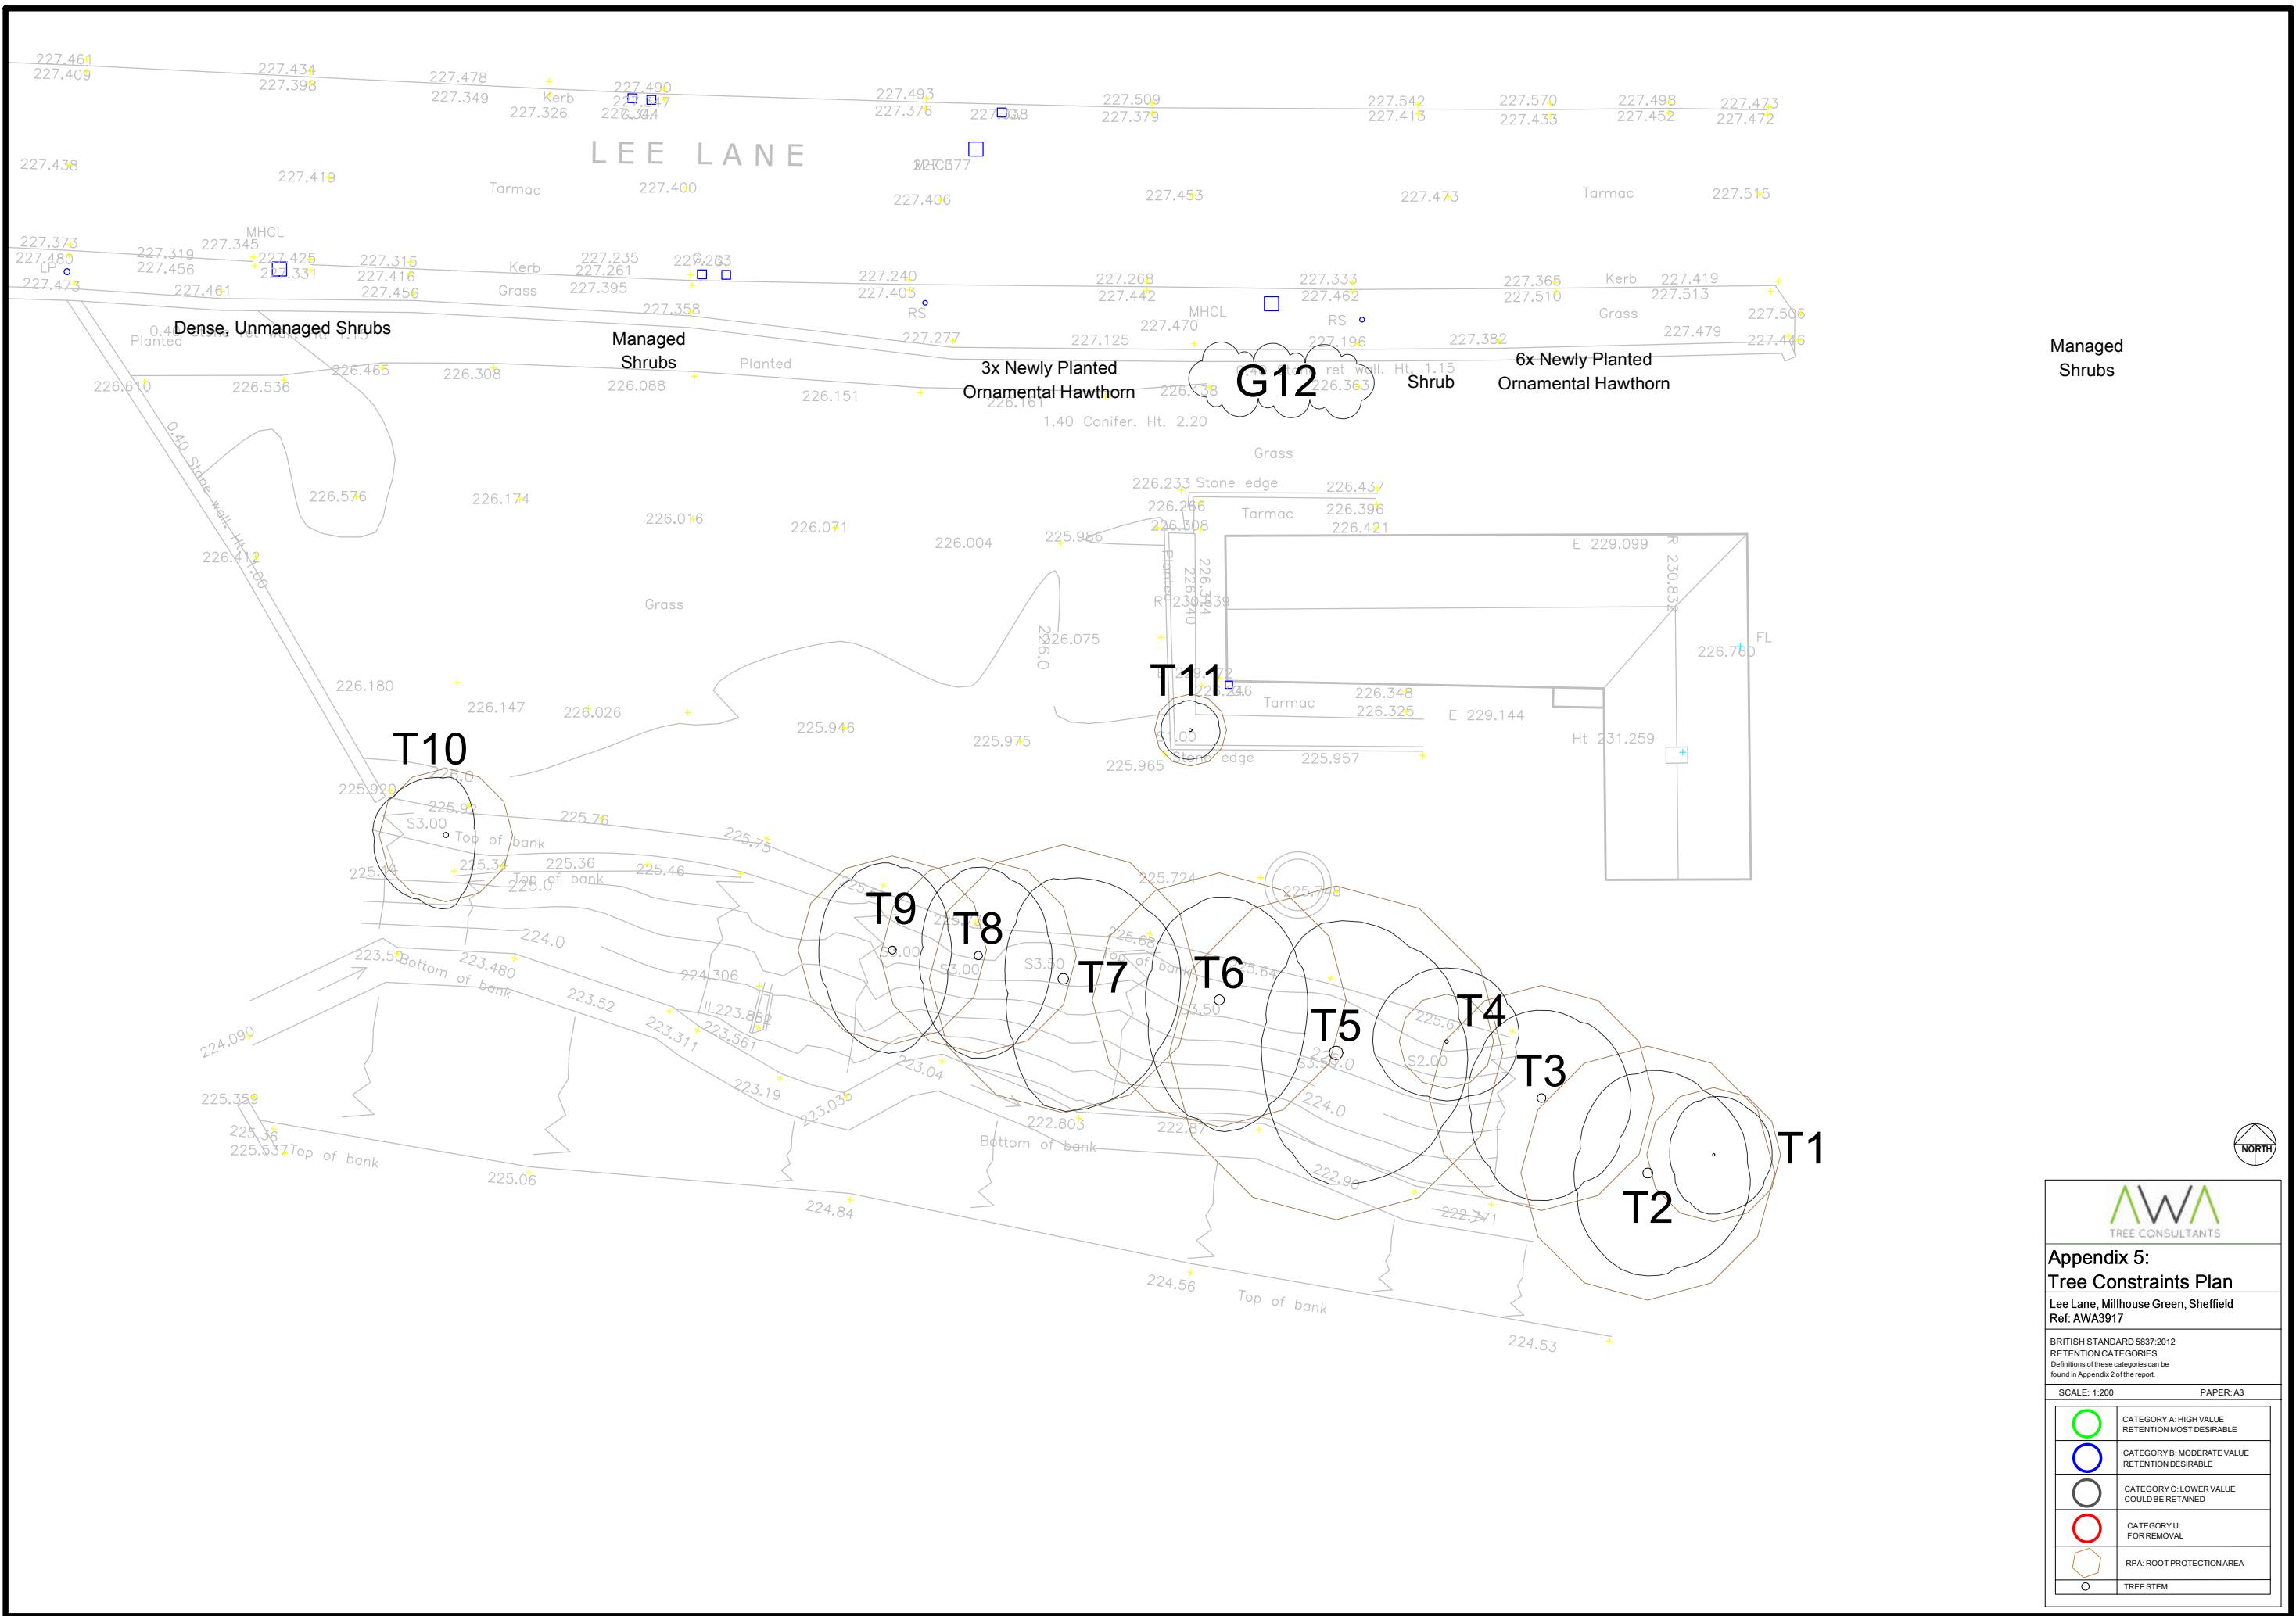
**Appendix 5:**  
**Tree Constraints Plan**  
Lee Lane, Millhouse Green, Sheffield  
Ref: AWA3917

- 3.2.1 The tree survey revealed 12 items of woody vegetation, comprised of 11 individual trees and 1 hedge.
- 3.2.2 All surveyed trees are retention category 'C' (explanatory details regarding the retention categories are included at Appendix 3).
