## **ELSECAR BUILDING 10**

### **DESIGN AND ACCESS STATEMENT**

Subject: ELSECAR HERITAGE-BUILDING 10, IMPROVEMENT WORKS

## ELSECAR HERITAGE-BUILDING 10, IMPROVEMENT WORKS

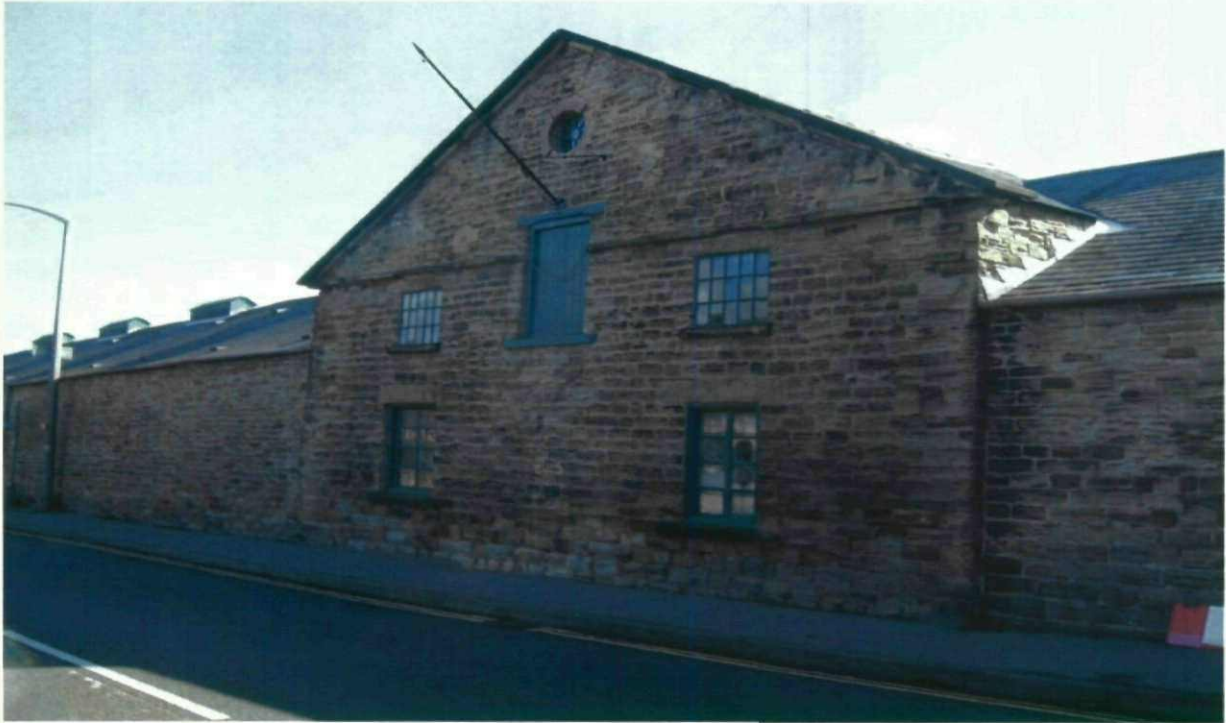
Wath Road Elevation

The external sandstone stonework is extremely eroded due to a combination of weathering aggravated by the long term polluted colliery environment and by previous hard pointing. Consequently some stonework has weathered back by over 50mm or 35% of the thickness of the outer leaf. Since these walls are rubble filled, it has been found on similar adjacent buildings that long term consolidation of the rubble fill has left voids at high level and a tendency to push out the lower stones and mortar. It is proposed to low pressure grout and re-tie these walls. Given the degree of erosion of the stonework, in particular to the gables, it is considered that in adverse weather and high winds in particular there is a risk of the stonework collapsing. Replacement of the eroded stone and repointing with an appropriate lime mortar is therefore recommended. Timber battens were found to have been built and coursed into the inner leaf of the external walls. These timbers have deteriorated due to damp, woodworm and rot. It is recommended that they should be removed (in short lengths) and replaced with brick to avoid endangering the stability of the walls.

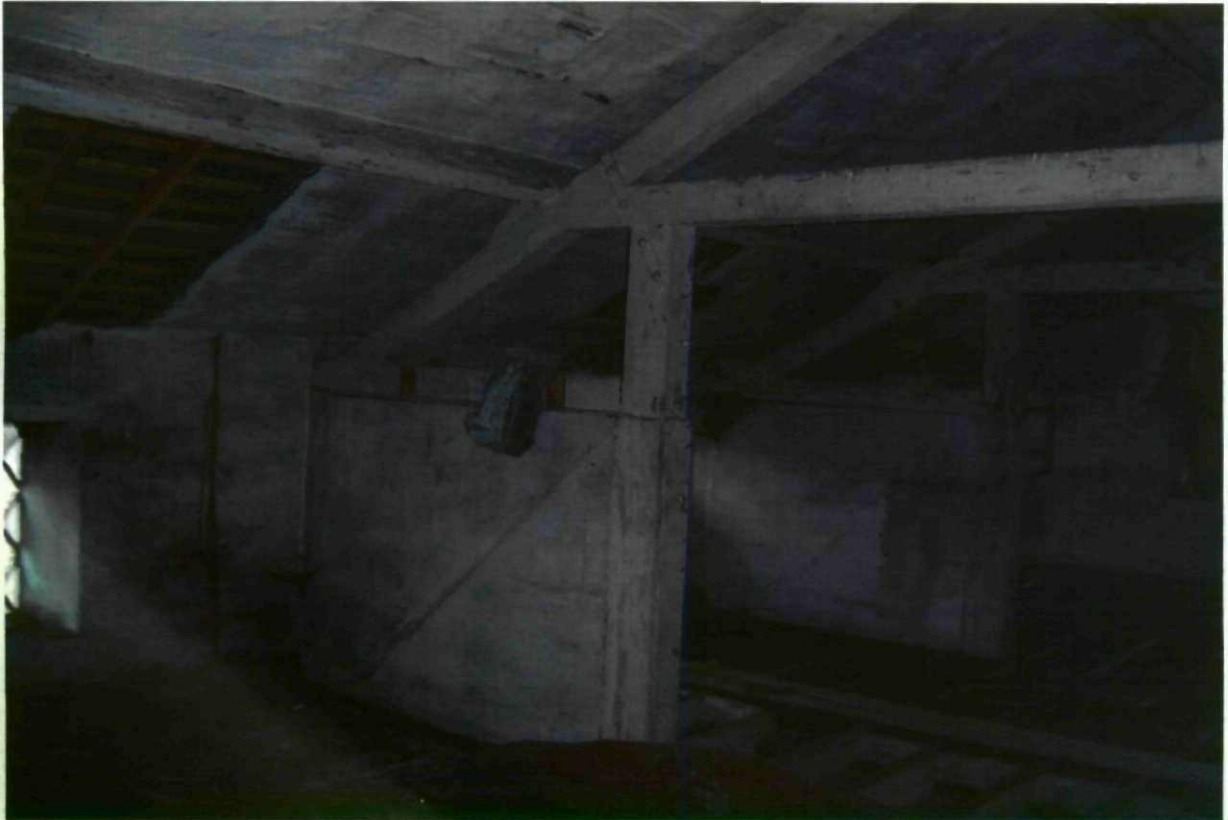
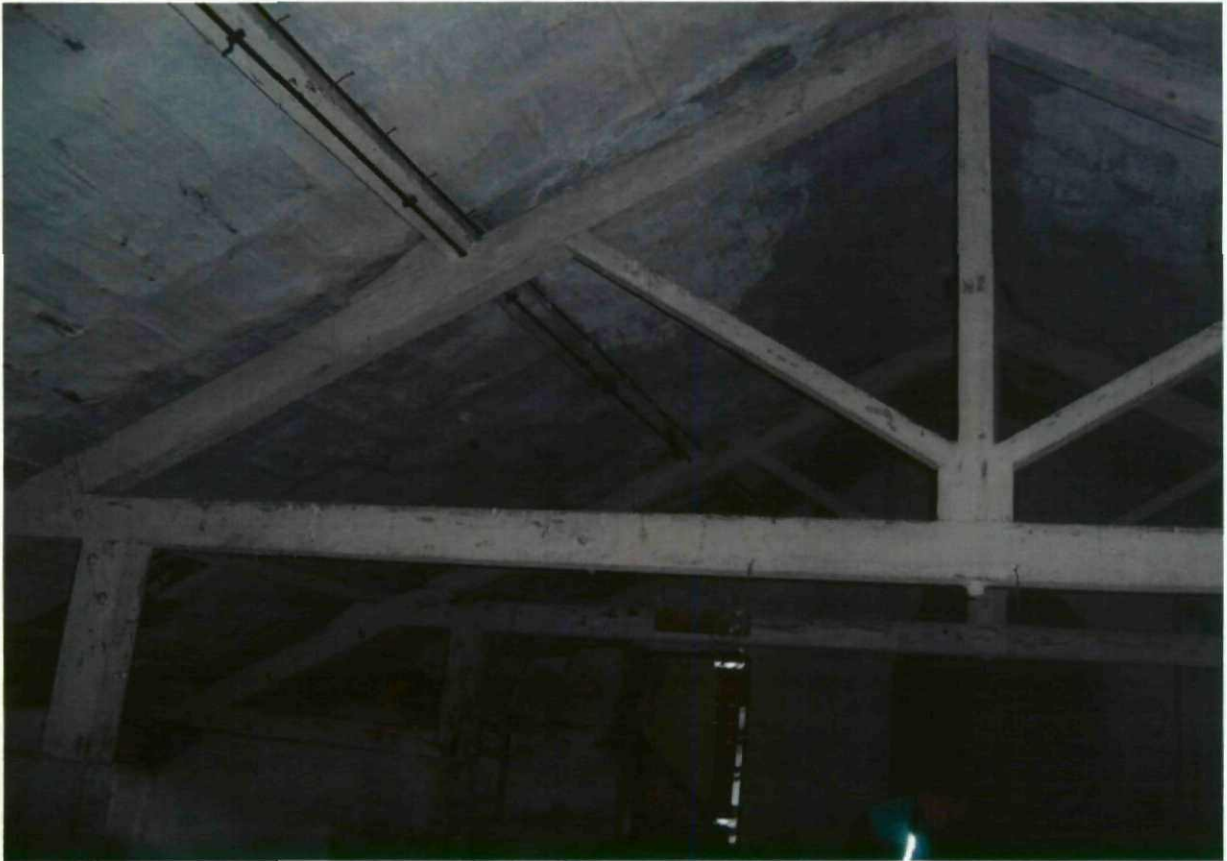
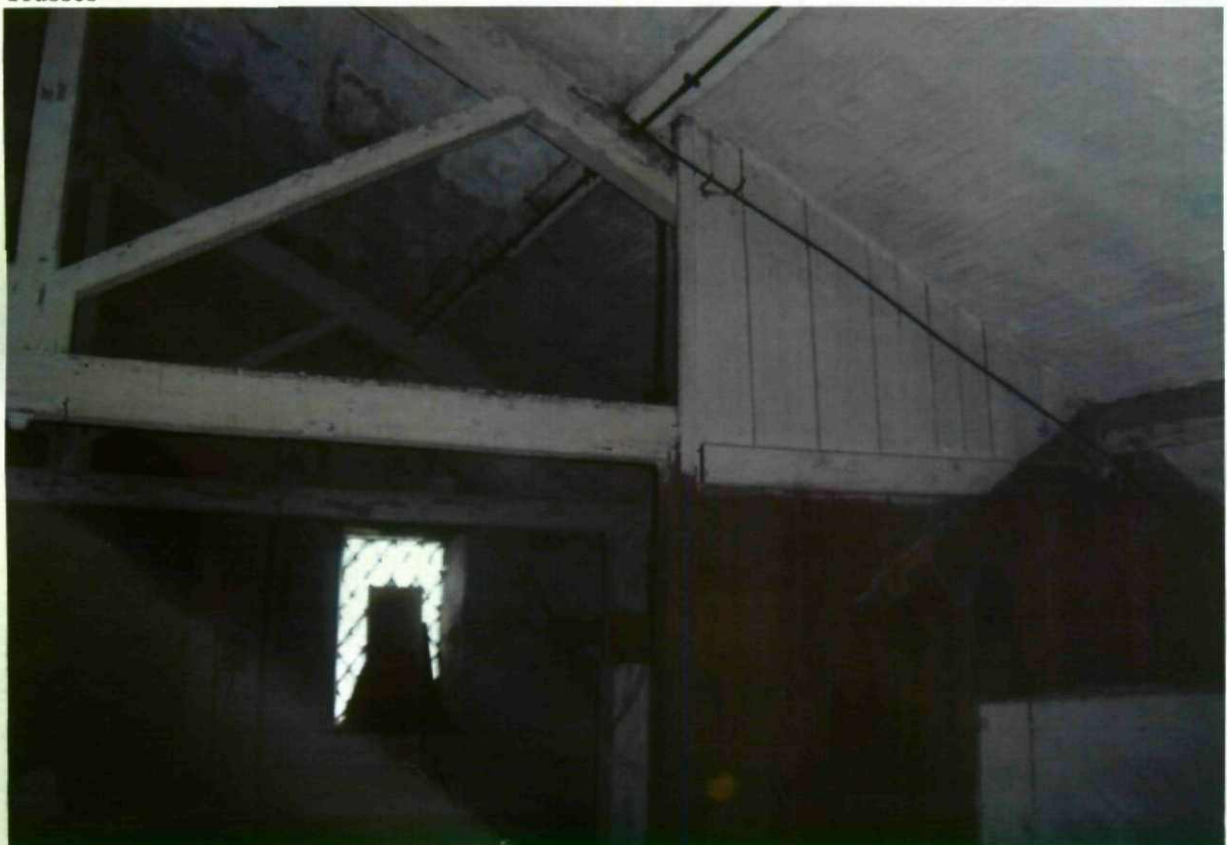
Trusses

To the front of the building a large area of first floor floor-boards has been removed. The remainder including floor-joists are affected by woodworm and rot. It is proposed to either treat or replace these members. A first floor beam and a number of valley rafters and purlins are also affected by woodworm and rot; it is proposed to treat and repair these. Numerous roof slates are missing, loose or perished; the roof covering is considered to have past its serviceable life and should be replaced.

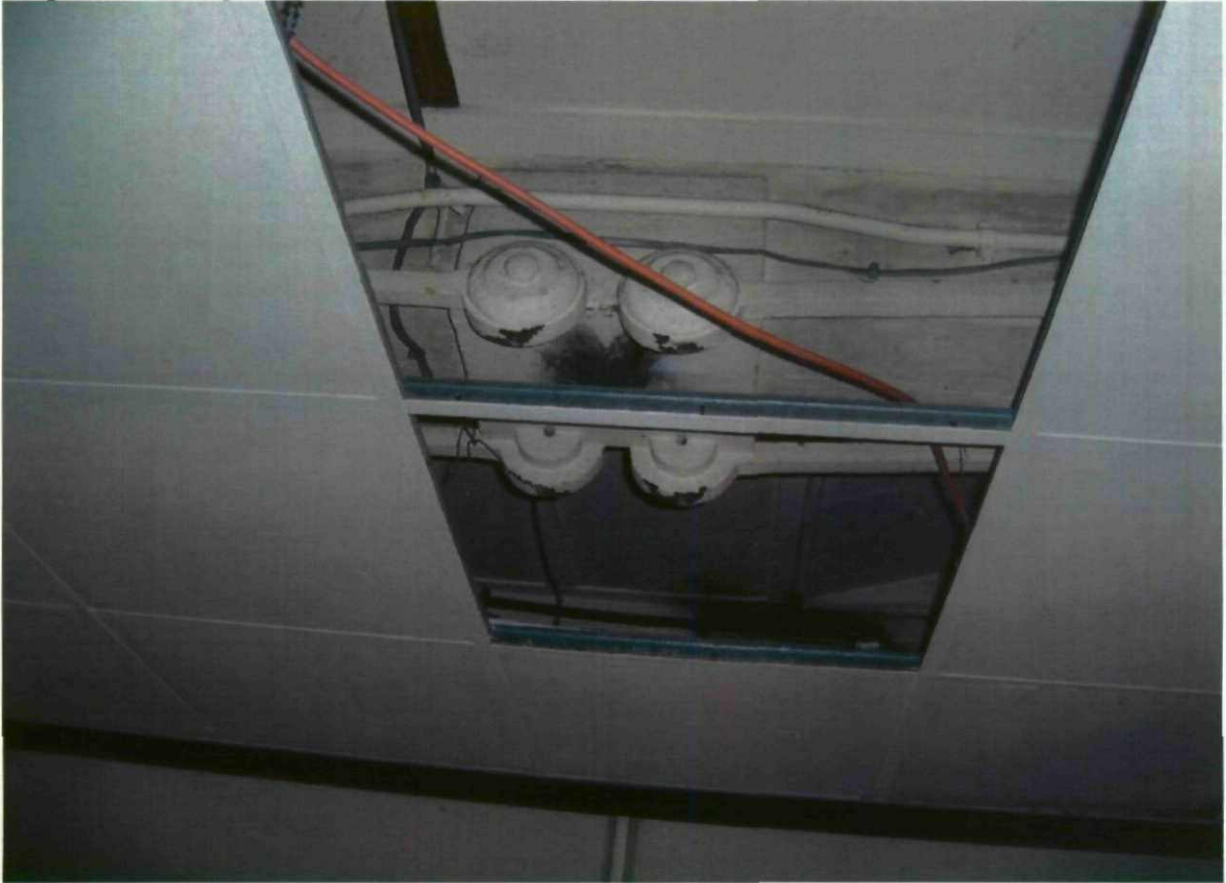
Suspended Ceiling/Trussed Beam

Due to dampness through out the building a chemical damp proof course is proposed. Most of the internal plaster is damp, loose or spalling and requires replacement. Internally at ground floor the original lay-out has been much altered with a mix of block and timber stud partitions and an inappropriate suspended ceiling. Details of its renovation as well as proposed details for doors and windows are illustrated on the architect's drawings.
