## **Heritage statement**

Alterations to listed building including repair and repointing of external stonework and replacement of ground floor windows and doors

114 Wath road  
Elsecar  
Barnsley  
S74 8JF

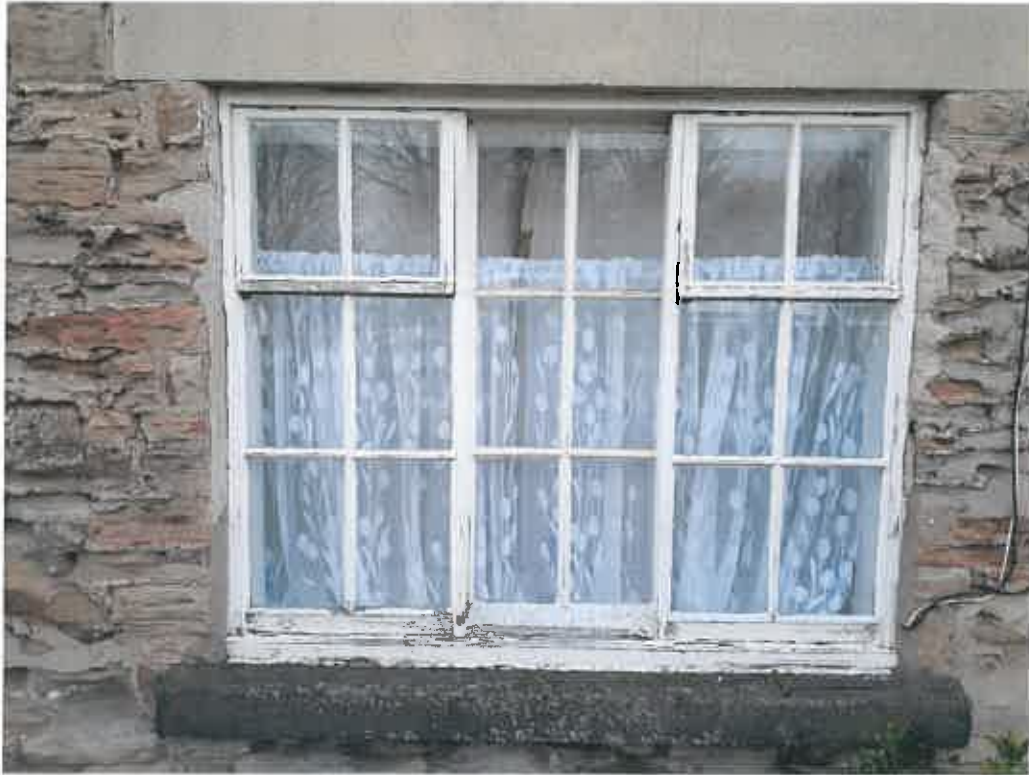
The ground floor windows are showing visible signs of decay and are in need of repair – see figures 1, 2, 3 and 4 below.

Figure 3 – Existing ground floor front window

The windows and front external door will be replaced like for like with due care given to the impact upon the listed building and the conservation area. They are required to be replaced in order to make the dwelling habitable, upholding the owner's comfort and safety. The existing front window is of a sliding mechanism with the middle section slightly recessed in comparison to the two outer sections. There has been recent similar works throughout Reform Row which this application is to aim to replicate, again upholding the good standard of design set by these works and respecting the necessary conservation of the listed building and Conservation area. Kirk and Cranston Ltd. (Carlton, Barnsley) will be constructing and fitting the proposed windows. The company is familiar with the area and have substantial knowledge of the windows needed to uphold conservation requirements having fitted windows with similar specifications in the area recently. As stated in the previous section, 114 Wath Road was used as an example of what would be required.

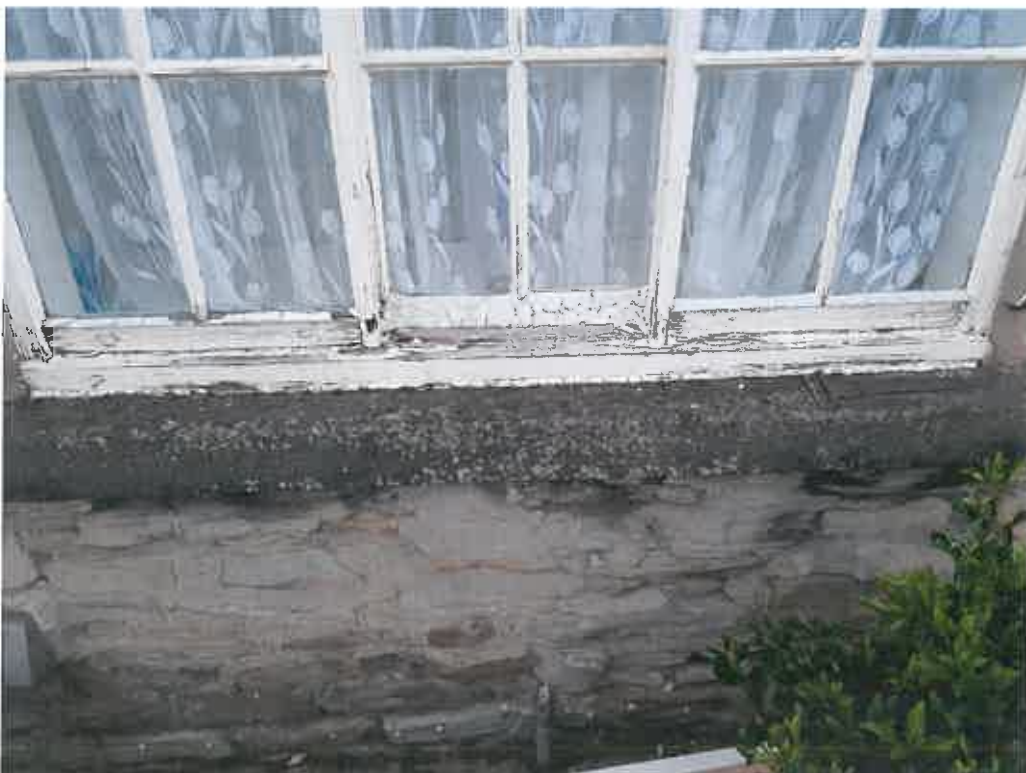
Figure 4 – Close up of existing ground floor front window showing visible signs of decay

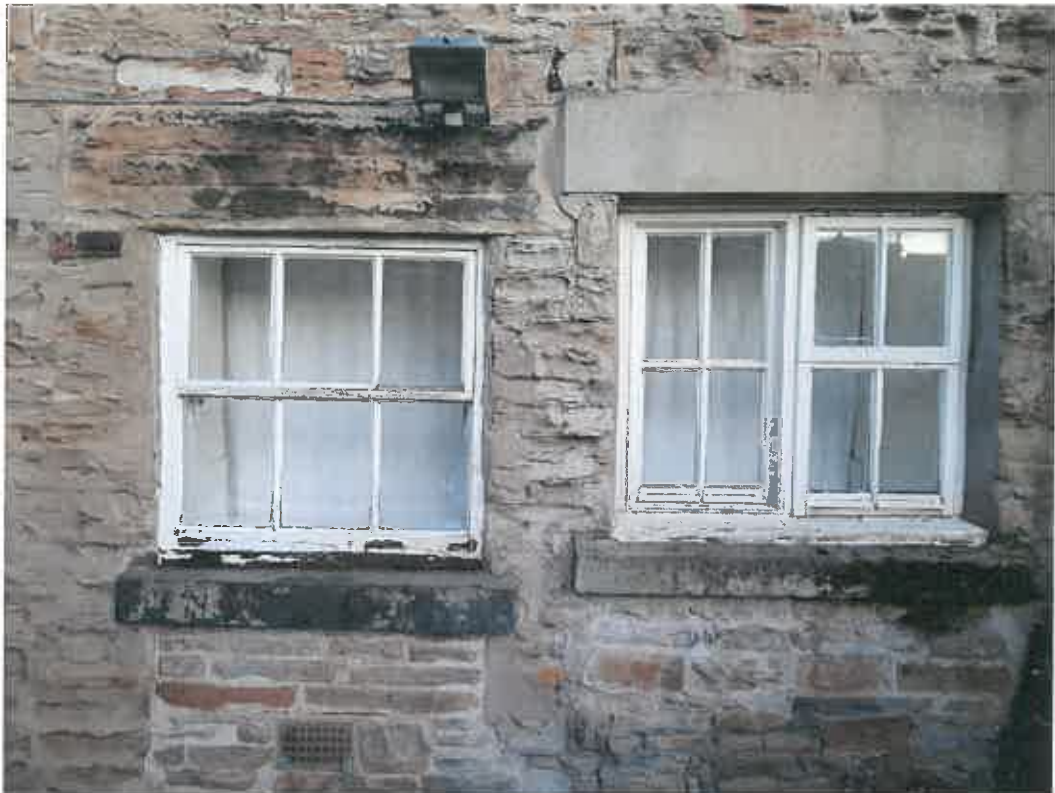
Figure 4 – Existing ground floor rear elevation windows

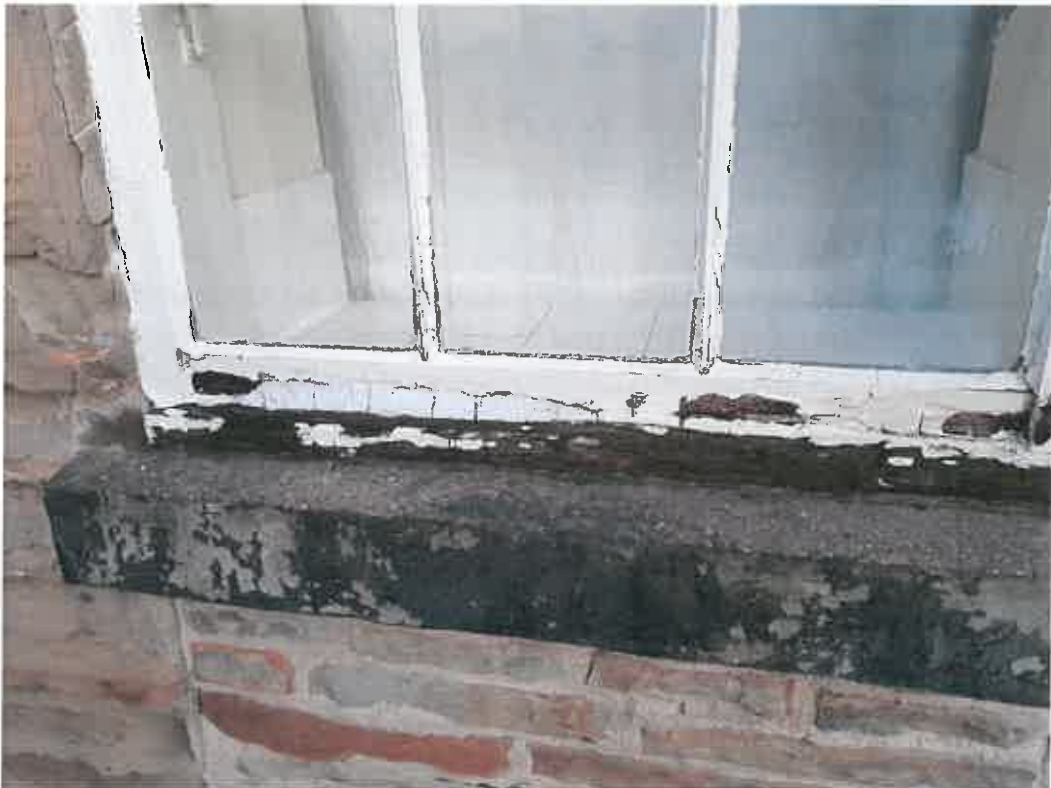
Figure 5 – Close up of existing ground floor rear window (left hand side) showing visible signs of decay

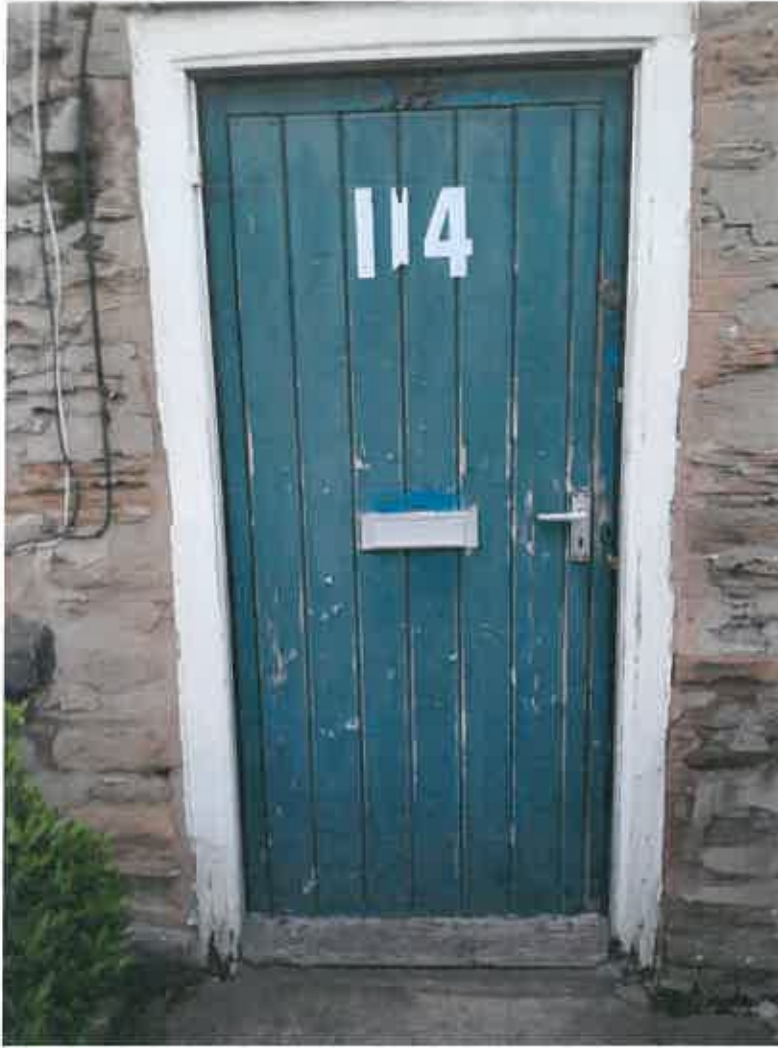
Figure 6 - Existing external front door with visible signs of decay

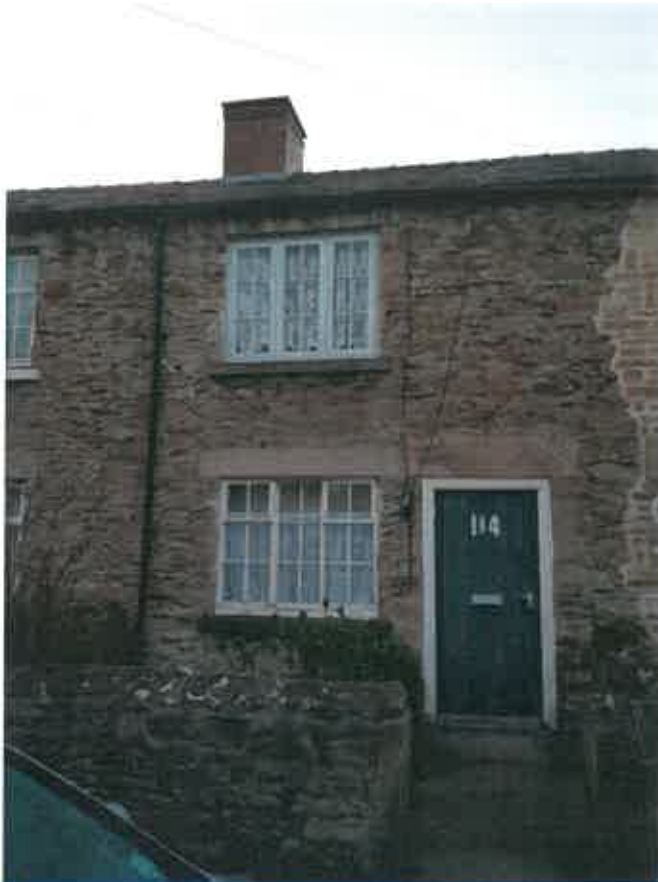
Figure 6 – Front elevation of the property – most of this area will require repair and repointing

As is common on Reform Row, the front and rear external walls of the property are in need of repair due to the weathering of large parts of the existing stonework. The

sandstone will be replaced where necessary and will be repointed using a lime mix mortar with a mix ratio to the conservation officer's requirements. Milton Construction Company (Hoyland, Barnsley) will be undertaking the work to repair and repoint the stonework. The company is familiar with the area and have also done similar work at a nearby dwelling – 130 Wath Road which was approved in 2014.

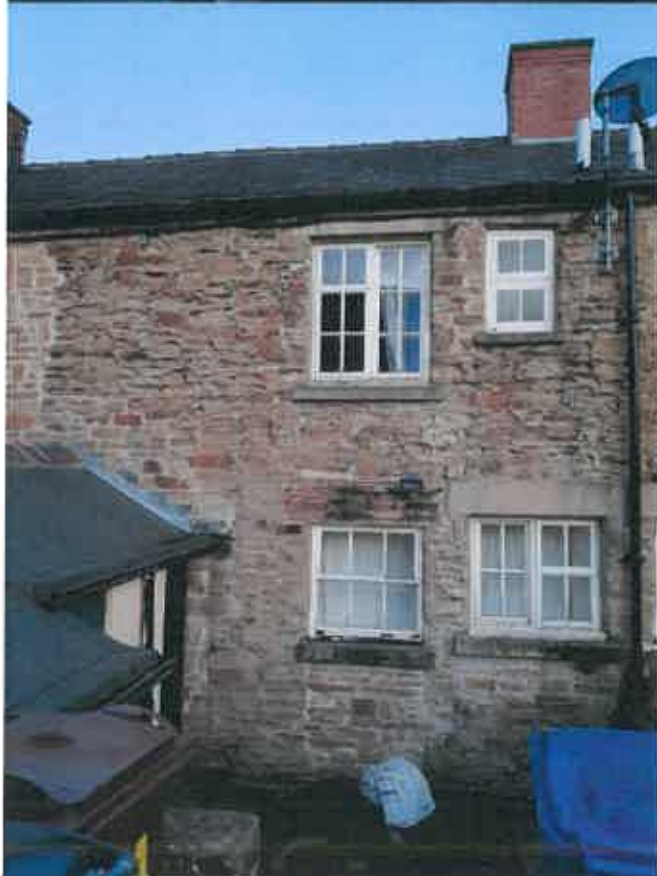
Figure 7 – Rear elevation of the property – most of this area will require repair and repointing. Just visible on the left hand side is the neighbouring property which has undergone similar works recently
