3500 OCH

WENTWORTH CASTLE, STAINBOROUGH, BARNESLEY: PROPOSED REPAIR OF OLD COACH HOUSE: CHANGES TO EXTERNAL APPEARANCE

DESIGN AND HERITAGE STATEMENT

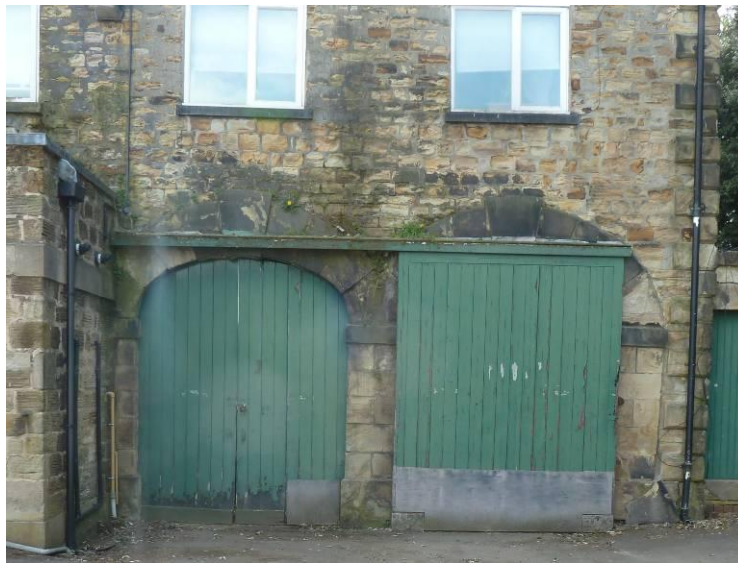
- Replacement of the sliding door to the northernmost garage with side-hung doors to match the remainder and removal of the unsightly externally mounted sliding door track

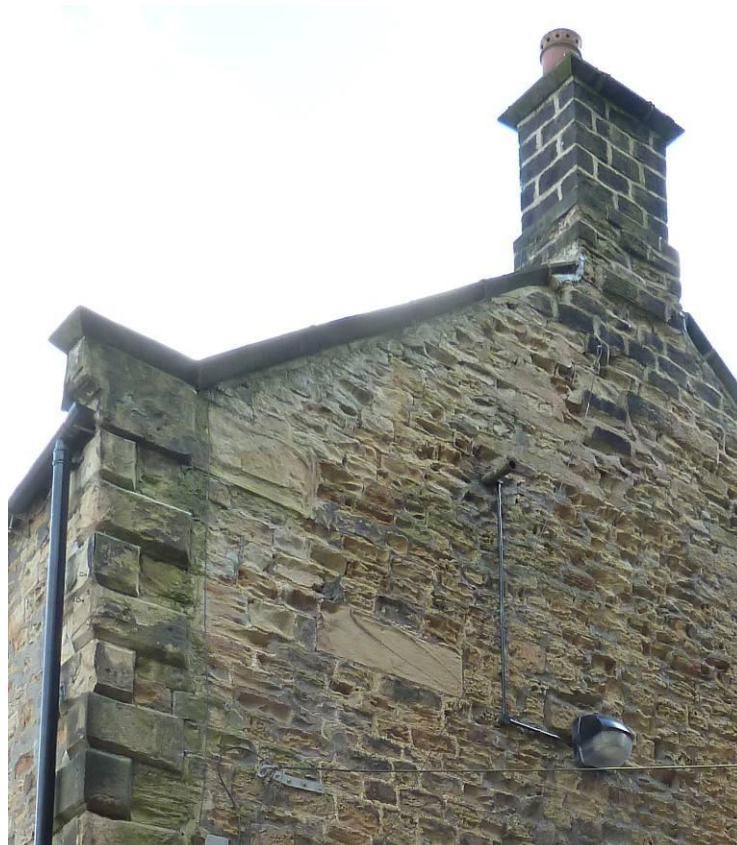
- Over-cladding the north gable with naturally durable hardwood on grounds and the provision of some thermal insulation. This is necessary because the masonry in this part of the building is so severely eroded as to be beyond economic repair.

The over-cladding of the north gable is the most significant change. To avoid the necessity to make extensive alterations to the gable parapet coping and the quoins and to leave these features which contribute to the character of the building exposed, it is proposed that the cladding spaced some 100mm off the wall is contained by a mill-finished aluminium angle trim to the top and both sides. The naturally durable boards will be jointed with an aluminium Z section to avoid butt joints. The boards will be finished with Tong Oil varnish to give them initial protection. This material is not durable and weathers away in an even fashion allowing the timber to adopt its natural weathered silver-grey colour in an even manner over a period of a few years without becoming streaked or marred by black staining. The aluminium will weather to a similar colour over the same period of time.
