**ARBORICULTURAL REPORT  
AND  
ARBORICULTURAL IMPACT ASSESSMENT  
to BS 5837:2012  
at  
1 Foxmill View  
Millhouse Green  
Penistone  
South Yorkshire  
S36 9AB**

**JCA Ref:**  
12255/AJB

### Appendix 6: Tree Constraints Plan

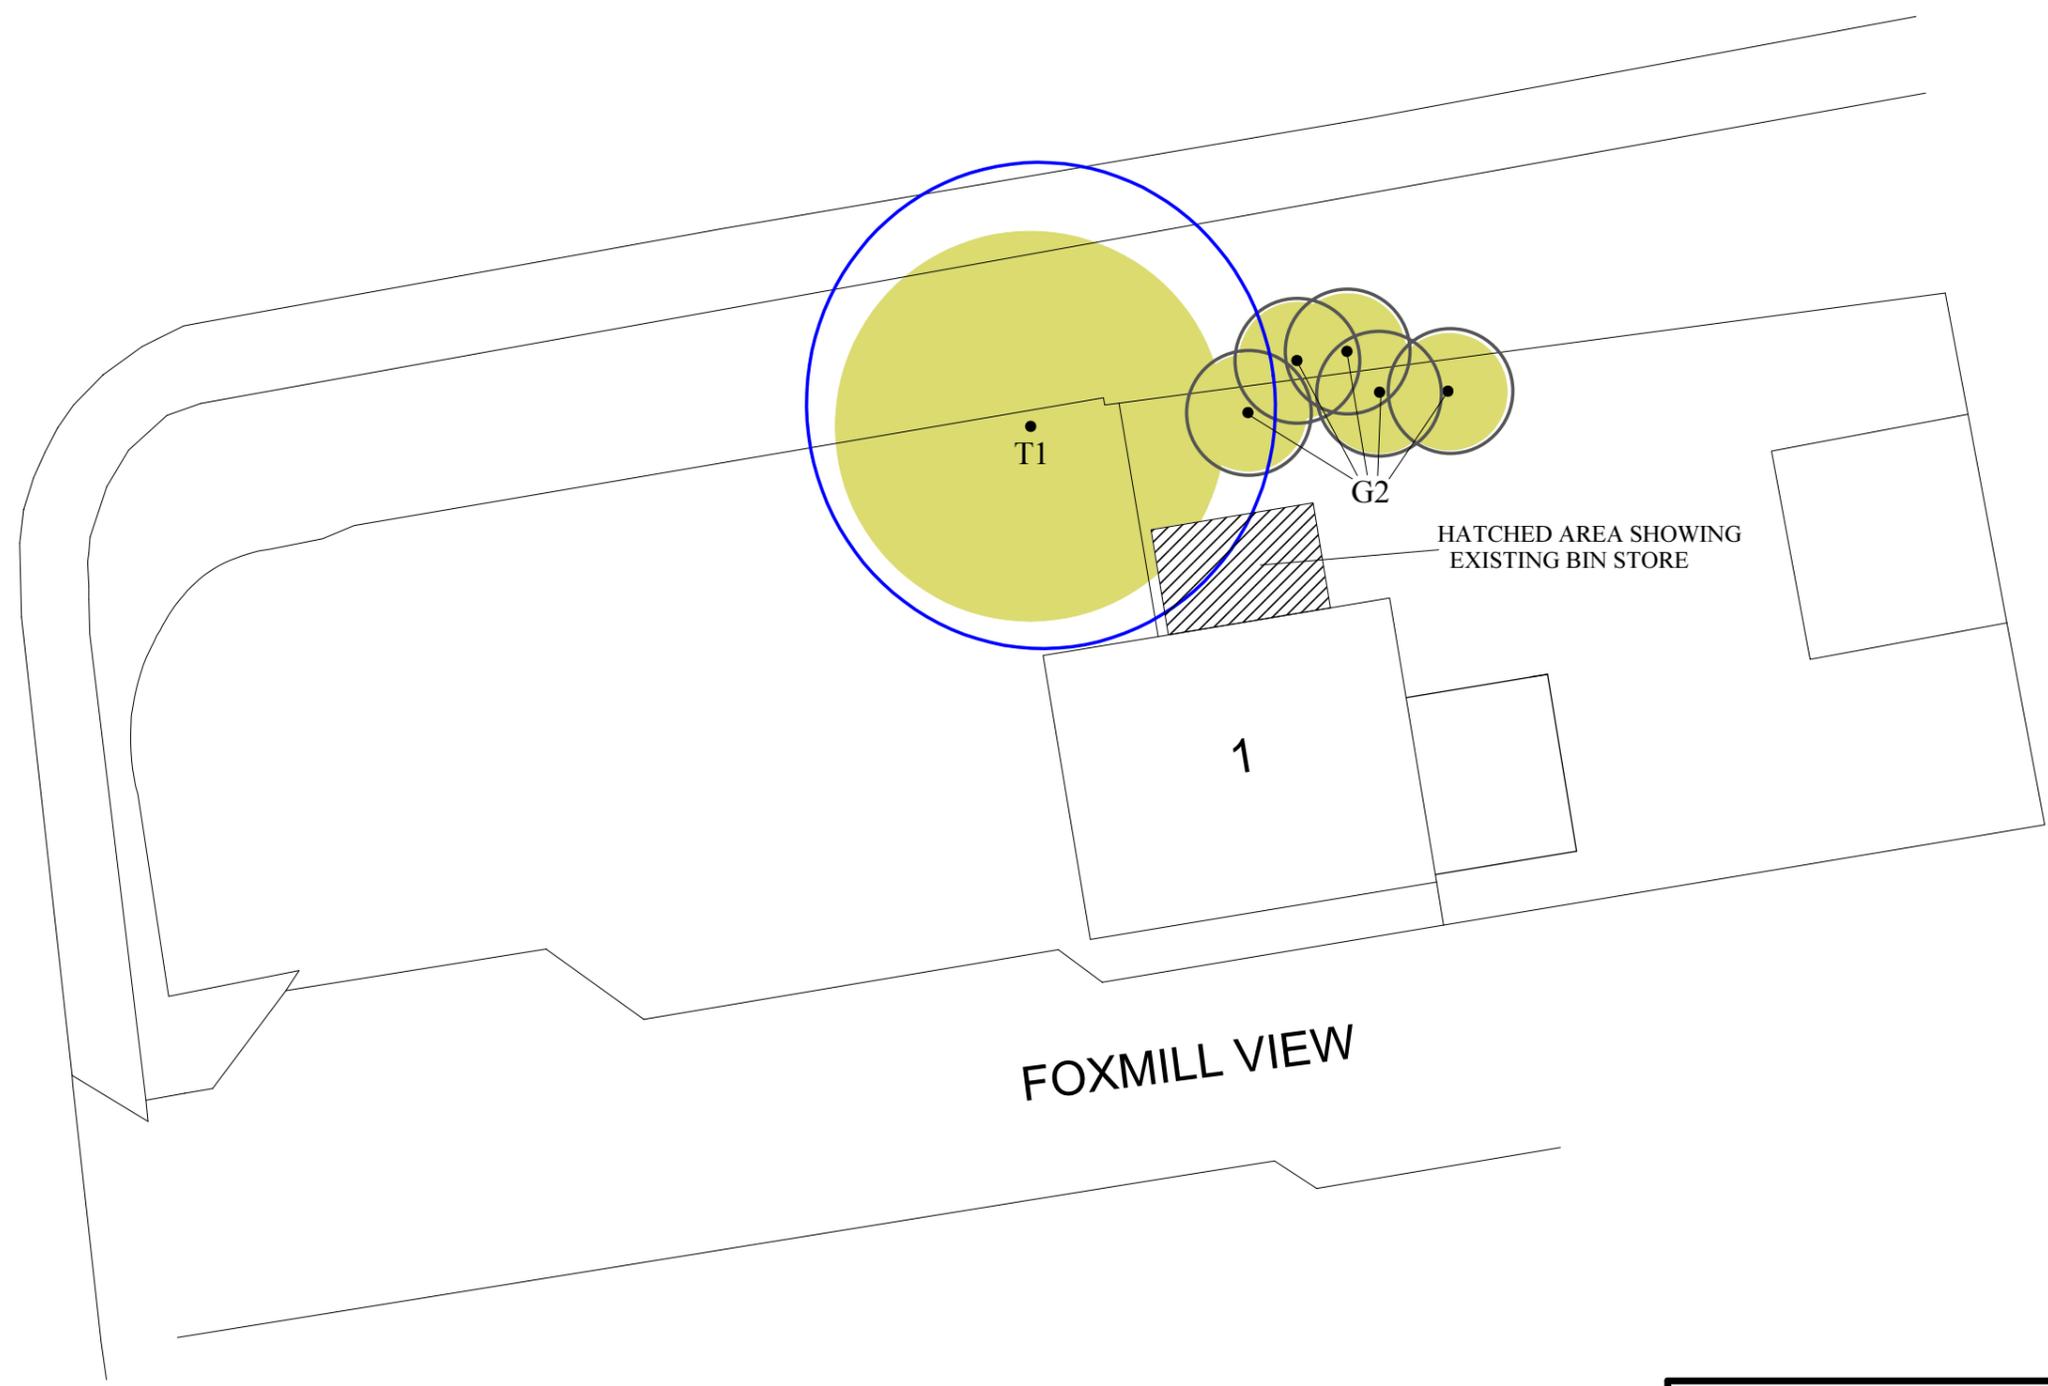
- 5.1.2 **T1** is a healthy tree of good form; however, the canopy of this tree touches the gable end of the existing building as it stands at present. As such; it is advised that it be pruned back by the removal of secondary branches only in order to allow for a clearance distance of 1.5m between the branch extents and the gable of the building. The minor deadwood noted throughout the crown should also be removed as part of this remedial work.

- 5.1.3 As **T1** overhangs the public footpath it shall also require future maintenance in order to maintain a clearance height of 2.5m for pedestrian traffic above the adjacent public footpath.

- 5.1.4 **G2** is comprised of what are presumed to be five self-seeded Sycamores and Common Ash of low overall value; these trees require no remedial action at this time.

HATCHED AREA SHOWING EXISTING BIN STORE

- 6.8.1 **T1** and **G2** will be protected during the construction phase by a temporary protective barrier (protective fencing), in accordance with BS 5837: 2012. The installation of the temporary protective barrier will be the very first job on site following the tree removal and pruning works.
- 6.8.2 Wherever possible the temporary protective barrier will be positioned to enclose the entire **Root Protection Area (RPA)** and canopies of the retained trees, in order to create a **Construction Exclusion Zone (CEZ)**.

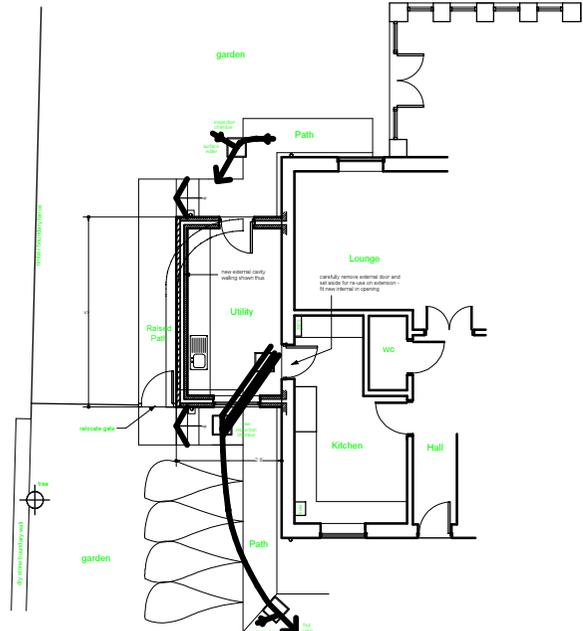
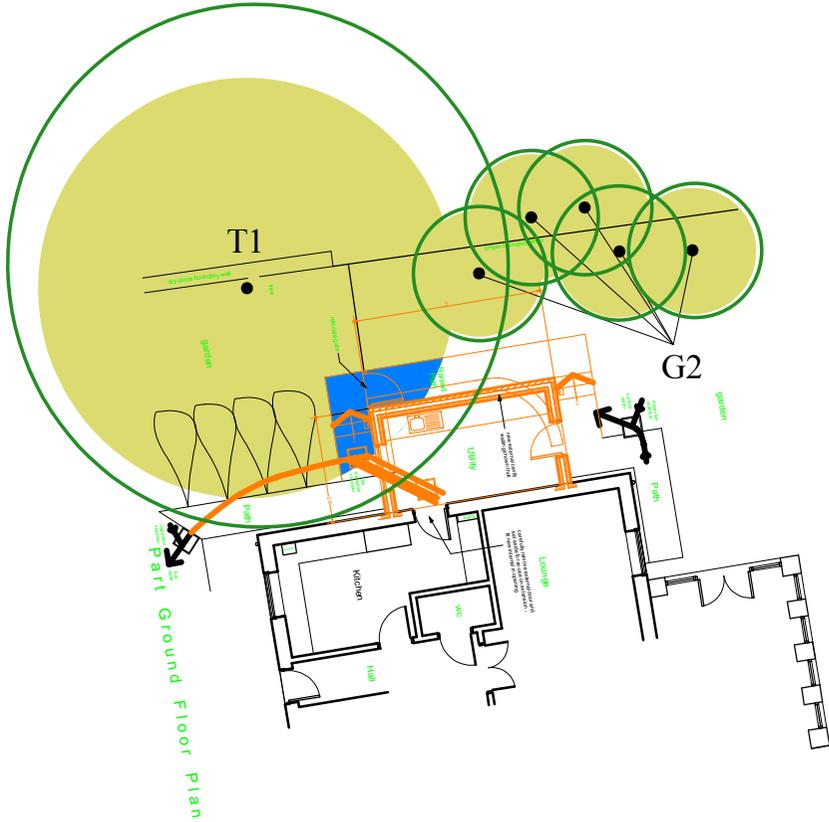
**Appendix 7:  
Development Proposals**

- 6.4.1 The proposed single storey extension is to be constructed on the same footprint as the existing bin store. The erection of this feature is considered to be outside the root protection area of **T1** will not result in any significant degree of root loss.

- 6.5.1 The proposed footpath and retaining wall encroach within the root protection area of **T1**. As such; they are to be constructed following the existing contours in ground level in order to minimise the risk of root damage to **T1**.

- 6.6.1 The proposed inspection chamber manhole is located within the far extent of the root protection area of **T1** (4.9m away from the base of the tree which has a root protection radius of 5.52m).
- 6.6.2 The excavations required in order to install this feature are likely to result in a negligible degree of fibrous root damage to **T1**. As such; the location of this manhole is considered to be acceptable as long as the excavations required remain vertical to its required footprint and do not encroach any further into the rooting zone of this tree.

- 6.3.1 In addition to the remedial works recommended for **T1** in **Section 5.1.2**, in order to facilitate the construction of the proposed single storey extension it will necessary to facilitate the construction of the proposed single storey extension it will necessary to crown lift the southern aspect of **T1** to a height of no more than 4.5m by the removal of secondary branches only where possible.

- 6.5.2 The exact method of construction of the proposed footpath and retaining wall are not known at present, as such; these issues will be discussed at a later date in an Arboricultural Method Statement in accordance with *BS 5837:2012 Trees in relation to design, demolition and construction - Recommendations*.
- 6.5.3 It is important to note that all excavations within the root protection area must be carried out in a cautious manner in order to minimise root damage to **T1**. Only hand tools are permitted within the area shown in blue on the Development Proposals Plan at **Appendix 7**. The use of machinery within this area is not permitted.
