Woodwalk, Hoyland – BS 5837: 2012 Arboricultural Report, Impact Assessment and Method Statement

Ref: 21805

Report Title: Wood Walk Hoyland – BS 5837:2012 Arboricultural Report,
Impact Assessment and Method Statement

Version: V5.0
Issue Date: May 2026
Report Ref: 21805

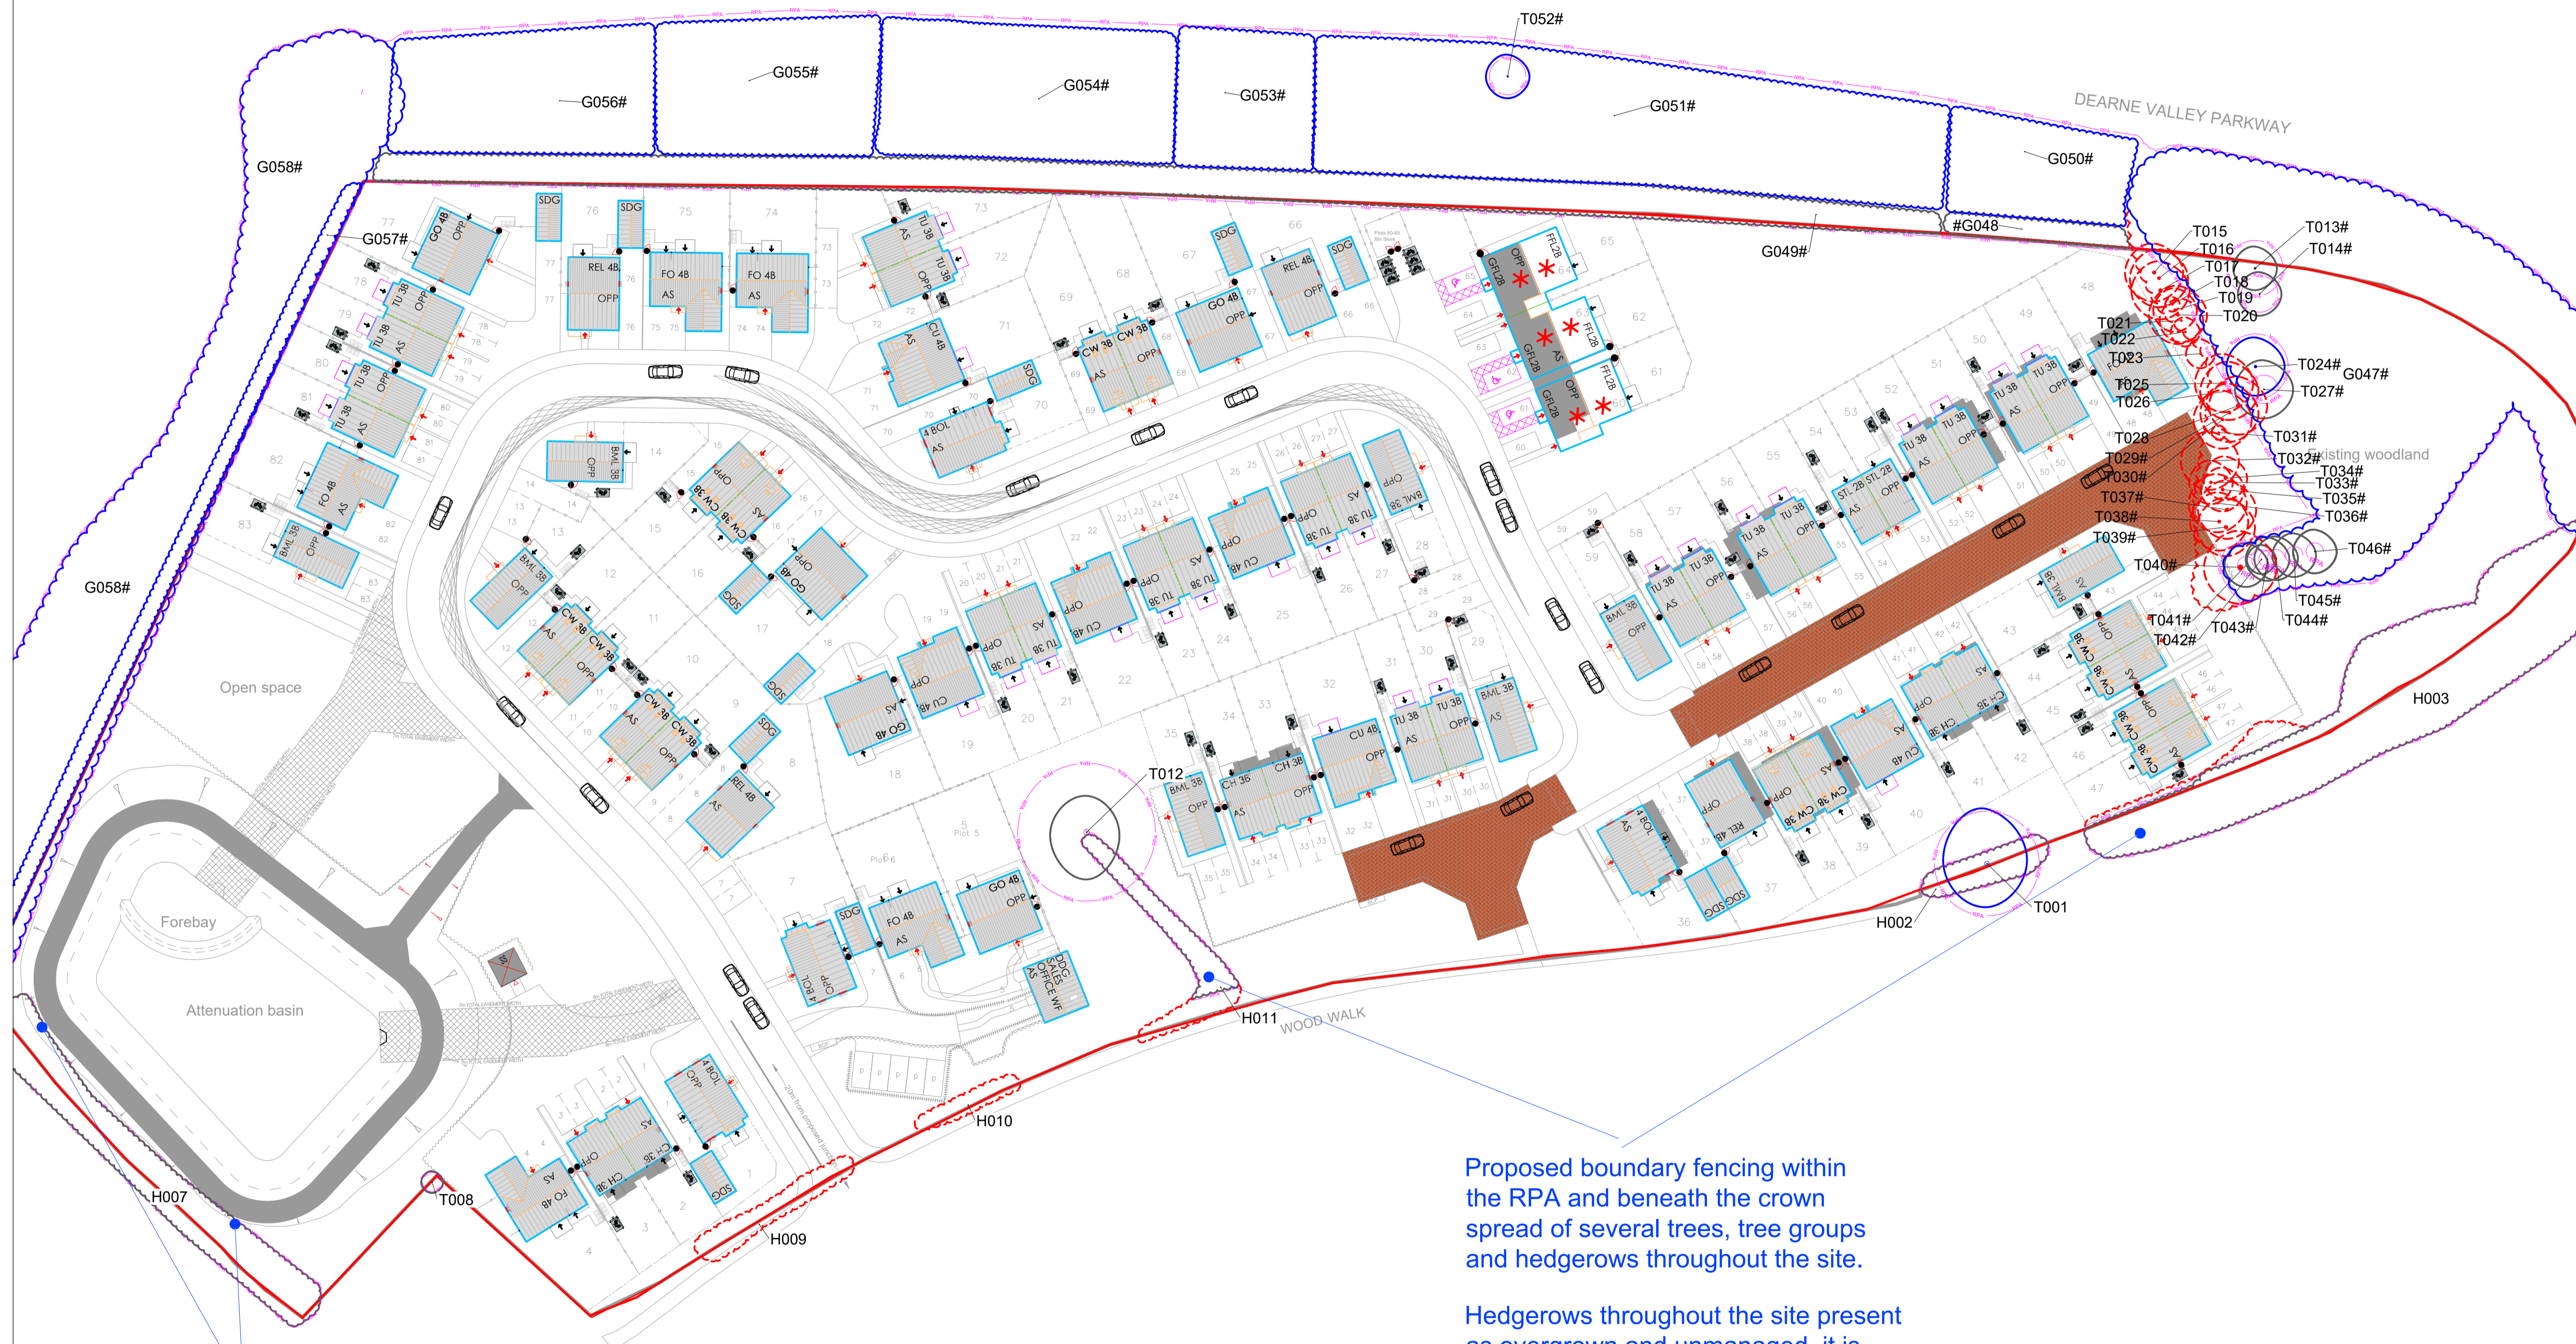
Proposed access track at edge of RPA and canopy of H007 here.

Proposed boundary fencing within the RPA and beneath the crown spread of several trees, tree groups and hedgerows throughout the site.

Hedgerows throughout the site present as overgrown and unmanaged, it is recommended that these be brought under formal/periodic management through regular cyclical pruning.
