Gun Room in Wentworth Castle Gardens

Bat Survey Report

7th May 2025

Document ref: MBE/BAT/2025/011/02				
Purpose and Description	Originated	Checked	Reviewed	Date
For Planning	R Bell MCIEEM <i>R Bell</i>	P Middleton MCIEEM <i>P Middleton</i>	R Bell MCIEEM <i>R Bell</i>	07/05/2025

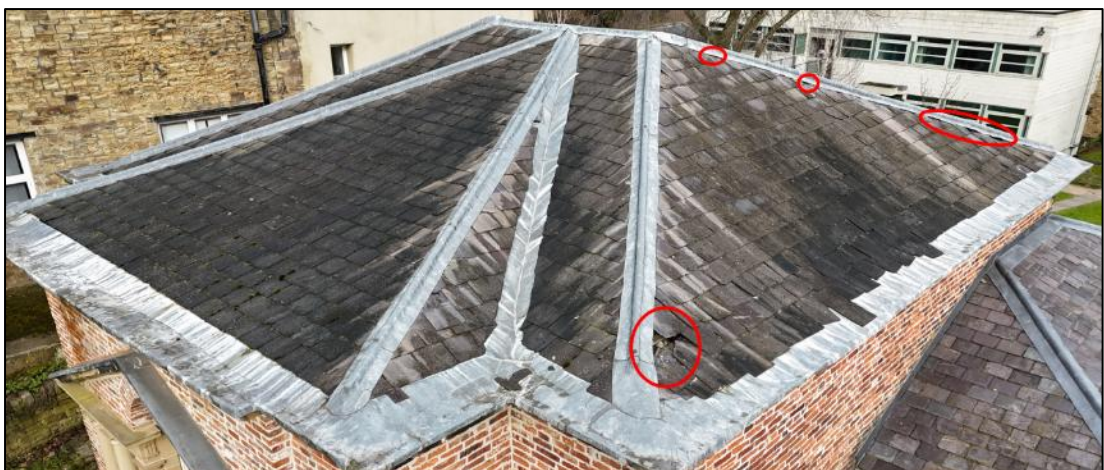
- Various sections of lifted flashing on the hips, ridge and wall tops of the main roof (Plate 7).
- Some missing and slipped slates on the roof of the main house (Plate 7).
- An open joint (c.2 cm x c. 5 cm) between decorative stone blocks on wall top of southwest elevation (Plate 8).
- Gaps, up to 3 cm in width, between the wooden fascia board and masonry on the northeast elevation of Dairy Cottage (Plate 9).

Plate 7. Missing slates and lifted flashing on main roof

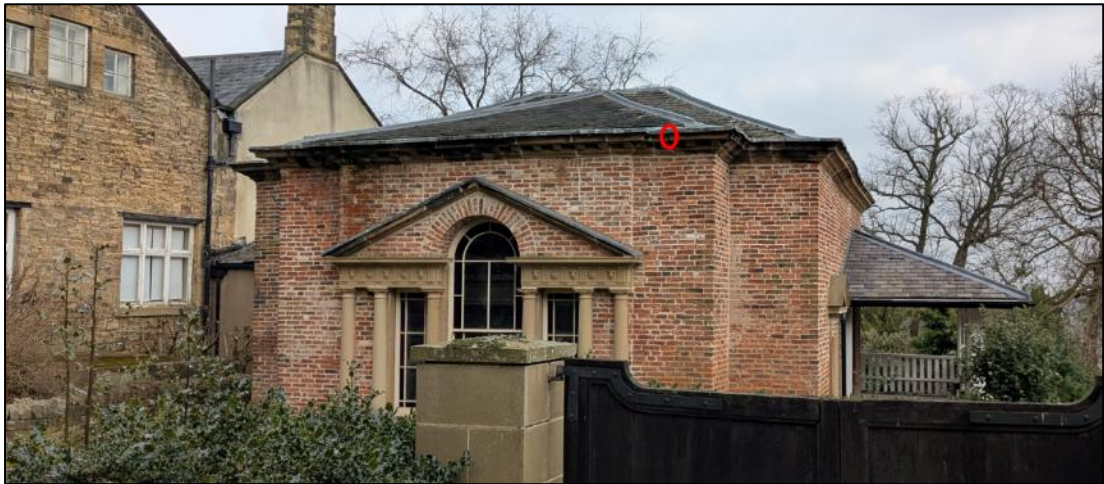
Plate 8. Open joint on southwest elevation of main building

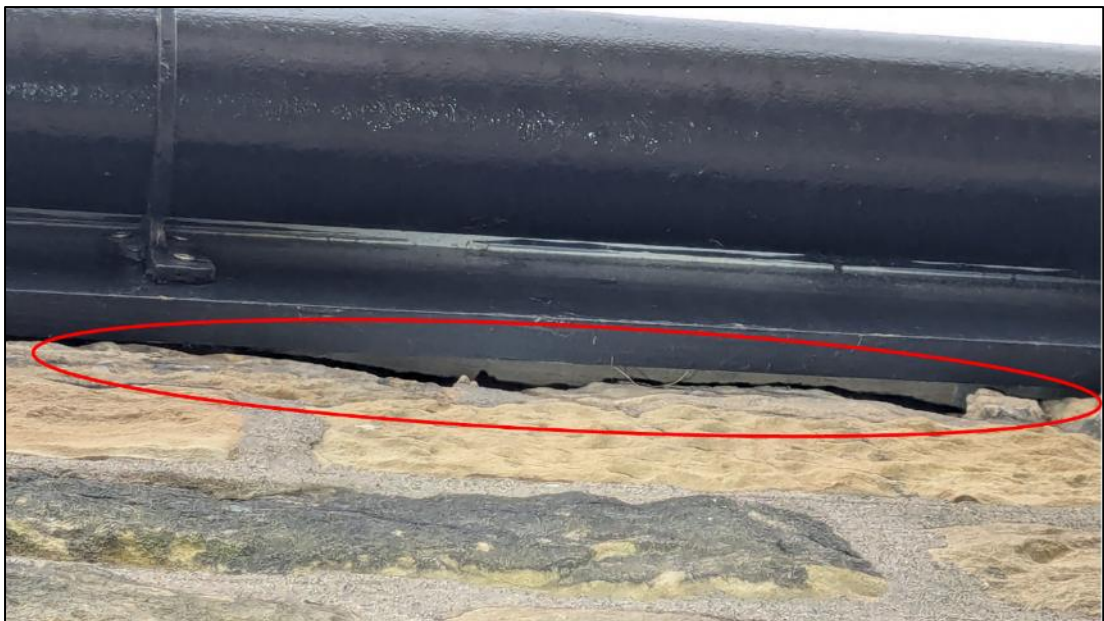
Plate 9. Gap behind fascia board on northeast elevation of Daisy Cottage

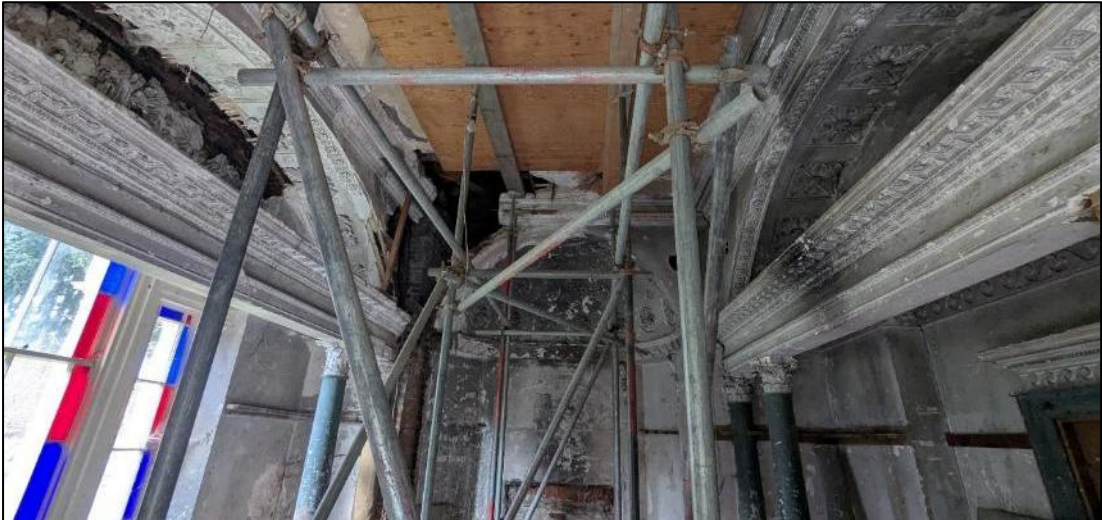
Plate 10. Interior of Gun Room

- 5.2.8 The main roof was lined with hessian-backed Type 1F bituminous felt and suspended on a ridge beam, rafters, purlins and battens. A roof void c.1.2 m high was present, with the ceiling having partially failed. The ceiling within the interior of the main building was supported with scaffold, with plaster remaining on internal walls. No signs of bats were recorded from any area within the interior of this building (Plate 10).

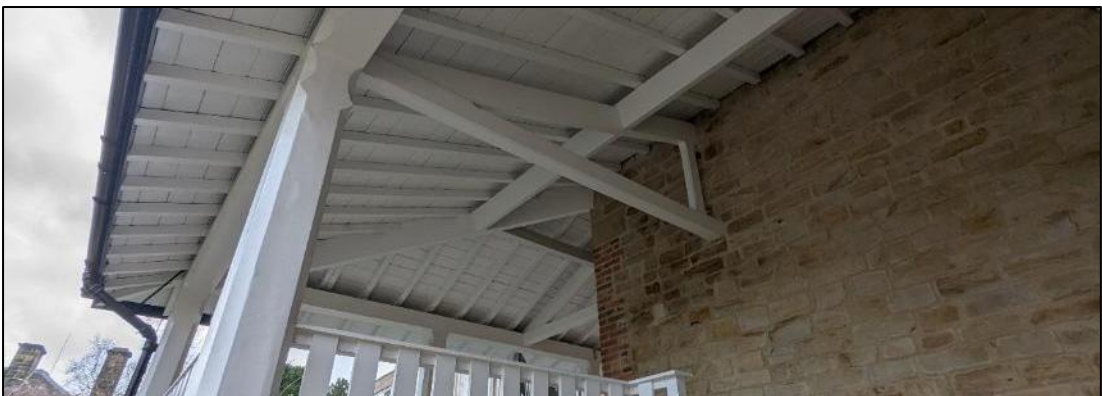
Plate 11. Interior of veranda roof

- 5.2.10 The veranda roof was lined with hessian-backed Type 1F bituminous felt as well as wooden sarking, suspended on rafters and purlins (Plate 11). In two places, gaps were

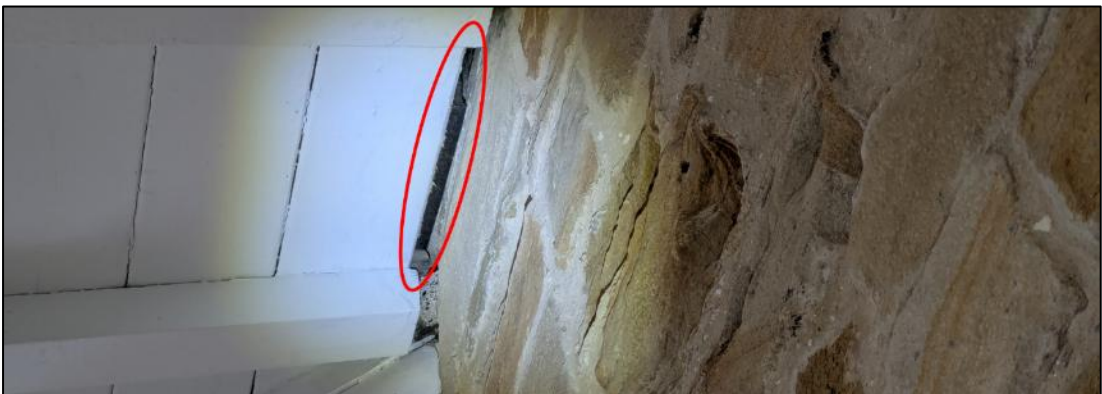
present at the top of the wooden sarking. In one of these locations, this opening would allow bats access behind the flashing at the junction of the veranda roof and the wall of the main section of the building. No signs of bats were however recorded from any section of the veranda.

Plate 12. Gap at top of sarking on underside of veranda roof, potentially allowing bats access to crevice space behind flashing.
