**MINING RISK ASSESSMENT**

**HUNGER HILL FARM, HAIGH HEAD ROAD, HOYLANDSWAINE**

**DC21 LTD.**

Report No J2166/12/E

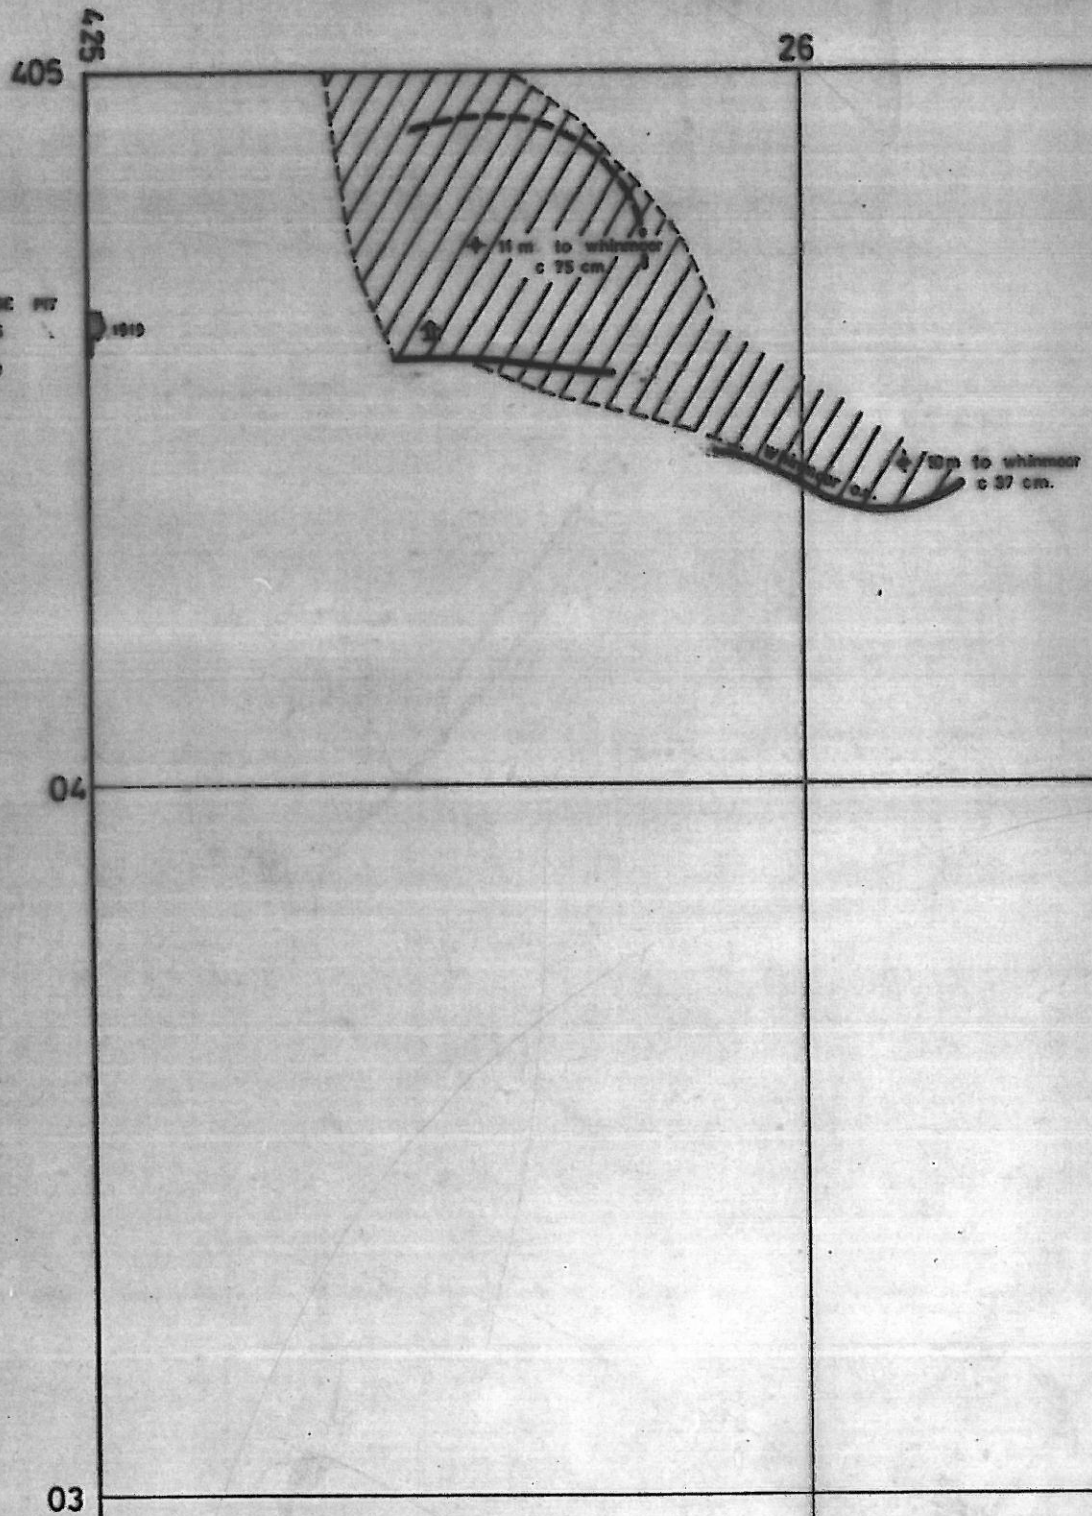
WELLHOUSE PT  
WORKINGS  
1919-21  
CAT. No. 577

The abandonment plan shows a hatched area of possible workings within the Whinmoor Coal associated with the Wellhouse Pit from 1919 to 1921. Two shaft markers are on the plan and state '*11m to Whinmoor, c 75cm*' and '*10m to Whinmoor, c 37cm*'. Furthermore, there are lines on the plan, which when compared to the BGS map sheet, appear to show the outcrops of the Top Whinmoor Coal. The plan is reference to Ordnance Survey grid lines, these grid lines have been used to overlay the plan on to a modern aerial view of the site, this work is also presented within Appendix 3, although it should be appreciated that there is a limited accuracy to this process.

Hatched area indicates possible workings as shown  
on Coal Commission plans - no accurate records  
at M.R.O. Rammarah.

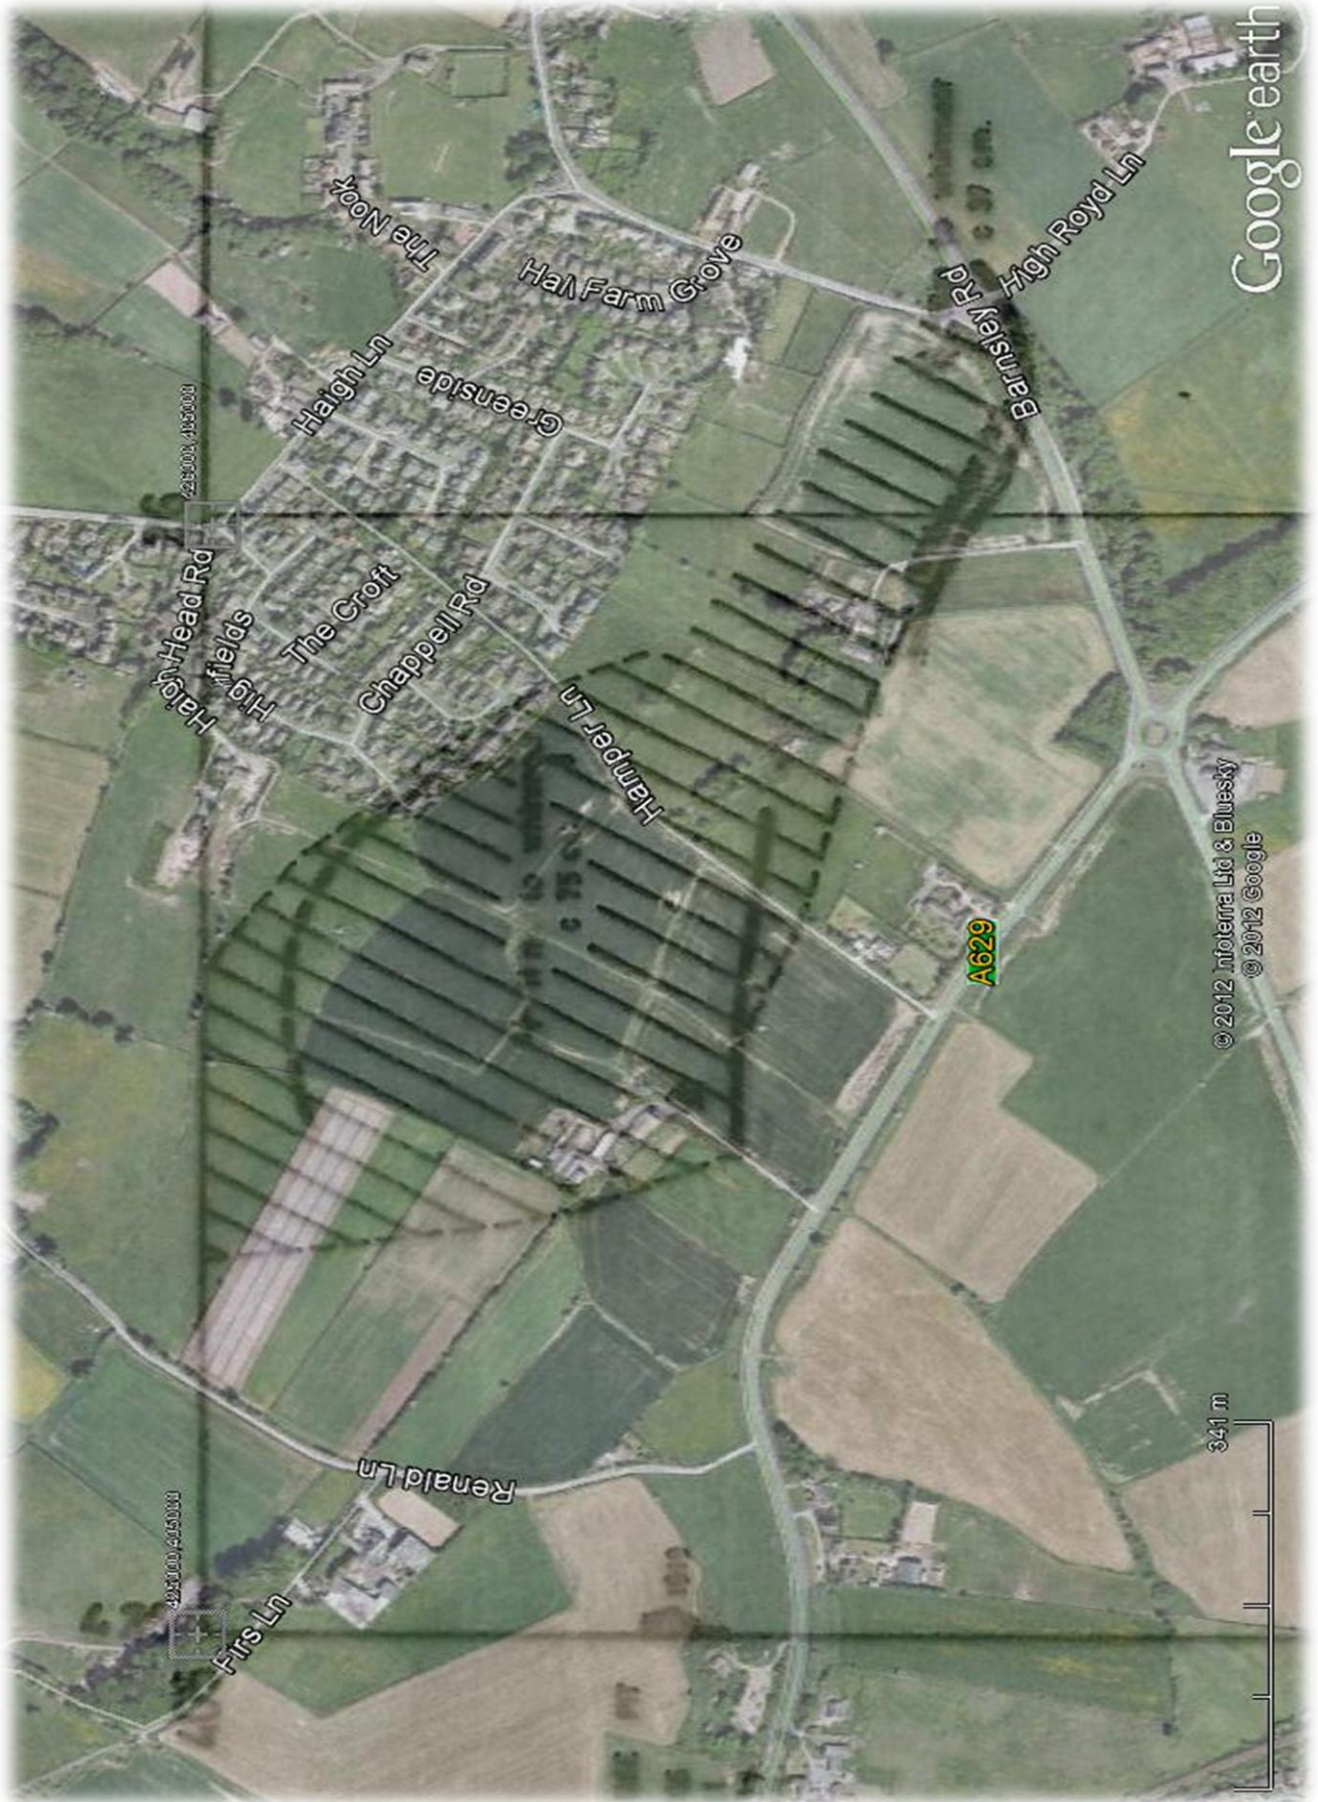
Title: **Coal Abandonment Plan Overlay**

The overlay of the mine abandonment plan clearly shows that the turbine location is located above the possible workings and in addition, the shaft marker on the plan shows a reasonable correlation with the location of the suspected shaft given by the client.

It should be appreciated that the height above sea level of the ground at the position of the mine shaft and the turbine are approximately the same, within say 1m. On this basis, it is considered that there are workings within the Whinmoor Coal seam at approximately 11m depth below the turbine position.

As a consequence of the above, it is concluded that there may be an insufficient thickness of competent rock above any workings within the Top Whinmoor Coal. Therefore, the risk of instability to the workings is considered to be moderate/high, particularly as the thickness of weaker overburden is not known and that the foundation is likely to stress the ground immediately above the workings.

It is therefore recommended that the ground below proposed turbine location be investigated for the presence of fault breccia. Should the fault be found below or in close proximity to the turbine foundation, it would need to be grouted to stabilise the weak material and the foundation base designed to cope with some movement.

In regard to the shallow potentially worked coal seams, the ground below the proposed turbine foundation would again need to be investigated to establish the nature of the underlying material and the presence of any voids. Any voids revealed may need to be stabilised, which is typically achieved by grouting. However, it should be noted that a single investigated position would not be sufficient as it may encounter a pillar within the workings and miss an adjacent void.

As an alternative to grouting, it may be possible to found the turbine base on drill and cased piles. In this scenario, the casing would need to be drilled to the underside of any voids and the piles formed below within competent rock. If this approach is considered further then the advice of a specialist contractors would be required. It is probable that the chosen contractor would require additional investigation in order to formulate a suitable design. Such an investigation should include a rotary cored borehole with core recovery. It cannot be recommended that driven piles be employed as this installation method may lead to destabilising any workings. Equally, uncased piles would not be appropriate as there is no method to form the piles in voided ground.

As a consequence of the conclusions in this report, consideration may be given to relocating the proposed turbine. In this event, careful consideration will need to be given to the mine abandonment plans and the area of workings below the site, as the same considerations will be required within these areas.
