ARBORICULTURAL REPORT

& Impact Assessment

***Greenland Cottages,
High Hoyland,
Barnsley,
South Yorkshire
S75 4AZ***

Reference: AWA1983

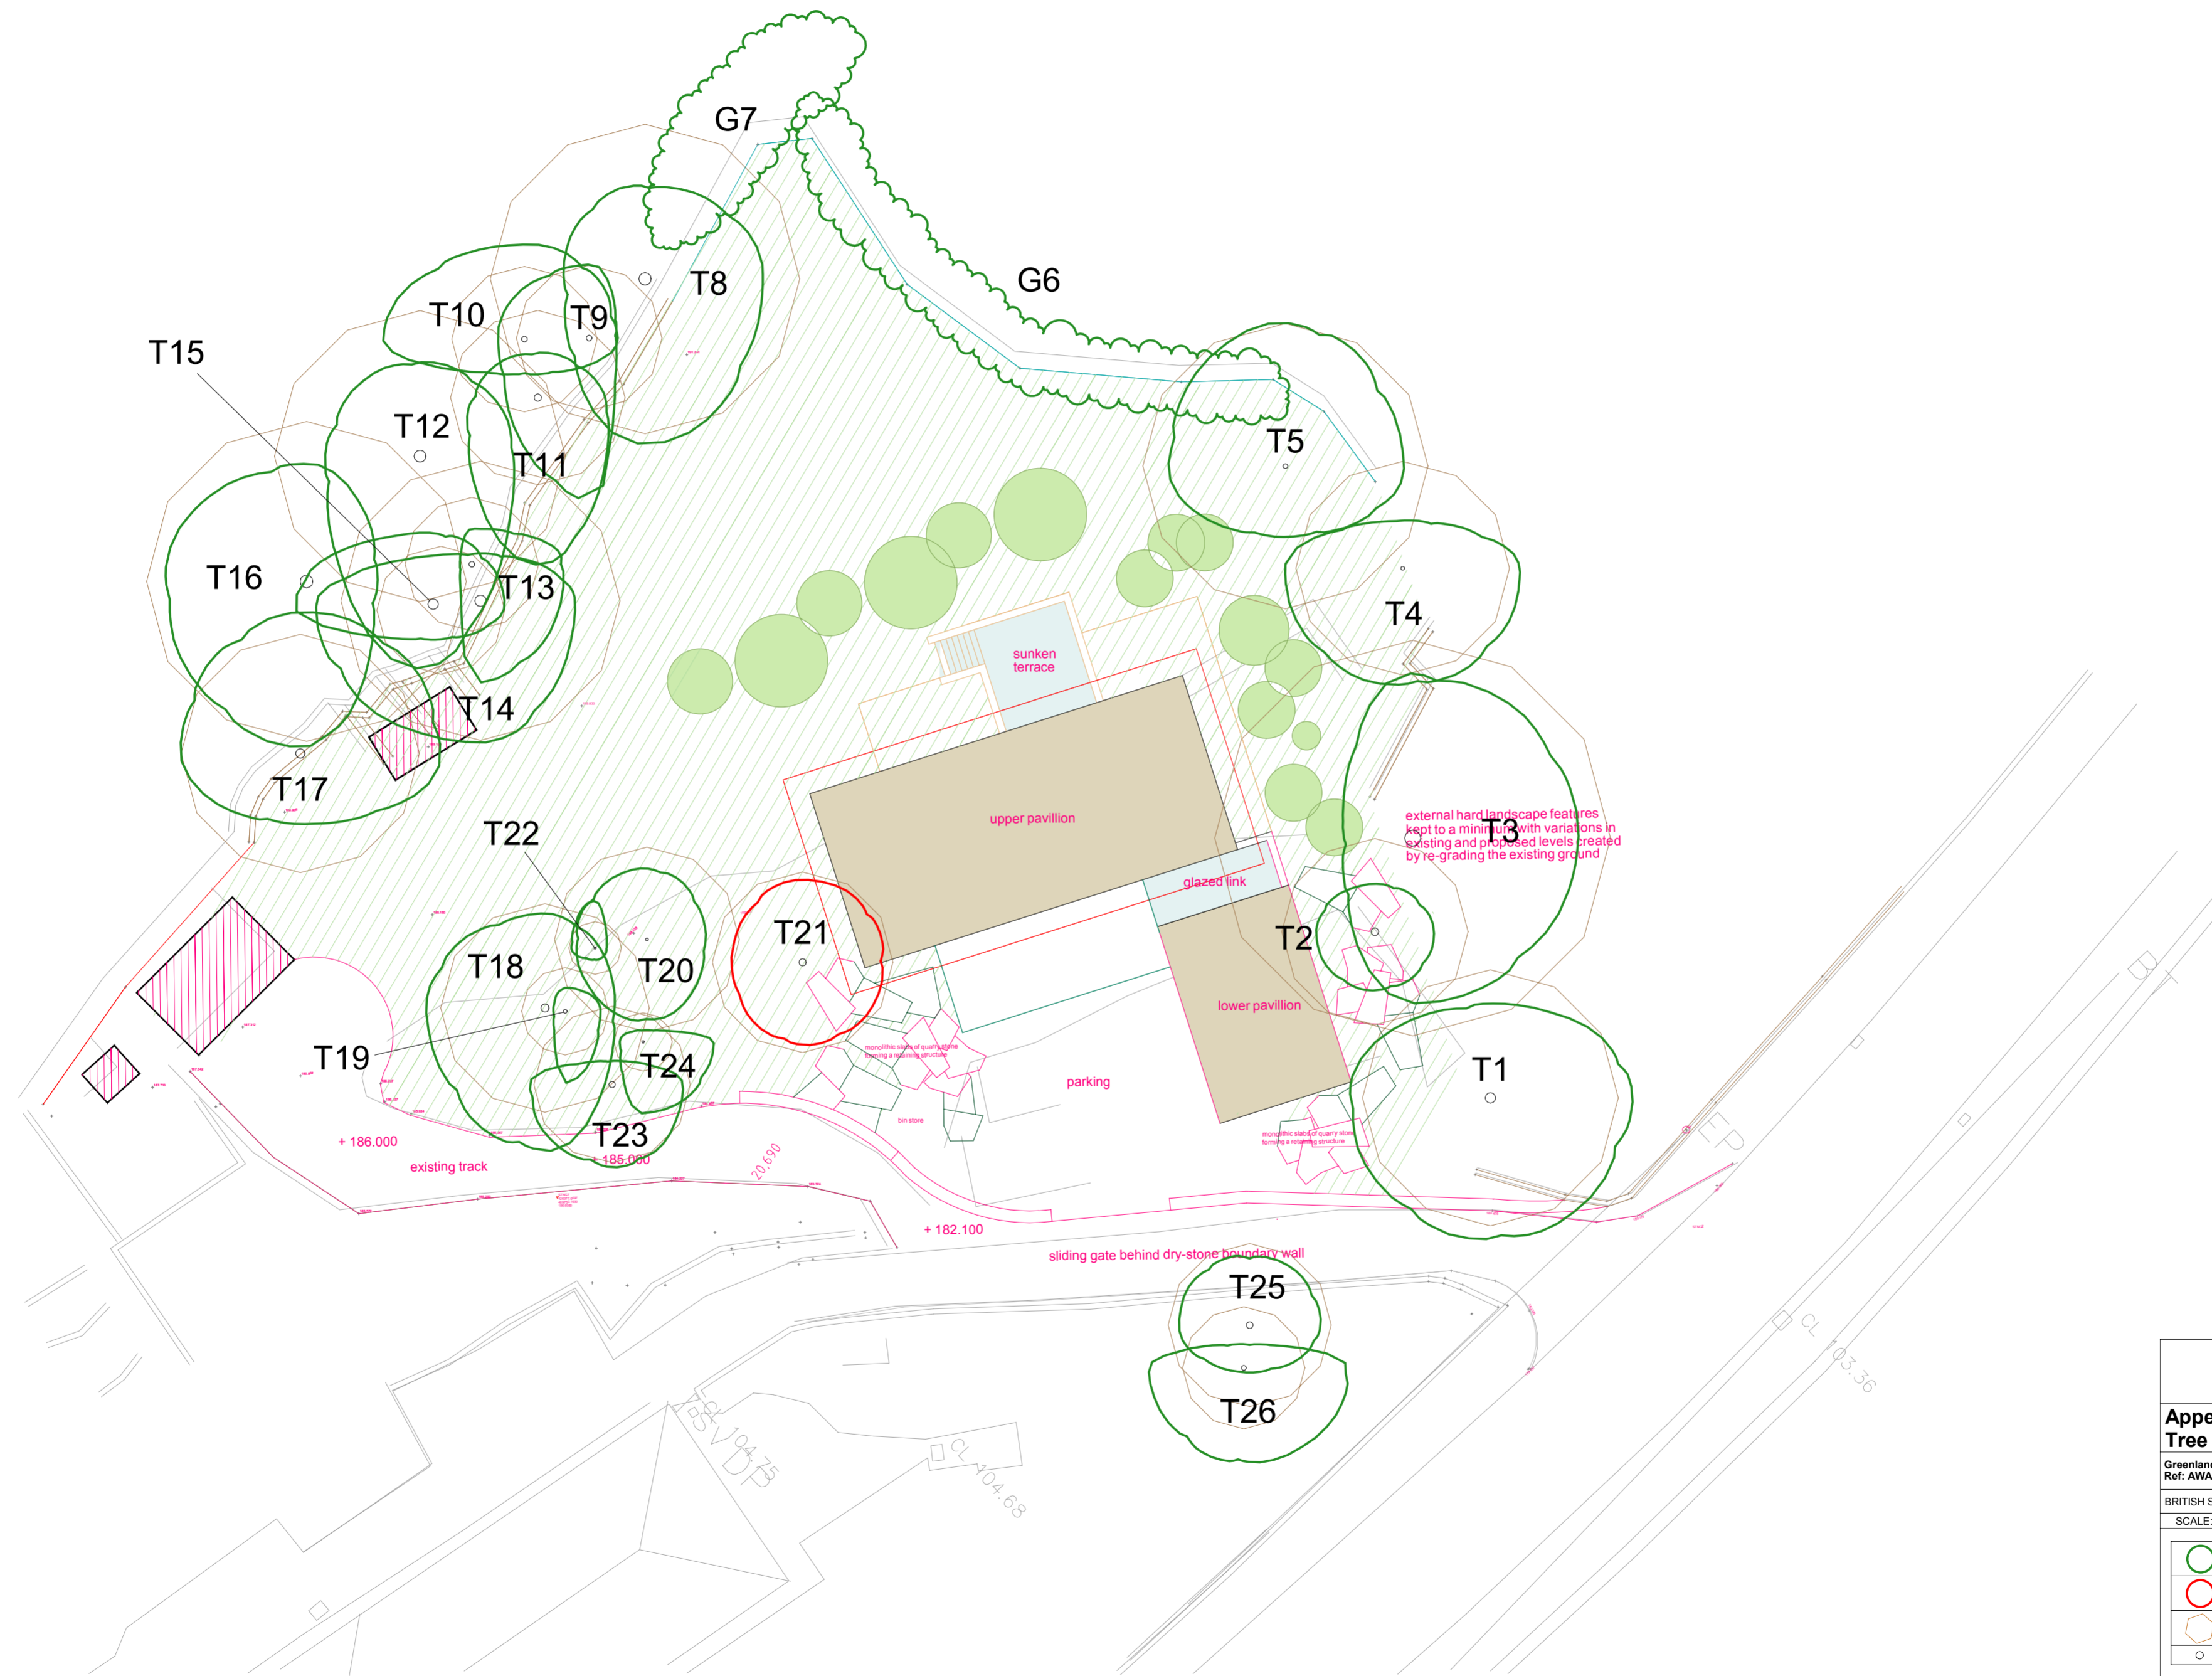
Appendix 6:
Tree Impacts Plan
 Greenland Cottages, High Hoyland, Barnsley
 Ref: AWA1983

- 4.2.1 From assessing the new development proposals, 1 tree will require removal as it is situated in the footprint of the structure or its retention and protection throughout the development is not suitable.
- 4.2.2 The tree that requires removal is T21, it is low value, retention category 'C', with limited future prospects and its removal will have little negative impact at the site.
- 4.2.3 Although able to be retained as part of the development, trees T2, T18 to T20 and T22 to T24 are only of low value with limited long term prospects. If their removal was desired, their limited amenity value could be easily replaced with new landscape plantings at the site which would improve the site's tree cover in the long term.

- 4.3.2 Potentially damaging activities are proposed in the vicinity of retained trees. The new development encroaches into the edge of the RPA of the Oaks T2 and T3. However, the solid bedrock to the west of the trees means it is very unlikely that significant roots will be within the development footprint and the retained trees should remain largely unaffected by the works, provided care is taken during construction.

- 4.5.1 The retained trees will require protection by fencing in accordance with BS 5837: 2012, during the development phase.
- 4.5.2 If required by the Local Planning Authority, an associated Arboricultural Method Statement, detailing protective fencing specifications and construction methods close to the retained trees can be provided.
