# Preliminary Environmental Risk Assessment and Coal Mining Risk Assessment Technical Note – Trinity Academy Temporary School

**Date:** December 2020

**Client Name:** Department for Education

**Document Reference:** WIE17125-100-TN-001

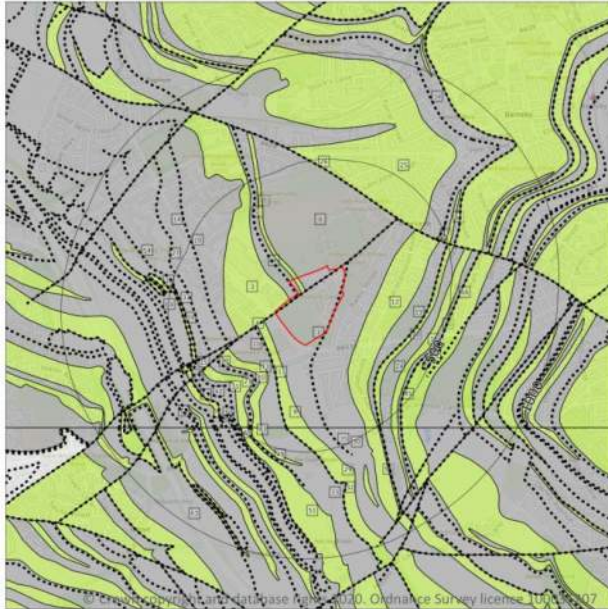
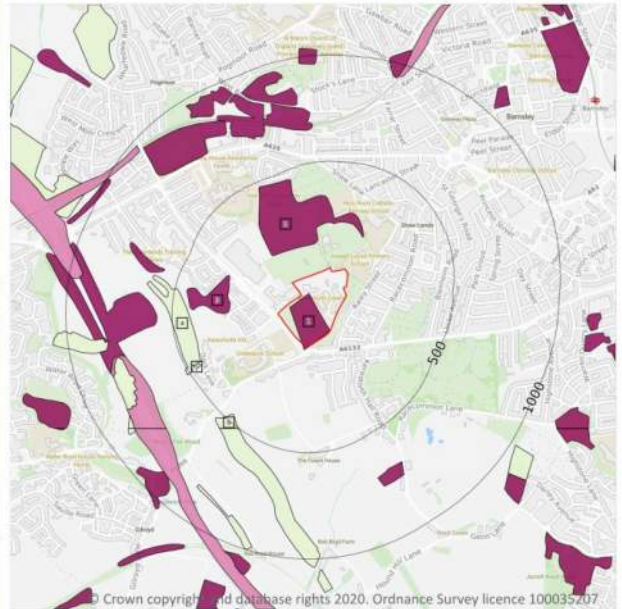
Figure 1: Geology

The Site is indicated to be underlain by Made Ground. A summary of the geology is provided in Table 1.

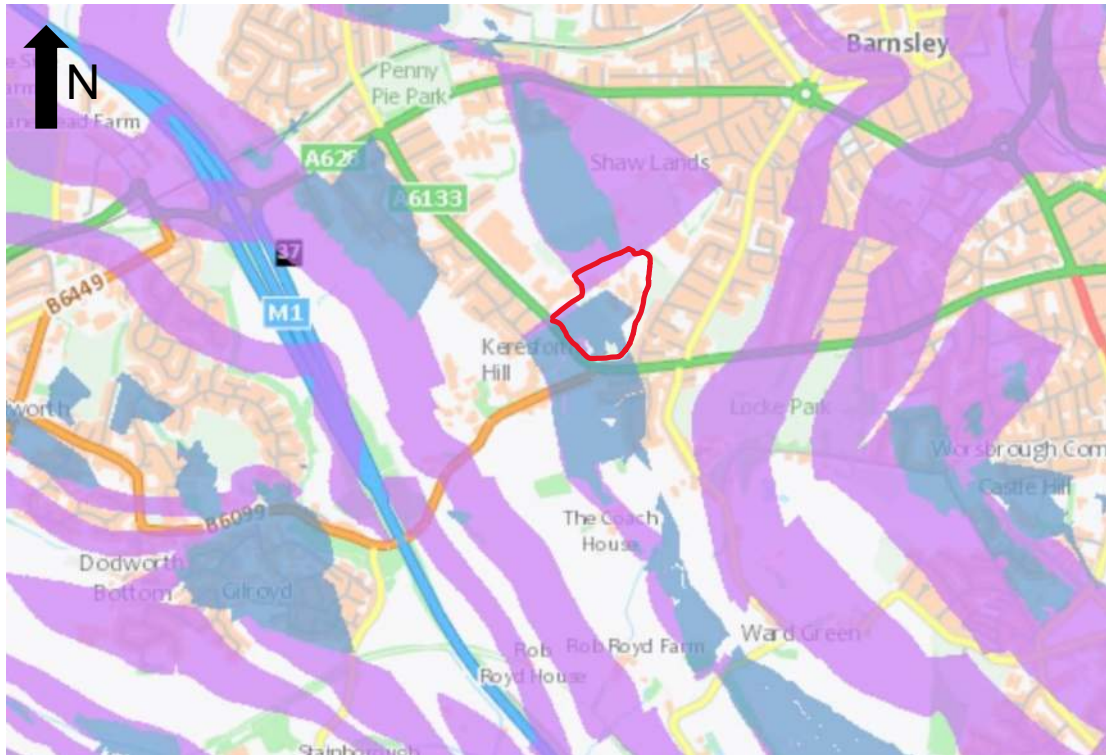
Figure 2: Known and Probable Shallow Workings (Probable workings in purple and known workings in blue) (Coal Authority Interactive Map Viewer)

The online Coal Authority Interactive Map Viewer indicates that past shallow workings are present below the Site. There are further areas of probable shallow workings identified beneath the Site. These are considered to be associated with potential workings in the Barnsley Coal.

The Development High Risk Area generally corresponds to the areas of known and probable shallow workings.

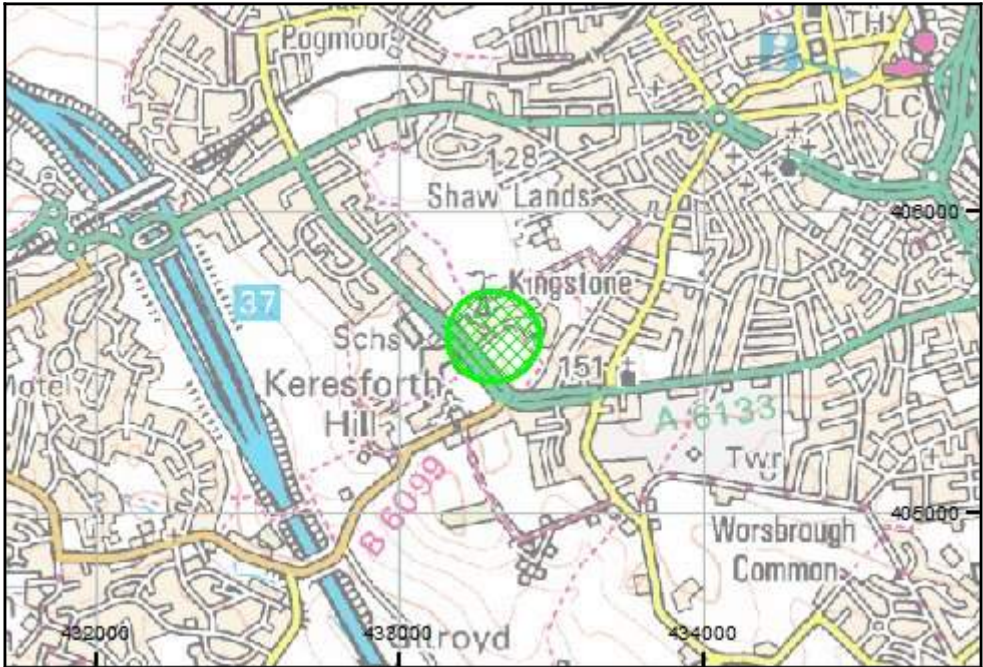
Public Safety Incident Report

**Surface Hazard at Playing Field adjacent to Keresforth Close, Barnsley.**  
**O.S. National Grid Co-ordinates at centre of collapse are 433300mE and 405590mN.**

I refer to the report of a surface hazard to the Coal Authority on 30<sup>th</sup> May, 2014, and our subsequent investigation of this ground collapse on 12<sup>th</sup> June, 2014, which was proven to be caused by shallow unrecorded workings within the Barnsley Seam. As such responsibility for its remediation rests with the Coal Authority.

| Hazard reported as:<br><br>Circular hole approx. 182 diameter, fairly deep | | | |
