# **ARBORICULTURAL REPORT**

### **to BS 5837:2012 at:**

***Niftylift,  
Platts Common Industrial Estate,  
Mason Way,  
Hoyland,  
Barnsley,  
South Yorkshire  
S74 9TF***

Reference: *AWA3642*

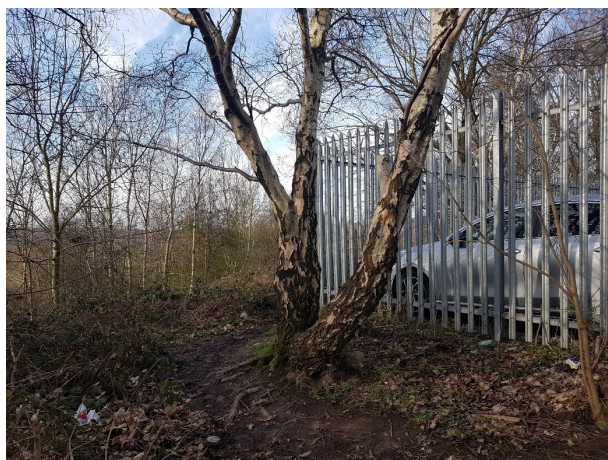
Photo 1: T1 from south

| | Tree Species | | | Measurements | | | | Crown (m) | | | | | Tree Condition | | | | | | | Value | | Management |
|---|---|---|---|---|---|---|---|---|---|---|---|---|---|---|---|---|---|---|---|---|---|---|
| T1 | Birch | Betula pendula | Semi-mature | 15 | 3 | 250, 190, 250 | No | 3 | 5 | 5.5 | 4 | 4.5 | Soil compaction. Exposed roots | Multiple stemmed at base. Slight lean east. Bark damage. Tight unions. Old pruning wounds. Minor decay. Stubs | Minor dieback. Minor deadwood. Minor snapouts. Old pruning wounds | Crown overhangs car park. One eastern main stem previously removed from fence, leaving decayed stump. Minor dieback and lots of minor deadwood in crown. Exposed roots and soil compaction at base to west from footpath. | Fair | Fair | 10 to 20 yrs | Low | C | No works required |

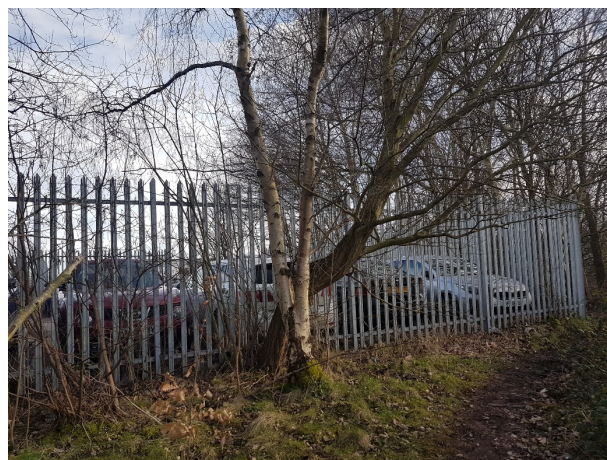
Photo 2: T2 and T3 from north

| | Tree Species | | | Measurements | | | | Crown (m) | | | | | Tree Condition | | | | | | | Value | | Management |
|---|---|---|---|---|---|---|---|---|---|---|---|---|---|---|---|---|---|---|---|---|---|---|
| T3 | Willow | Salix caprea | Semi-mature | 12 | 1 | 280 | No | 1.5 | 0.5 | 0.5 | 3.5 | 5 | Exposed roots. Soil compaction | Single stemmed. Significant lean south west. Epicormic growths. Old pruning wounds. Bark damage | Minor deadwood. Minor snapouts | Growing from base of fence. Old pruning wounds at base from removed stems. | Good | Fair | 10 to 20 yrs | Low | C | Removal required to facilitate development |

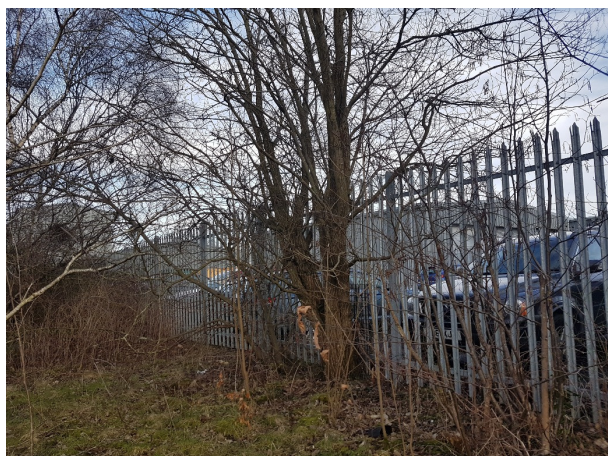
Photo 3: T4 from west

- 3.2.4 Willow T4 and Birch T8 are recommended for removal regardless of development at the site due to their poor condition; T4 has numerous poor unions and is growing through and embedded in the boundary fence, and T8 has extensive dieback in its crown.

| | Tree Species | | | Measurements | | | | Crown (m) | | | | | Tree Condition | | | | | | | Value | | Management |
|---|---|---|---|---|---|---|---|---|---|---|---|---|---|---|---|---|---|---|---|---|---|---|
| T4 | Willow | Salix caprea | Semi-mature | 15 | 5 | 90, 200, 200, 200, 150 | No | 2 | 3.5 | 5.5 | 1.5 | 3 | No visual defects | Multiple stemmed at base. Slight lean east. Bark damage. Partially included bark. Tight unions. Rubbing stems. Split unions | Minor deadwood. Minor snapouts | Growing from base of fence. Growing through and embedded in fence. Multiple stemmed at base with tight unions, partially included bark, split unions and rubbing stems. Growing through and embedded in fence. Large epicormic growths at base to north east. Tight unions prevented accurate stem measurements. | Good | Poor | 10 to 20 yrs | Low | U | Removal recommended regardless of development |

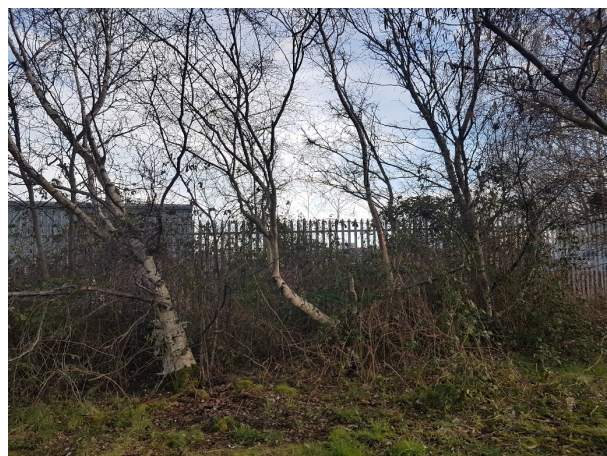
Photo 4: T8, T9 and T10 from north west

| | Tree Species | | | Measurements | | | | Crown (m) | | | | | Tree Condition | | | | | | | Value | | Management |
|---|---|---|---|---|---|---|---|---|---|---|---|---|---|---|---|---|---|---|---|---|---|---|
| T8 | Birch | <i>Betula pendula</i> | Semi-mature | 11 | 5 | 150, 100, 100, 80, 60 | No | 2 | 3 | 3 | 3.5 | 1 | Exposed roots | Multiple stemmed at base. Slight lean east. Stubs. Bark damage. Tight unions | Major dieback. Minor deadwood. Moderate deadwood. Minor snapouts | Limited access due to dense undergrowth. Extensive dieback in crown with lots of minor deadwood. | Poor | Fair | <10 yrs | Low | U | Removal recommended regardless of development |
| T9 | Birch | <i>Betula pendula</i> | Semi-mature | 10 | 2 | 120, 80 | No | 2 | 3 | 3.5 | 1.5 | 1 | Exposed roots | Twin stemmed at 0.5m. Slight lean north east. Tight unions. Partially included bark. Bark damage. Minor cavities. Minor decay | Minor deadwood | | Fair | Fair | 10 to 20 yrs | Low | C | Removal required to facilitate development |

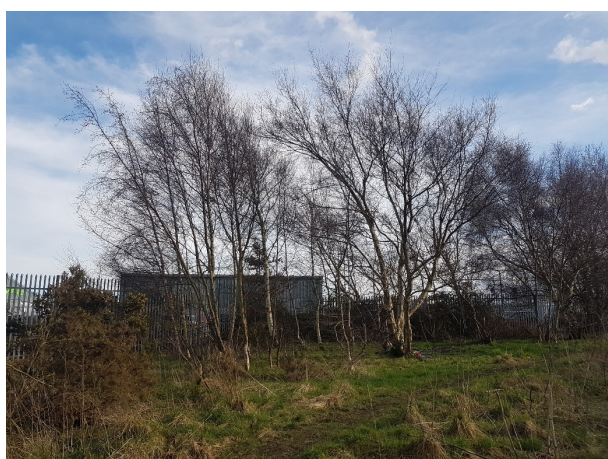
Photo 5: G13 and T14 from north

| | Tree Species | | | Measurements | | | | Crown (m) | | | | | Tree Condition | | | | | | | Value | | Management |
|---|---|---|---|---|---|---|---|---|---|---|---|---|---|---|---|---|---|---|---|---|---|---|
| G13 | Birch | <i>Betula pendula</i> | Young | 11 | 10 | 70 | No | 0.5 | See plan | | | | Exposed roots | Single stemmed and Multiple stemmed. Stubs. Bark damage. Tight unions | Minor deadwood. Minor snapouts | Group of young to semi mature Birch | Fair | Fair | 10 to 20 yrs | Low | C | Removal required to facilitate development |
| T14 | Birch | <i>Betula pendula</i> | Semi-mature | 12 | 3 | 150, 220, 280 | No | 2 | 4.5 | 4 | 4 | 4.5 | Exposed roots | Multiple stemmed at base. Vertical. Old pruning wounds. Stubs. Bark damage. Tight unions | Minor deadwood. Minor snapouts | Large eastern main stem previously snapped out at base | Good | Good | 20 to 40 yrs | Moderate | C | Removal required to facilitate development |

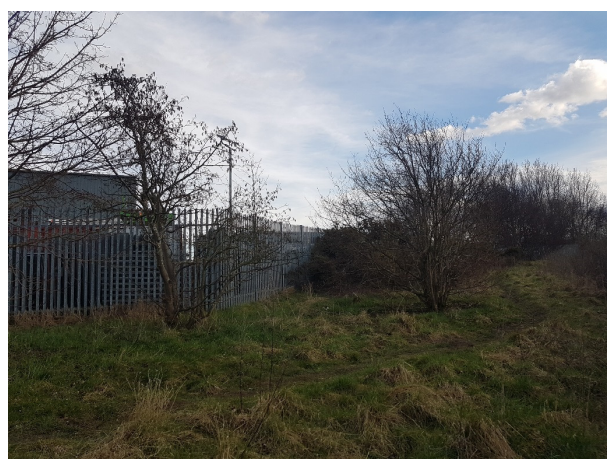
Photo 6: T15 and T16 from north west

| | Tree Species | | | Measurements | | | | Crown (m) | | | | | Tree Condition | | | | | | | Value | | Management |
|---|---|---|---|---|---|---|---|---|---|---|---|---|---|---|---|---|---|---|---|---|---|---|
| T15 | Hazel | <i>Corylus avellana</i> | Young | 5.5 | 10 | 40 | No | 0.5 | 2 | 2 | 2 | 2 | No visual defects | Multiple stemmed at base. Vertical. Bark damage. Tight unions. Rubbing stems | Minor deadwood | | Good | Good | 20 to 40 yrs | Low | C | Removal required to facilitate development |
| T16 | Alder | <i>Alnus sp.</i> | Semi-mature | 7 | 2 | 120, 180 | No | 0.5 | 2 | 3.5 | 3 | 2.5 | No visual defects | Twin stemmed at base. Slight lean north east. Tight unions. Partially included bark. Epicormic growths. Stubs. Bark damage. Minor decay | Minor deadwood. Minor snapouts | Two main stems with large epicormic growths to south east. Partially included bark union at junction of two main stems. | Fair | Fair | 10 to 20 yrs | Low | C | Removal required to facilitate development |

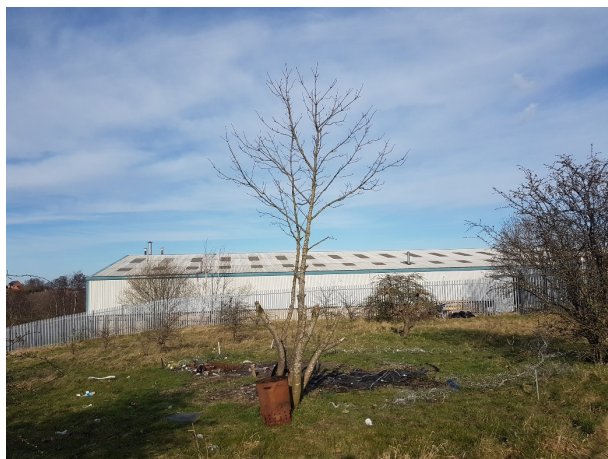
Photo 7: T23 from south west

| | Tree Species | | | Measurements | | | | Crown (m) | | | | | Tree Condition | | | | | | | Value | | Management |
|---|---|---|---|---|---|---|---|---|---|---|---|---|---|---|---|---|---|---|---|---|---|---|
| T23 | Norway Maple | Acer platanoides | Semi-mature | 7 | 2 | 110, 60 | No | 3.5 | 1.5 | 2 | 1.5 | 0.5 | No visual defects | Twin stemmed at base. Slight lean north east. Old pruning wounds. Stubbs. Bark damage | Minor deadwood | Only 2 stems remaining, other stems removed at 1m to 1.5m. Screws in stem. | Fair | Fair | 10 to 20 yrs | Low | C | Removal required to facilitate development |

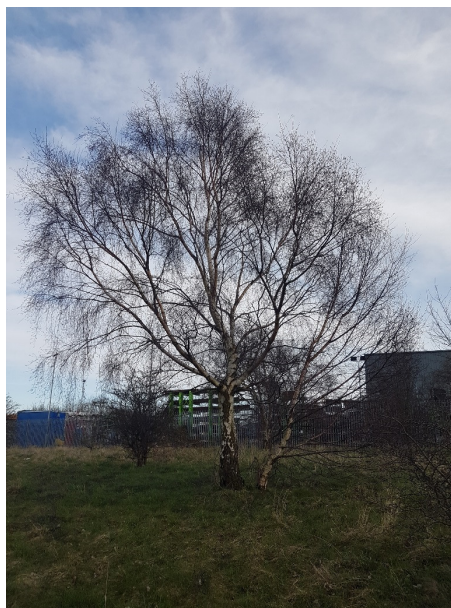
Photo 8: T27 from north west

| | Tree Species | | | Measurements | | | | Crown (m) | | | | | Tree Condition | | | | | | | Value | | Management |
|---|---|---|---|---|---|---|---|---|---|---|---|---|---|---|---|---|---|---|---|---|---|---|
| T27 | Birch | Betula pendula | Semi-mature | 9 | 2 | 280, 110 | No | 0.5 | 4 | 4.5 | 3.5 | 3.5 | Exposed roots | Twin stemmed at base. Slight lean south east. Bark damage. Epicormic growths | Minor deadwood | | Good | Good | 20 to 40 yrs | Low | C | Removal required to facilitate development |

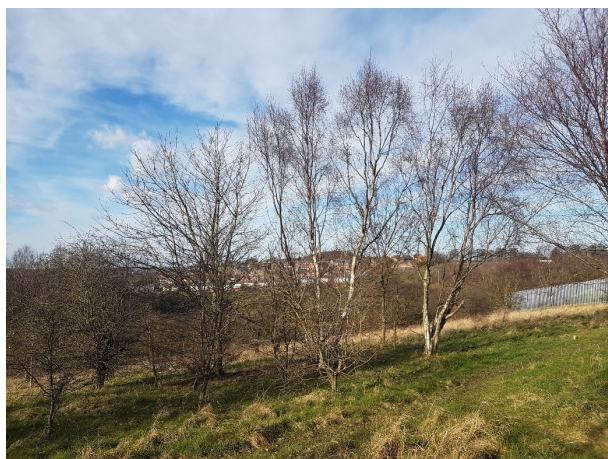
Photo 9: T30, T31 and T32 from south

| Tree Species | | | | Measurements | | | | Crown (m) | | | | | Tree Condition | | | | | | | Value | | Management | |
|---|---|---|---|---|---|---|---|---|---|---|---|---|---|---|---|---|---|---|---|---|---|---|---|
| | T30 | Birch | Betula pendula | Semi-mature | 10 | 4 | 120, 60, 130, 110 | No | 1.5 | 3.5 | 4 | 2.5 | 1 | No visual defects | Multiple stemmed at base. Slight lean north east. Old pruning wounds. Stubs. Bark damage. Tight unions | Minor deadwood. Minor snapouts | | Fair | Fair | 10 to 20 yrs | Low | C | Removal required to facilitate development |
| | T31 | Birch | Betula pendula | Semi-mature | 10 | 6 | 70 | No | 2 | 3 | 3 | 2 | 1.5 | No visual defects | Multiple stemmed at base. Vertical. Epicormic growths. Bark damage. Old pruning wounds. Stubs. Tight unions | Minor deadwood. Minor snapouts | Wound at base from snapped stem | Fair | Fair | 10 to 20 yrs | Low | C | Removal required to facilitate development |

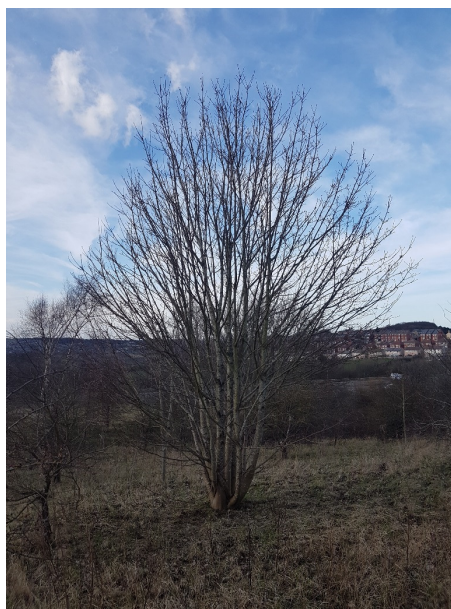
Photo 10: T34 from south

| Tree Species | | | | Measurements | | | | Crown (m) | | | | | Tree Condition | | | | | | | Value | | Management | |
|---|---|---|---|---|---|---|---|---|---|---|---|---|---|---|---|---|---|---|---|---|---|---|---|
| | T34 | Norway Maple | Acer platanoides | Semi-mature | 9 | 10 | 80 | No | 0.5 | 3.5 | 3.5 | 3.5 | 3.5 | No visual defects | Multiple stemmed at base. Vertical. Tight unions. Partially included bark. Rubbing stems | Minor deadwood | | Good | Fair | 10 to 20 yrs | Low | C | Removal required to facilitate development |

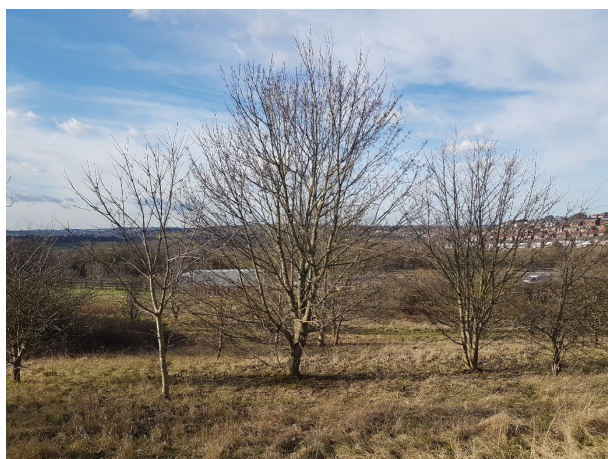
Photo 11: T36, T37 and T38 from south east

| Tree Species | | | | Measurements | | | | Crown (m) | | | | | Tree Condition | | | | | | | Value | | Management | |
|---|---|---|---|---|---|---|---|---|---|---|---|---|---|---|---|---|---|---|---|---|---|---|---|
| | T36 | Norway Maple | Acer platanoides | Young | 6 | 1 | 90 | No | 1.5 | 1.5 | 2 | 1.5 | 1.5 | No visual defects | Single stemmed. Vertical | Normal | | Good | Good | 10 to 20 yrs | Low | C | No works required |
| | T38 | Norway Maple | Acer platanoides | Semi-mature | 7 | 6 | 70 | No | 0.5 | 3 | 3.5 | 3.5 | 3 | No visual defects | Multiple stemmed at base. Vertical. Tight unions. Partially included bark. Rubbing stems | Minor deadwood | | Good | Fair | 10 to 20 yrs | Low | C | No works required |

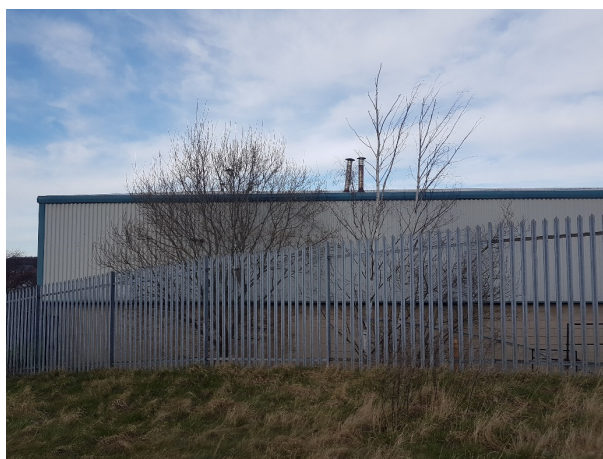
Photo 12: T41 and T42 from south west

- 3.2.6 Hawthorn T40, Willow T41 and Birch T42 are situated in adjacent land to the north east of the site and so were only given cursory inspections with measurements estimated and condition values indicative only. T41 and T42 are situated on slightly lower ground than the site.

| Tree Species | | | | Measurements | | | | Crown (m) | | | | | Tree Condition | | | | | | | | Value | | Management |
|---|---|---|---|---|---|---|---|---|---|---|---|---|---|---|---|---|---|---|---|---|---|---|---|
| | T41 | Willow | Salix caprea | Semi-mature | 8 | 6 | 70 | Yes | 0.5 | 3 | 2 | 3 | 3 | Limited access around base | Multiple stemmed at base. Slight lean south east. Bark damage. Rubbing stems | Minor deadwood | Adjacent, no access. Situated on slightly lower ground than site. Roots lifting paving at base. Crown in contact with building to north east. Growing through fence. | Good | Fair | 10 to 20 yrs | Low | C | No works required |
| | T42 | Birch | Betula pendula | Semi-mature | 9 | 2 | 100, 100 | Yes | 0.5 | 2.5 | 2.5 | 2.5 | 2.5 | Limited access around base | Twin stemmed at base. Vertical | Major dieback. Minor deadwood. Minor snapouts | Adjacent, no access. Situated on slightly lower ground than site. Major dieback in crown. | Poor | Fair | <10 yrs | Low | C | No works required |
