# ARBORICULTURAL REPORT (BS 5837:2012)

FOR  
PROPOSED DEVELOPMENT

ROUGH BIRCHWORTH LANE  
OXSPRING  
SHEFFIELD  
S36 8YZ

September 2022

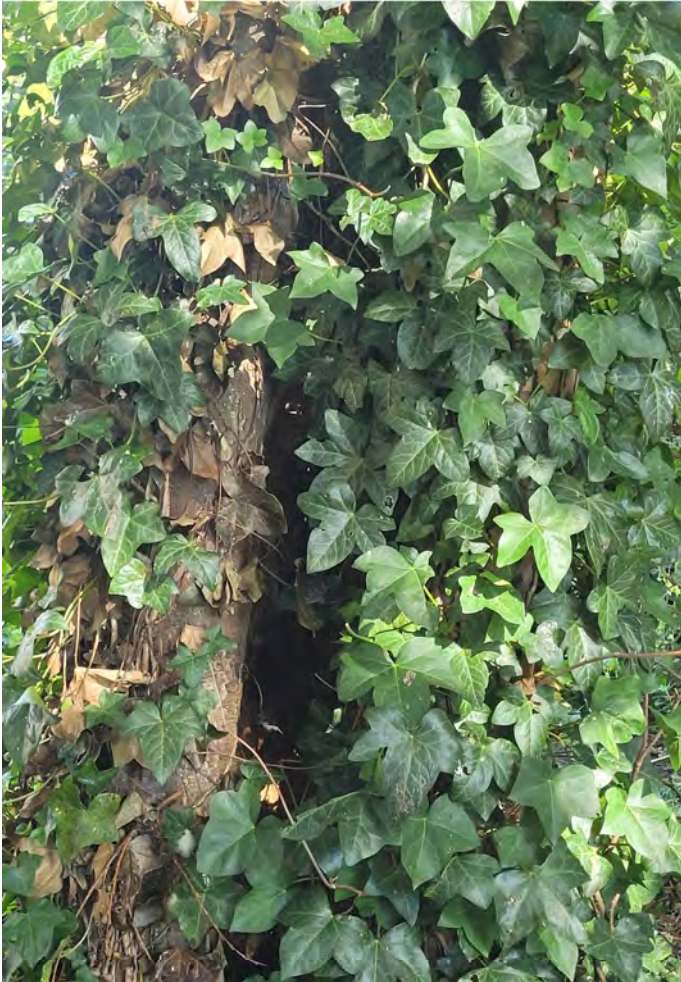
T33	Sycamore	500	12	M	5	4	2	4	3	C	A heavily suppressed specimen. Ivy clad with several stem shoots. Major stem decay and decay in top of crown. Possible habitat tree. Risk of collapse over access track. Recent works at base, soil moving and building waste piled up. Possible root damage.	Fell to ground level.	5-10	U	113.10	6.00

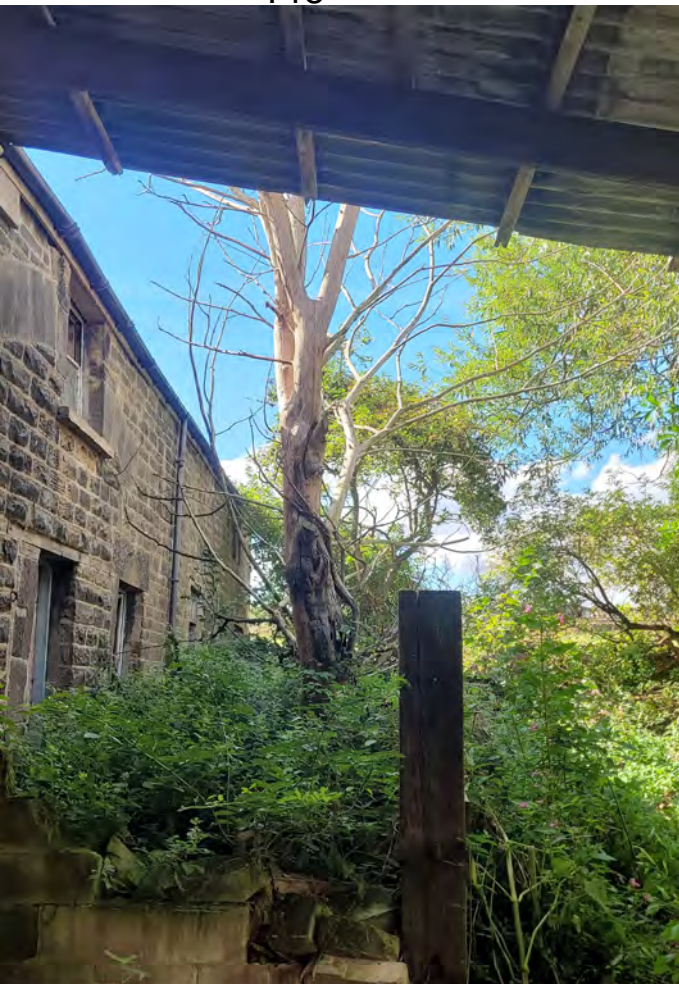
T15	Elm	0	7	EM	-	-	-	-	-	D	A dead tree adjacent old building.	n/a	n/a	U	0.00	0.00
T16	Sycamore	760	18	M	8	7	7	8	3	B	A large co-dominant specimen on the edge of the group adjacent to an old broken-down wall. Stem swamped in Ivy. Reasonable form and vigour. Recent works at base, soil moving and building waste piled up. Possible root damage.	Sever Ivy at base to 1m.	20+	B2	261.30	9.12
T17	Sycamore	580	16	M	7	5	4	4	3	B	A suppressed specimen on the edge of the group. Stem swamped in Ivy. Poor form, stem and basal shoots present. Recent works at base, soil moving and building waste piled up. Possible root damage.	Sever Ivy at base to 1m and remove basal shoots.	20+	B2	152.18	6.96
T18	Sycamore	500	16	M	5	2	4	5	3	B/C	A suppressed specimen within the group. Small crown. Ivy clad stem. Recent works at base, soil moving and building waste piled up. Evidence of root damage.	Sever Ivy at base to 1m.	10+	C2	113.10	6.00

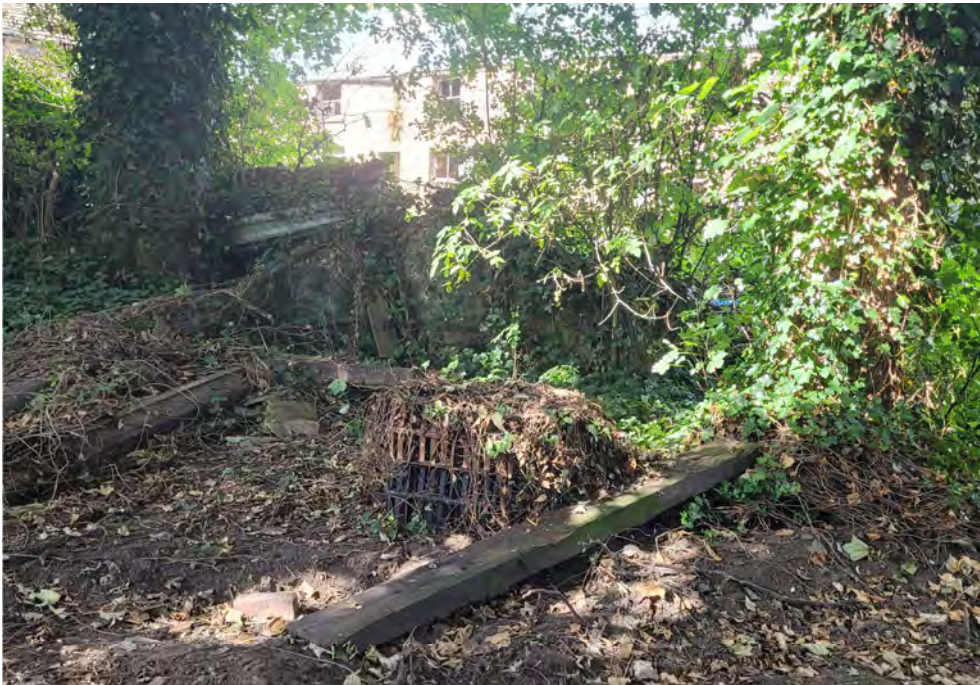
Ground disturbance and waste near T17 and surrounding trees
