# **ARBORICULTURAL REPORT**

## **& Impact Assessment**

***6 Norcross Gardens,  
Darfield,  
Barnsley,  
S73 9NY***

Reference: AWA3916

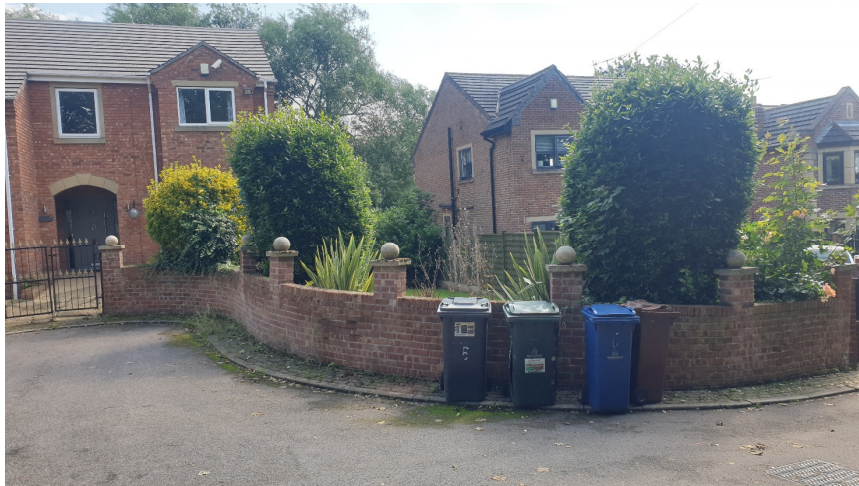
Photo 1: Front of the property, T7, and T8, looking east

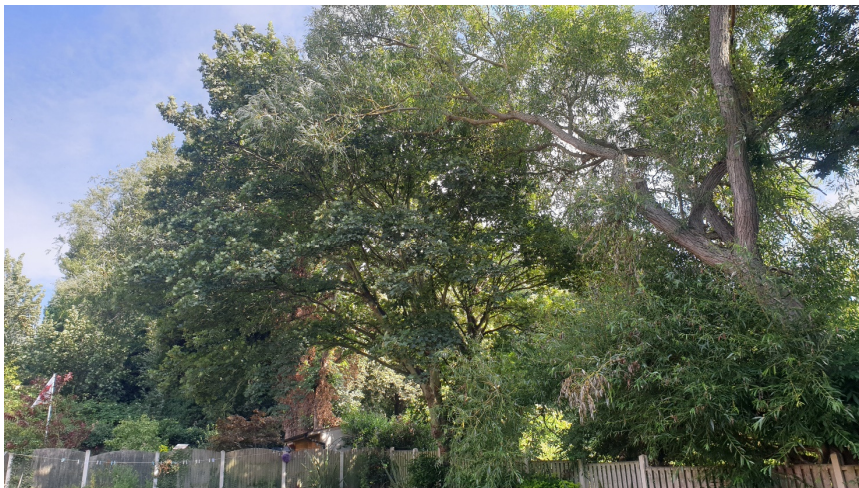
- 3.2.5 The site's most significant tree is an adjacent early-mature Sycamore T1, situated bordering the adjacent farmland to the east of the site. The tree is prominent from within the site and adjoining properties to the north, however, the western aspect of the crown is relatively overbearing, hanging low into the property's garden.

- 3.2.6 T2 is an adjacent Crack Willow situated bordering the adjacent farmland to the east of the site. The tree has multiple defects, including cavities with signs of decay and damage to a significant branch within the crown. The tree is unsuitable for its location overhanging the garden of a residential property, likely has limited future prospects and will likely require removal in future regardless of development at the site.

Photo 2: T1 and T2, looking north

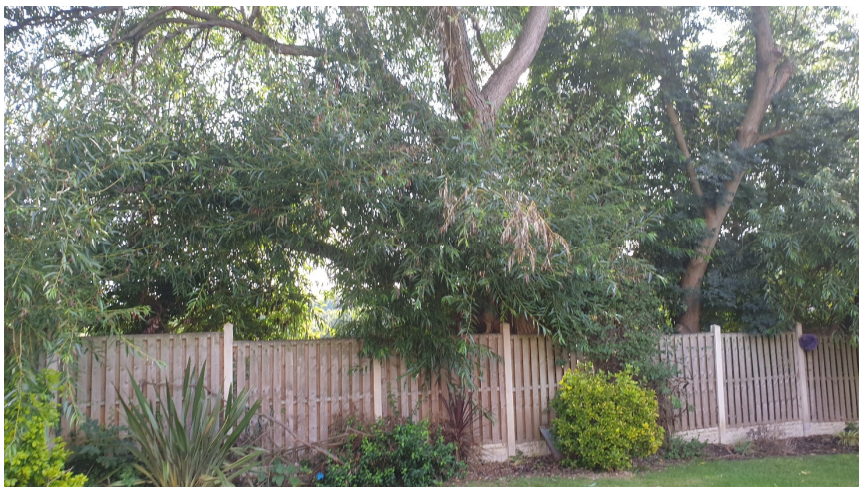
- 3.2.7 T3 is an adjacent early mature Ash situated bordering the adjacent farmland to the east of the site. The lower western branches of the tree appear to have previously had minor pruning works undertaken on them.

- 3.2.8 Many of the Ash trees in the local area show symptoms consistent with the fungal disease Ash Dieback. Once a tree is infected, the disease is usually fatal, either directly or indirectly. While the identified Ash trees T3, T5 and T6 may continue to provide landscape and wildlife benefits for some time, their long-term prospects are likely to be limited as a result of Ash Dieback.

Photo 3: T2 and T3 looking east

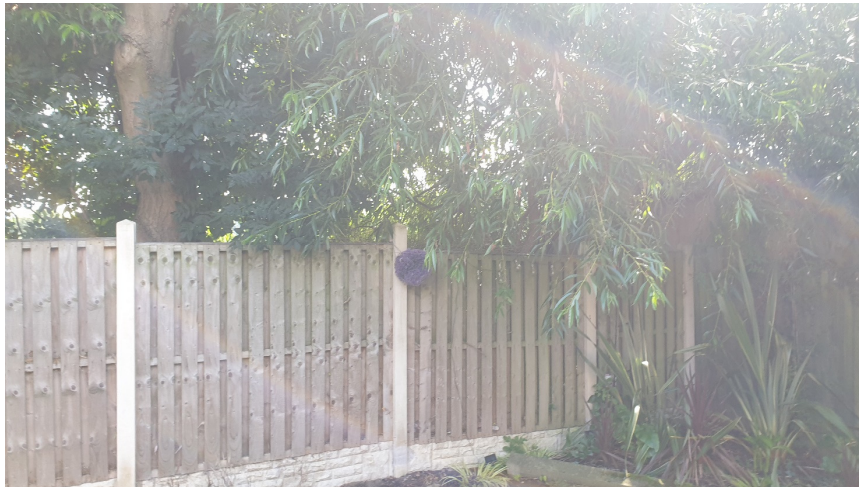
- 3.2.1 T4 is another adjacent Crack Willow with defects and structural issues situated bordering the adjacent farmland to the east of the site. The southern-most limb has a significant lean and is in contact with the shed in the garden of an adjacent property, with the damage to the shed likely to worsen in future as the tree matures. The upper crown contains a significant hanging branch that also overhangs the adjacent garden. The tree is unsuitable for its location overhanging the garden of a residential property, likely has limited future prospects and will likely require removal in future regardless of development at the site.

Photo 4: Significant lower epicormic growth on T4, looking south-east

- 4.2.4 Adjacent Crack Willow T4 will require minor pruning works to facilitate the proposed development. The lower western epicormic growth will require pruning back to the site boundary, not pruning beyond the site boundary, as detailed in Appendix 4. The tree will readily tolerate the required pruning work with little negative impact. T4 is in poor structural condition, is in contact with the shed of an adjacent property, is unsuitable for its location overhanging the garden of a residential property, likely has limited future prospects and will likely require removal in future regardless of development at the site.

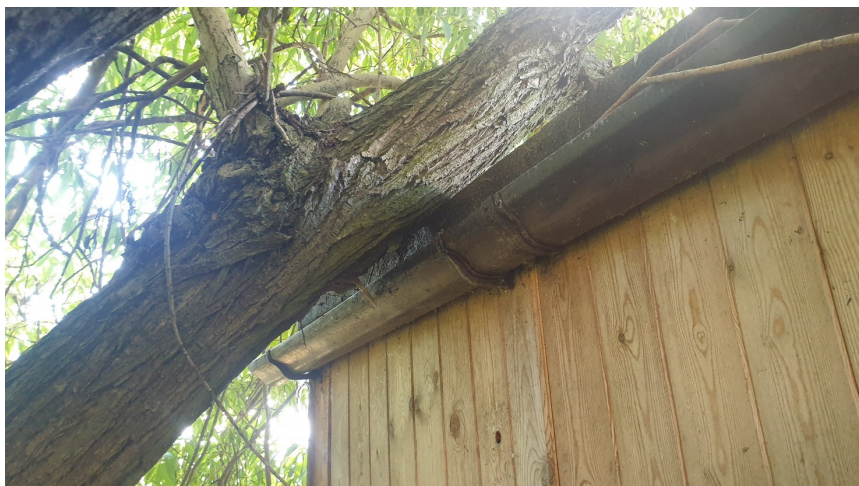
Photo 5: Large southern limb of T4 in contact with adjacent shed

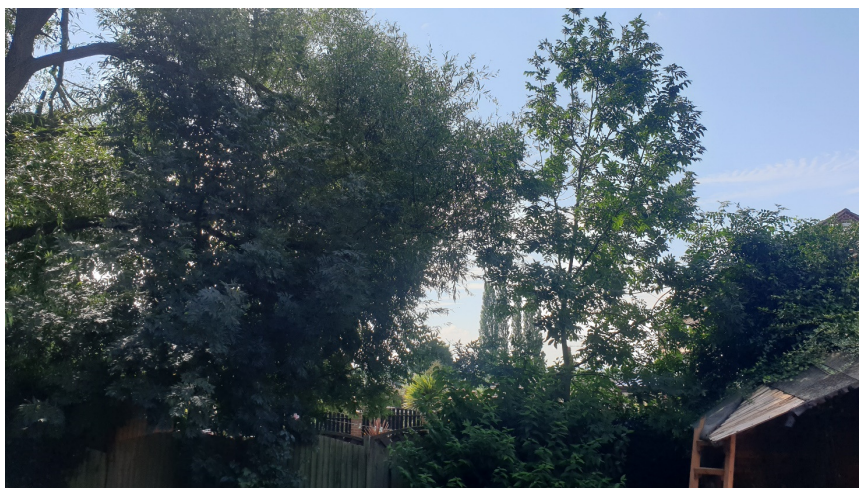
- 3.2.2 T5 is a small, likely self-seeded Ash, situated in the adjacent garden to the south of the site. Epicormic growth on the northern aspect show symptoms of Ash Dieback and it is overshadowed by a large lateral branch from T4, affecting its amenity value and long-term potential.

Photo 6: T5 and T6, looking south

- 4.2.5 Adjacent Ash T5 will require minor pruning works to facilitate the proposed development. The lower northern crown will require lifting to clear the proposed new garage, not pruning beyond the site boundary, as detailed in Appendix 4. The tree will readily tolerate the required pruning work with little negative impact. T5 has symptoms of Ash Dieback and likely has limited future prospects regardless of development at the site.

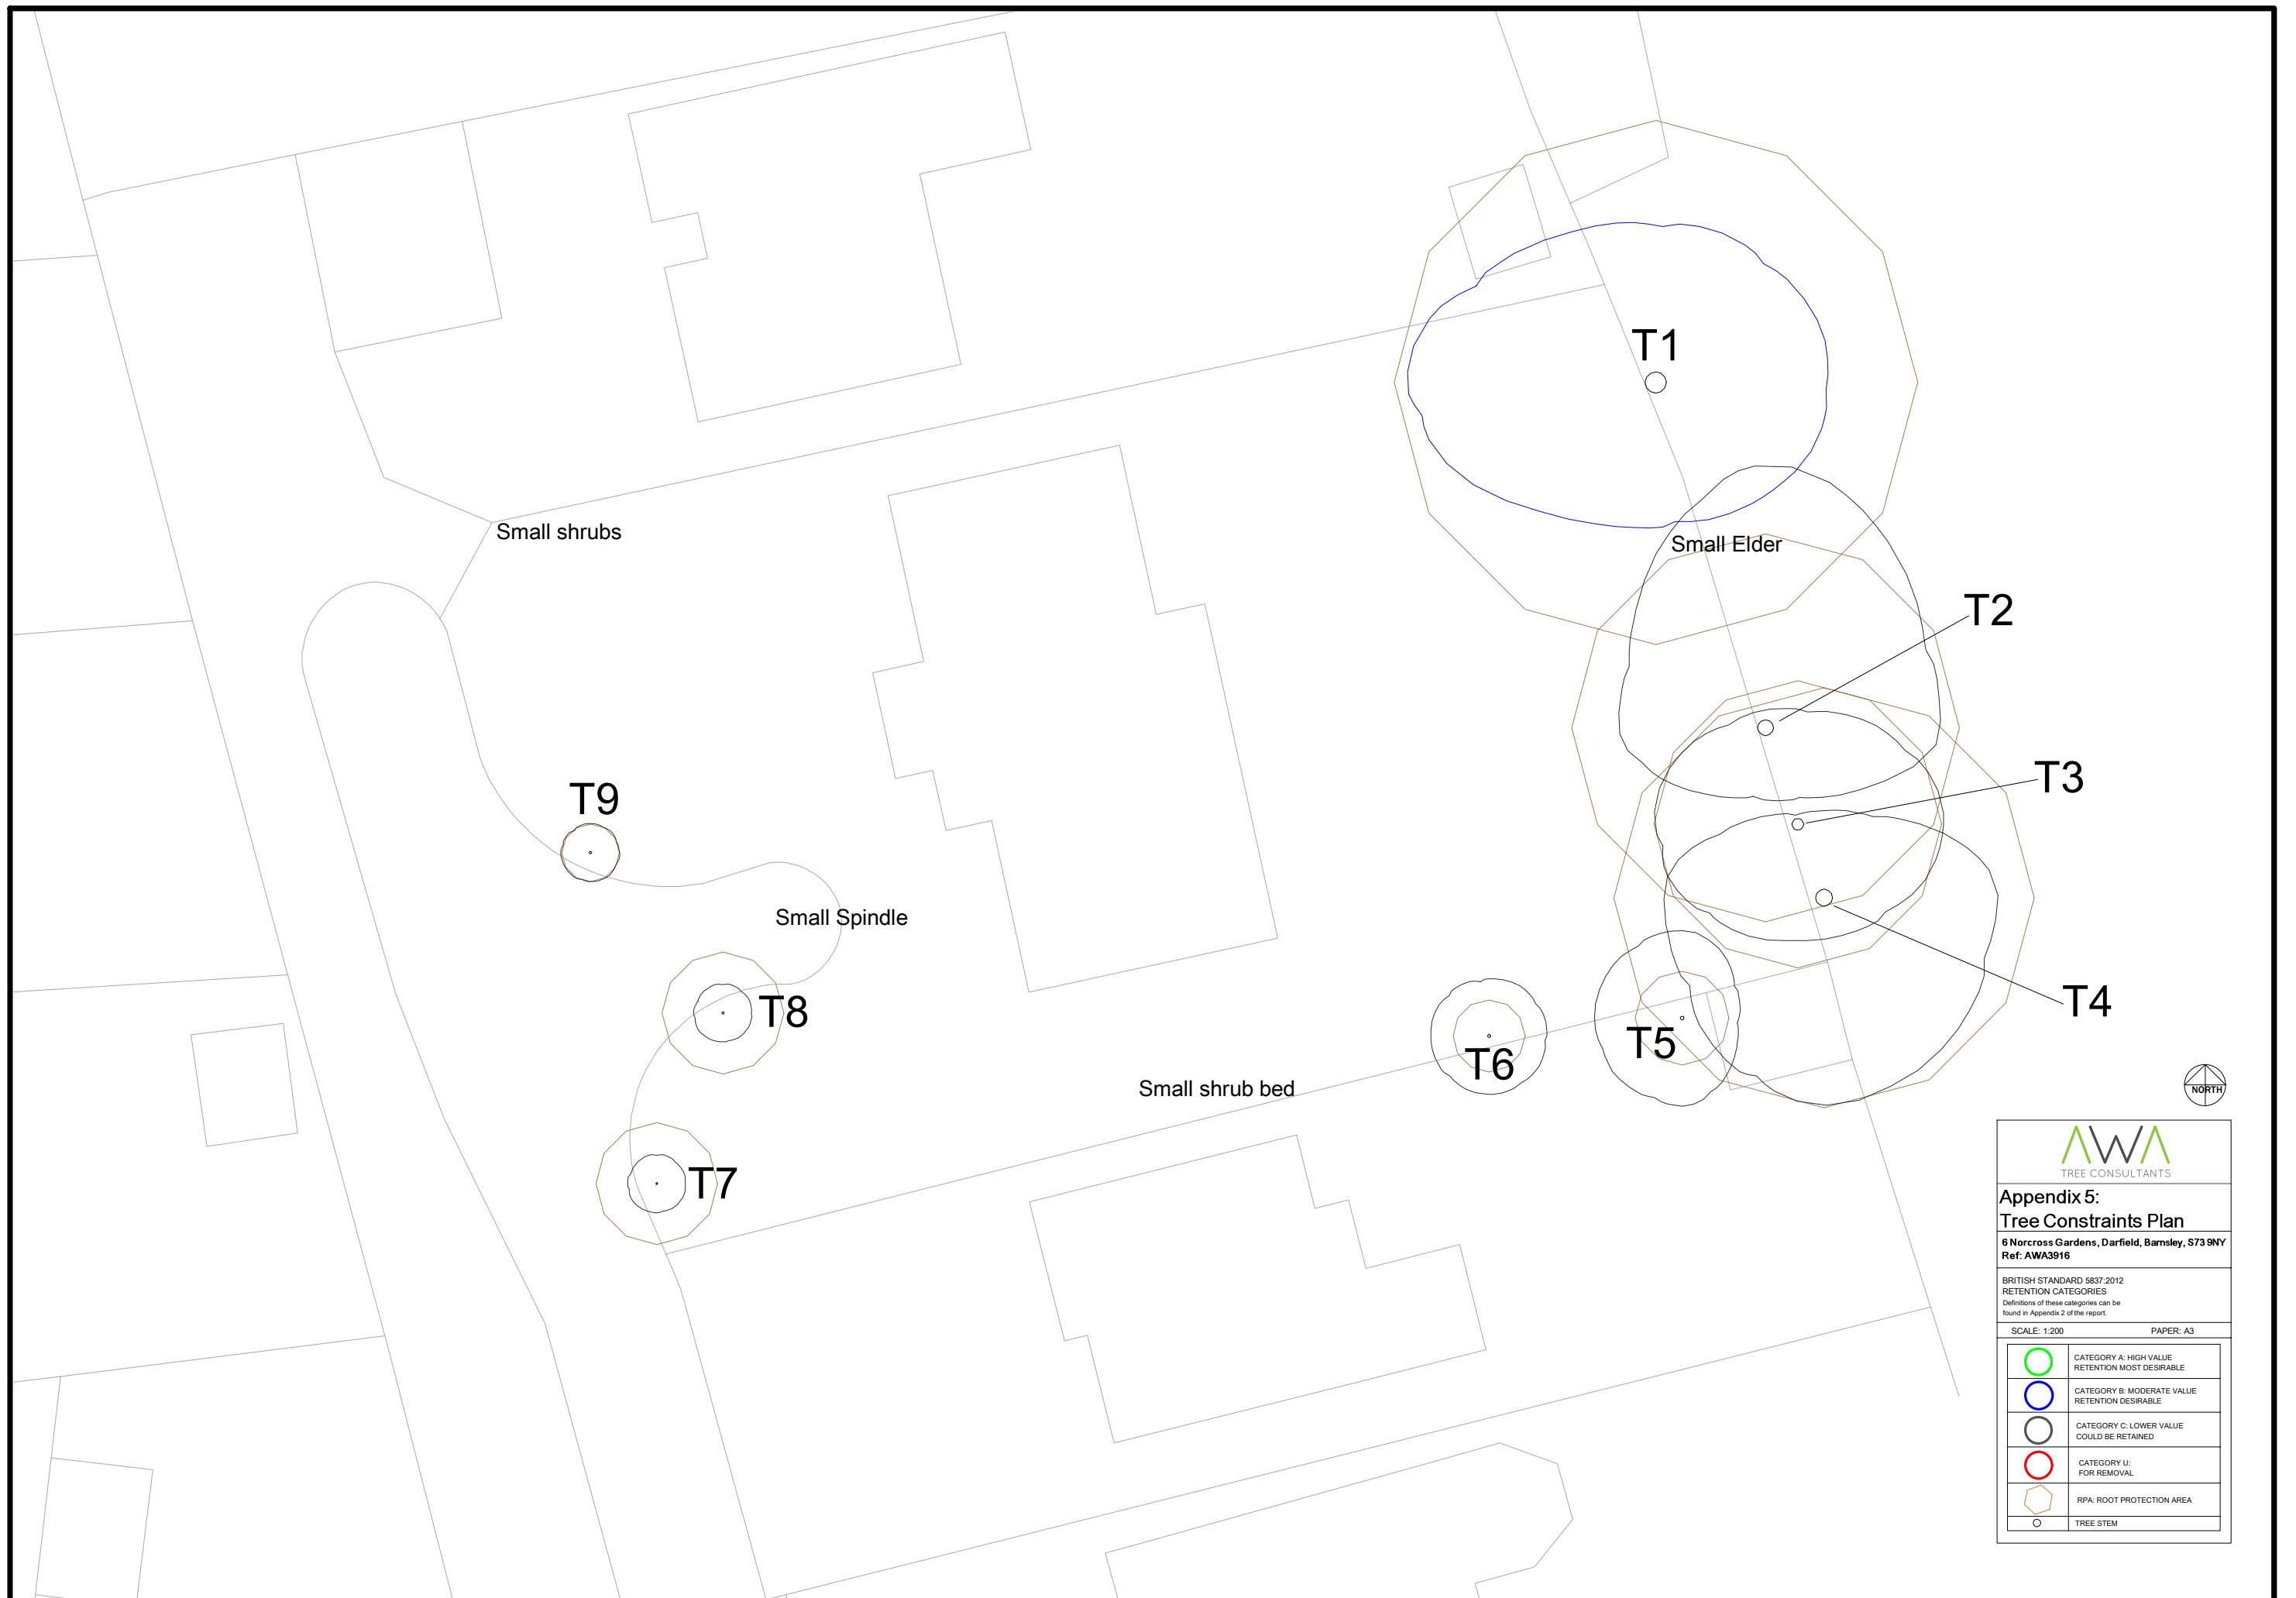
**Appendix 5:  
Tree Constraints Plan**

- 3.2.4 The tree Root Protection Area (RPA) detailed on the Tree Constraints Plan at Appendix 5 has been used as a layout design tool, to inform on the area around a tree where the protection of the roots and soil structure is treated as a priority.

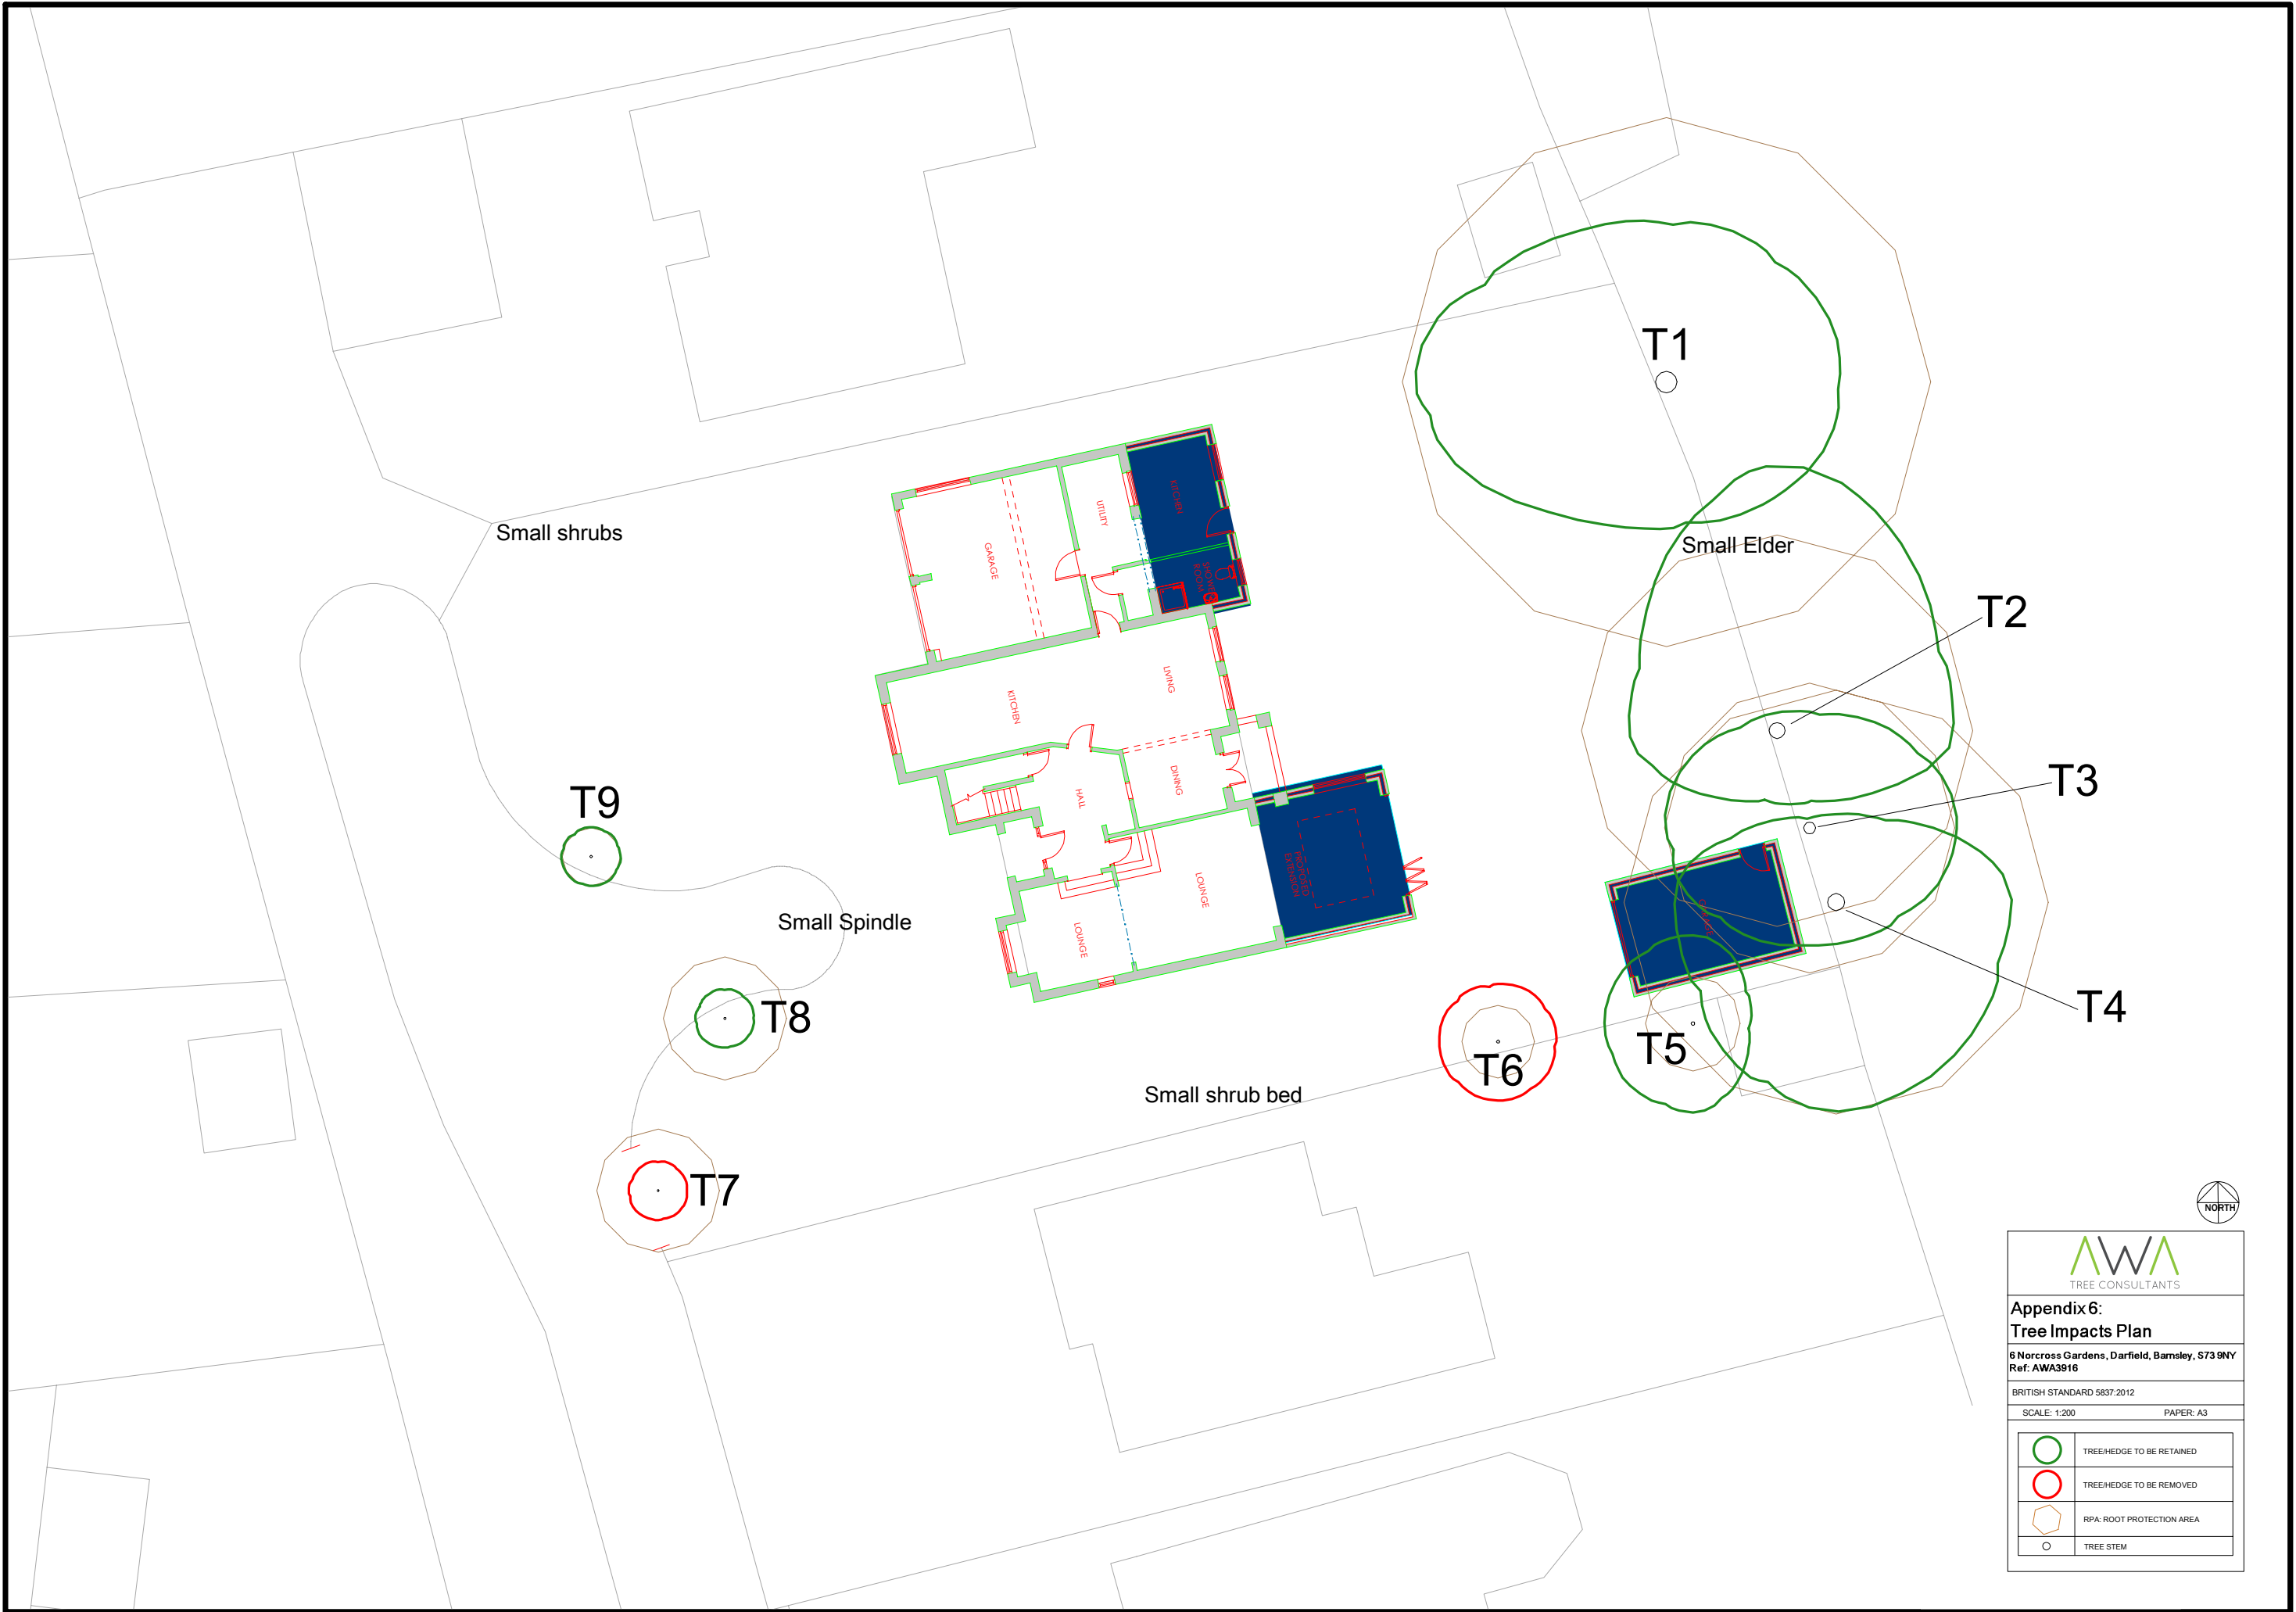
**Appendix 6:**  
**Tree Impacts Plan**

- 4.2.1 From assessing the new development proposals, 2 trees will require removal as they are situated in the footprint of the development or their retention and protection throughout the development is not suitable.

- 4.2.2 The trees that require removal are T6 and T7. These trees have been identified in red on the attached Tree Plan at Appendix 4.
- 4.2.3 The trees that require removal are lower value, retention category 'C' and their removal will have little negative impact. T6 is a small self-seeded Ash with limited future prospects, and T7 is a small Bay.

- 4.3.2 Potentially damaging activities are proposed in the vicinity of retained trees. The proposed new garage is situated within the RPAs of retained adjacent trees T2, T3, and T4. Construction within the RPA can have negative impacts on tree roots. However, if the proposed new garage can be constructed using specialist minimal dig foundations which will not damage tree roots, such as pad type foundations or pile and beam type foundations, the construction of the garage should not have a significant impact on the retained adjacent trees, provided care is taken during construction. T2, T3 and T4 all likely have limited future prospects regardless of development at the site; T2 and T4 are Crack Willows with significant structural defects which are unsuitable for their location overhanging the garden of a residential property and T3 is an Ash which will likely be impacted by Ash Dieback in future.

- 4.3.3 The proposed new garage also encroaches into the detailed RPA of retained adjacent Ash T5, however, the encroachment is minor as such, the retained tree should remain largely unaffected by the works, provided care is taken during construction. T5 has symptoms of Ash Dieback and likely has limited future prospects regardless of development at the site.
