ARBORICULTURAL REPORT

To **BS5837:2012** at:

***38 Bowden Grove,
Dodworth,
Barnsley,
S75 3TB***

Date: *April 2016*
Reference: *AWA1550*

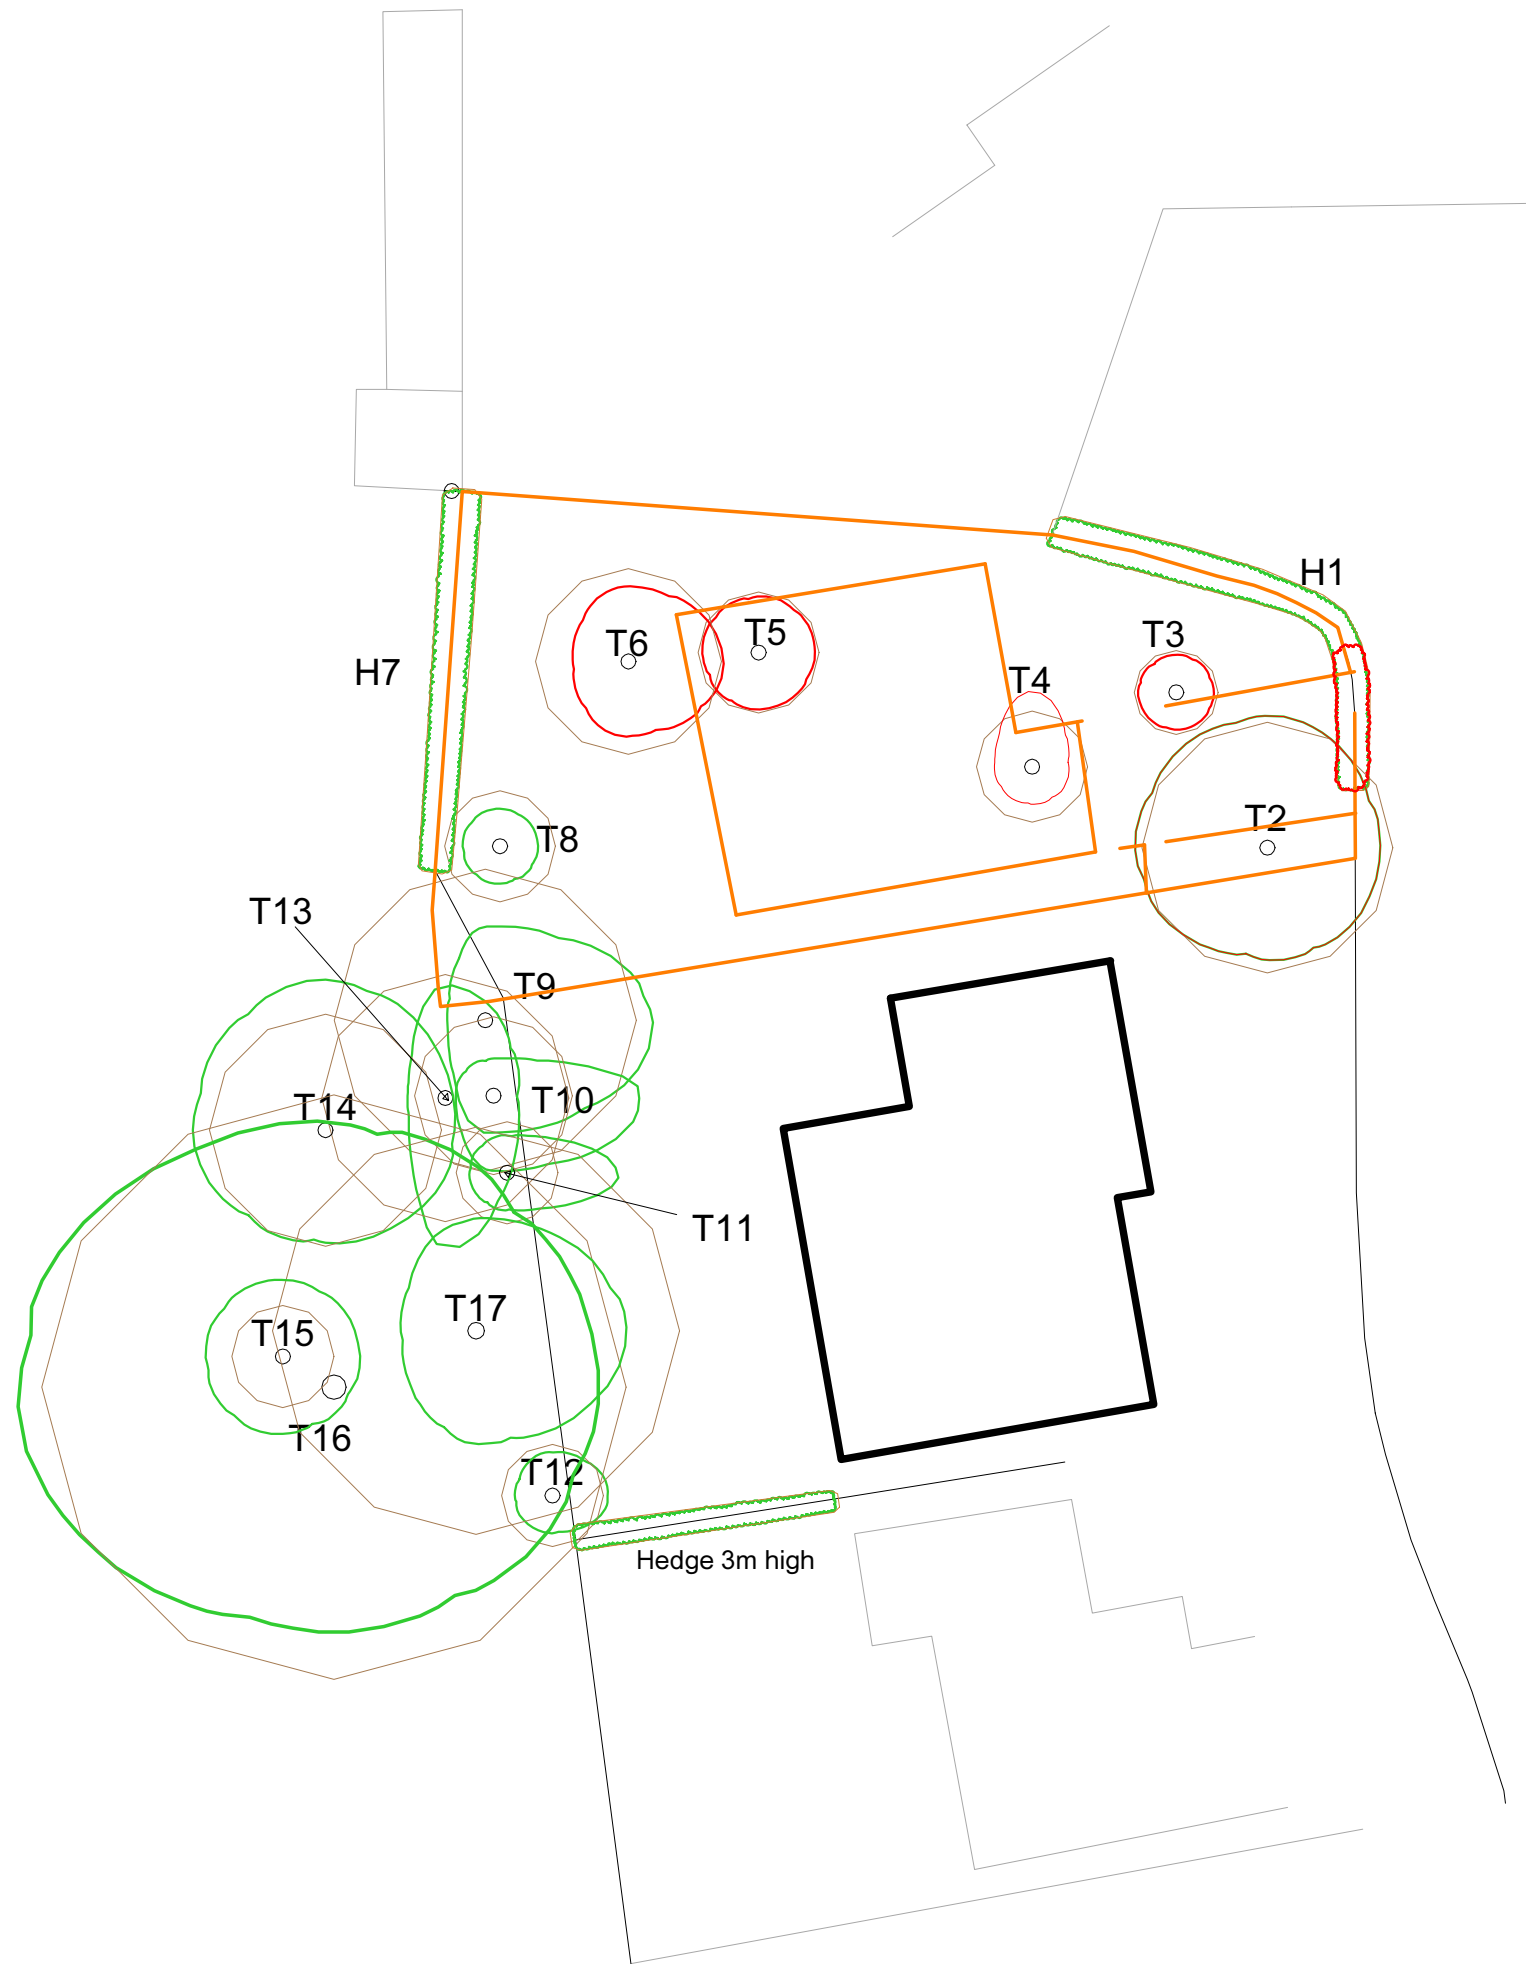
**Appendix 6:
Tree Impacts Plan**

- 3.3.2 From assessing the new development proposals, 5 trees and a section of hedge will require removal to facilitate the new development (H1, T2, T3, T4, T5 & T6), as they are situated within the footprint of the new development or their retention and protection throughout the development is not suitable. The trees requiring removal are highlighted in red on the Tree Impacts Plan and detailed in the tree data schedule at Appendix 4.

- 3.3.4 The tree Root Protection Area (RPA) detailed on the Tree Constraints Plan at Appendix 5, has been used as a layout design tool, to inform on the area around the trees where the protection of the roots and soil structure is treated as a priority. The trees and hedges along or beyond the western boundary will not be impacted by the proposed development, provided care is taken during construction.
