**Arboricultural Impact Assessment  
Land adjoining 50 Littleworth Lane  
Monk Bretton  
Barnsley**

Report Reference: TCC-2031-1

18 August 2024

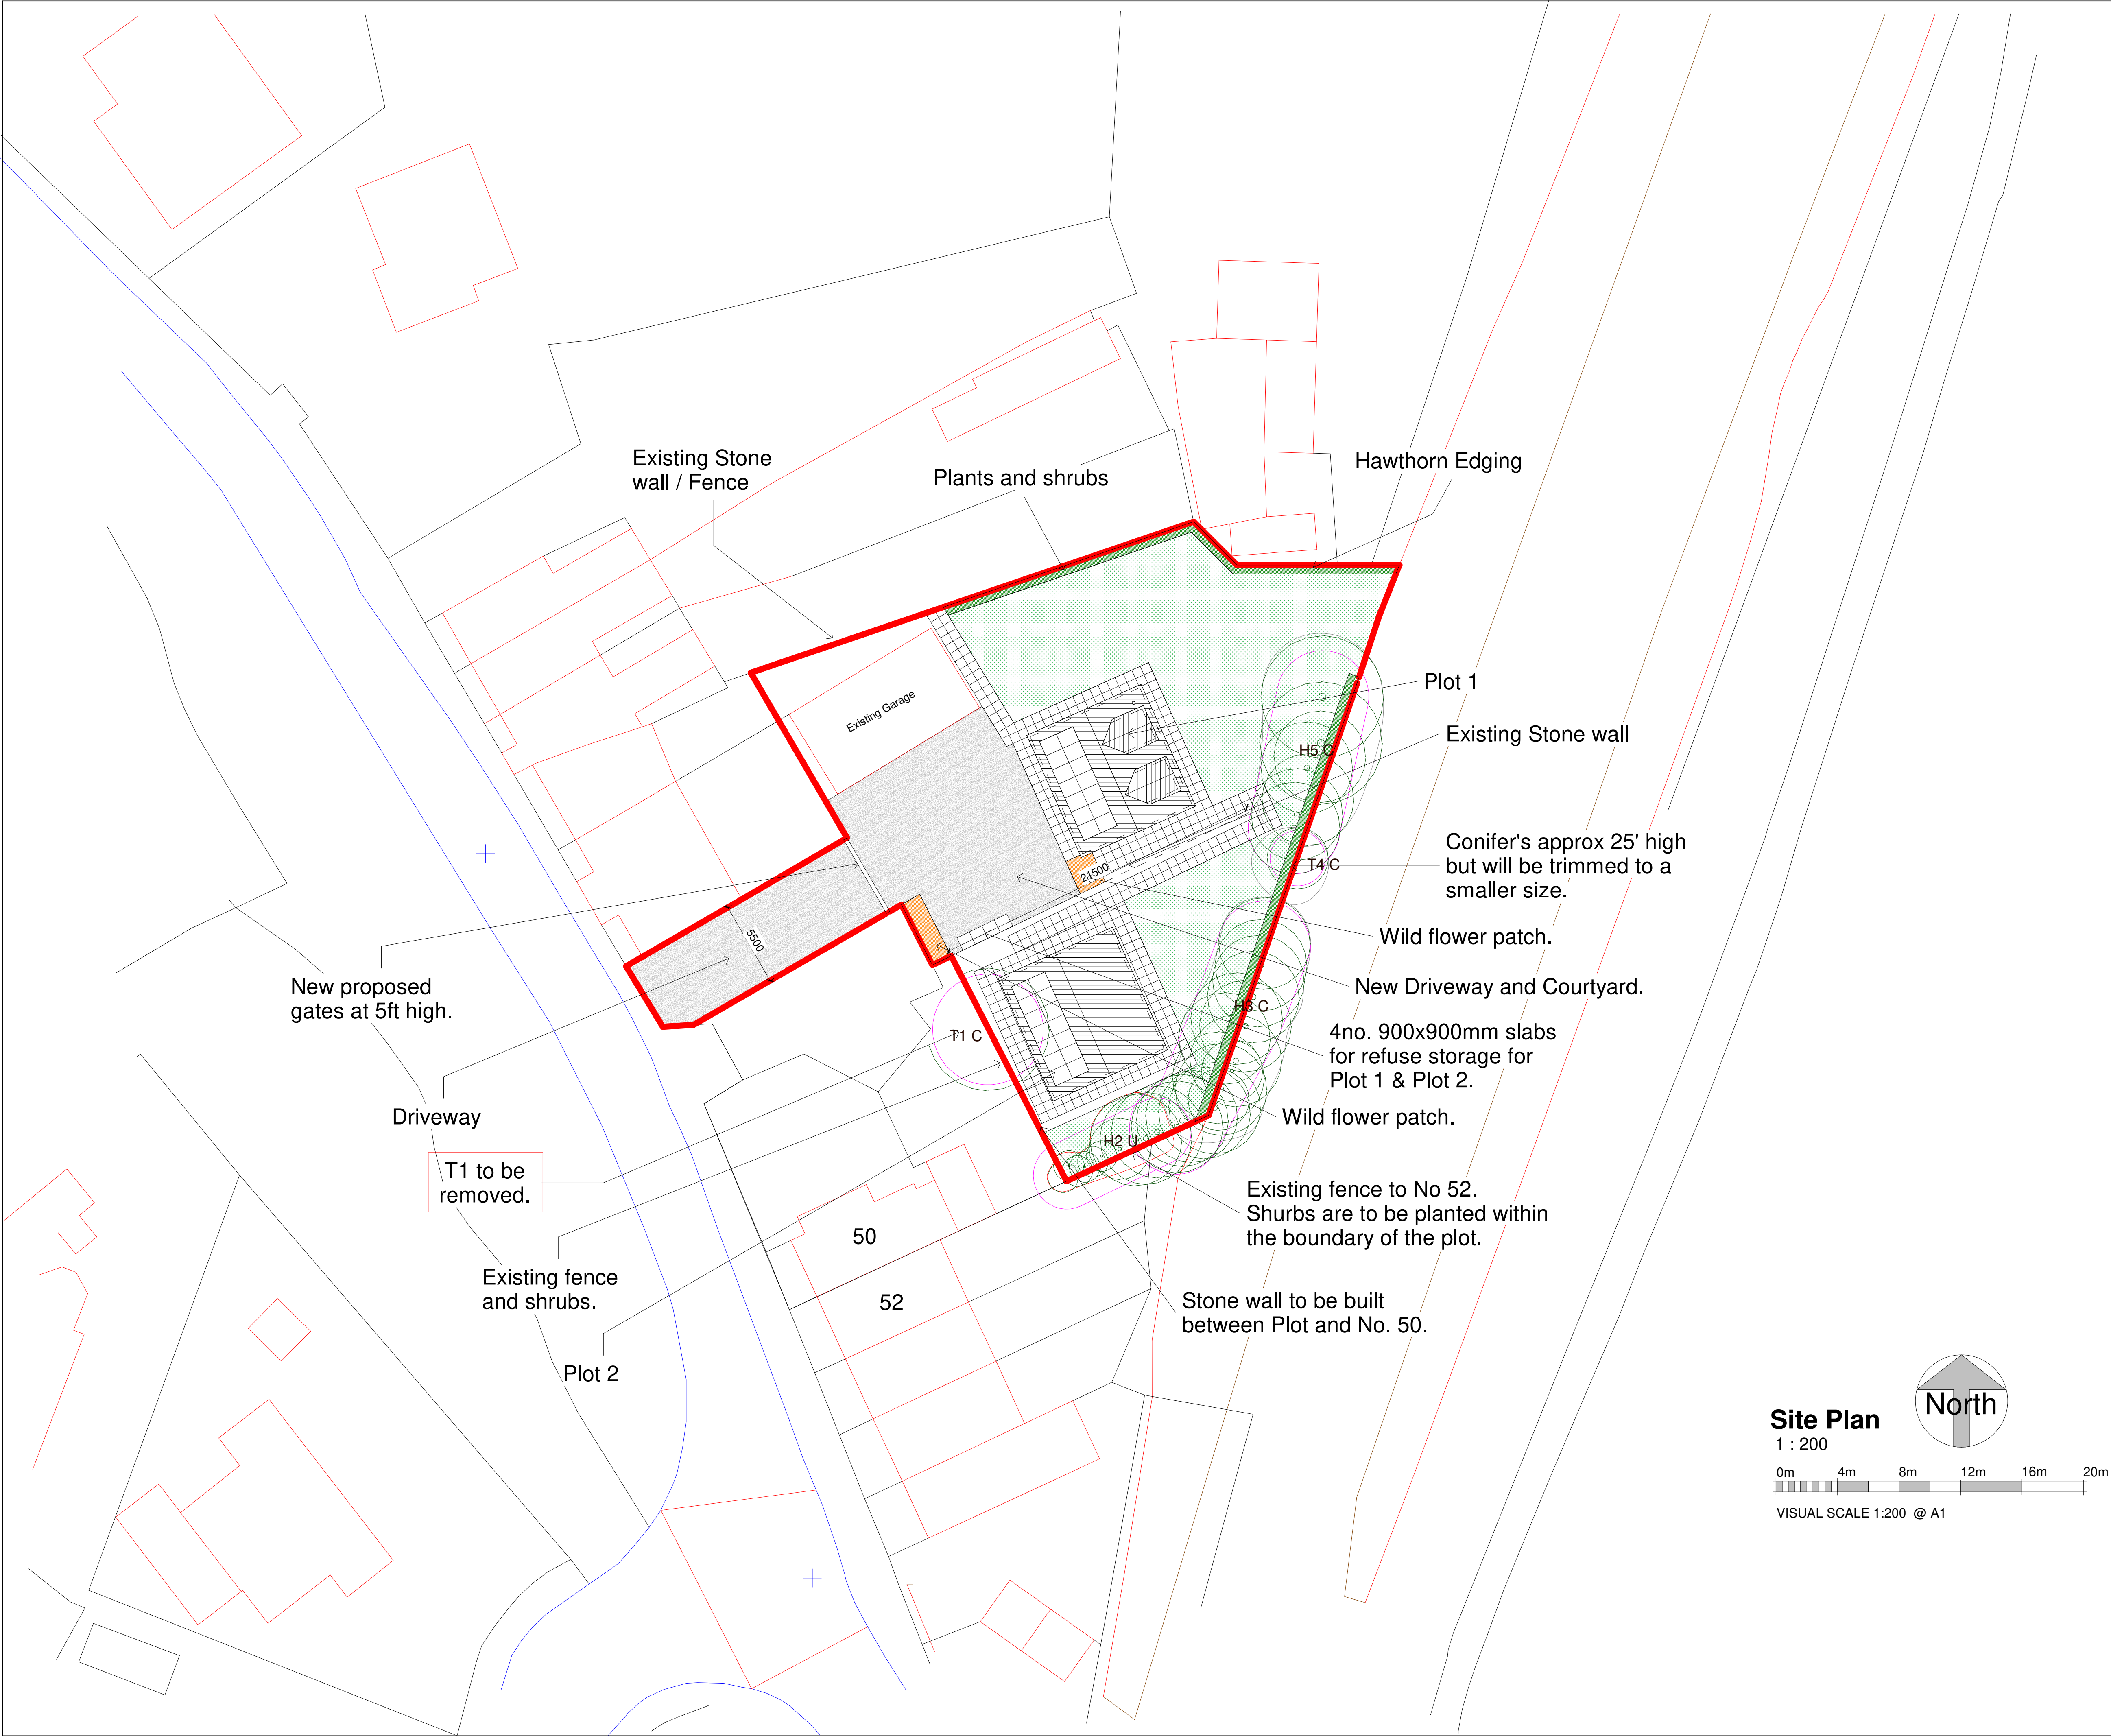
Appendix 5 -  
Tree Impact Plan

- 3.3.1 The area of roots that need to be protected around a tree to try to ensure it does not suffer damage during the construction process is called the Root Protection Area (RPA).
- 3.3.2 As recommended in BS5837 we have plotted the RPAs (in magenta) onto the attached Tree Constraints Plan (TCP) taking full account of the surrounding topographical factors, tree condition and the probable root disposition.
- 3.3.3 Construction of unit 2 will occupy ground within the RPA of Norway Spruce T1 and it is recommended that the tree be removed to accommodate the proposal.

- 3.3.4 Construction of pathways at plots 1 and 2 will encroach marginally within the RPA's of H3 and H5. To reduce injuries to these hedgerows the incorporation of a no dig Geogrid footpath construction is recommended, details of which can be effectively controlled by imposition of a suitably worded planning condition requiring the submission and approval of a pre-commencement Arboricultural Method Statement (AMS) or if necessary, an AMS can be submitted as part of the planning application.
