**Whitcher Wildlife Ltd.
Wildlife Consultants.**

BANK HOUSE FARM, SILKSTONE.

BAT MITIGATION STRATEGY.

Ref No:- 090823/MS.

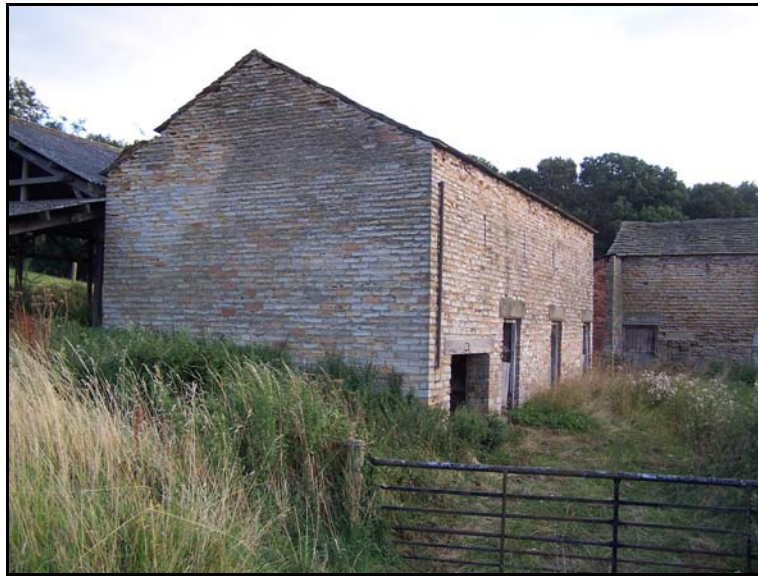
3.3.2. Building 1.

3.3.2.1.1. Building 1 is a two storey stone built barn with a stone tiled, pitched roof. The building is currently disused and has been for some time.

3.3.2.1.2. The walls of the building are coursed limestone with a rubble fill. The majority of the doors and windows within the building are missing or badly fitting.

3.3.2.2.1. The limestone walls of the building are much deteriorated and there are therefore occasional voids into the rubble fill of the walls although no bat field signs were identified around the exterior walls of the building.

3.3.2.2.2. The roof of the building is in a generally good state with no missing or slipped tiles and all the ridge tiles in place. There are abundant voids between the tiles and underneath the ridge due to the irregular shape of the tiles.

3.3.2.2.3. Approximately 25 bat droppings were identified within the 1st floor room of the building. The droppings were identified underneath the ridge of the building predominantly towards the southern end. A number of butterfly wings were also identified throughout the upper floor of the building.

3.3.2.2.4. Analysis of the droppings identified them as Natterers bat droppings.

3.3.2.2.5. Swallows nests were identified within a low garage area on the ground floor of the building. During this survey swallows were identified entering this area implying that the nests are currently in use. Occasional pigeons were also identified within the 1st floor room of the building.

3.3.2.3.2. Occasional old bat droppings were identified within the 1st floor room of the building with no concentration of droppings in any one area and the droppings were too old to enable the species to be identified.

3.3.2.3.4. A swallow nest was identified in a low garage area on the ground floor of the building. During this survey swallows were identified entering the garage and a swallow was seen sitting on the nest.

B1.1. No specific exclusion works will be carried out on Building 1 but the work on the building will commence during September when the bat roost is unoccupied.

B1.3. When work commences on Building 1 the ecologist will supervise the removal of the ridge tiles to ensure that no bats are present.

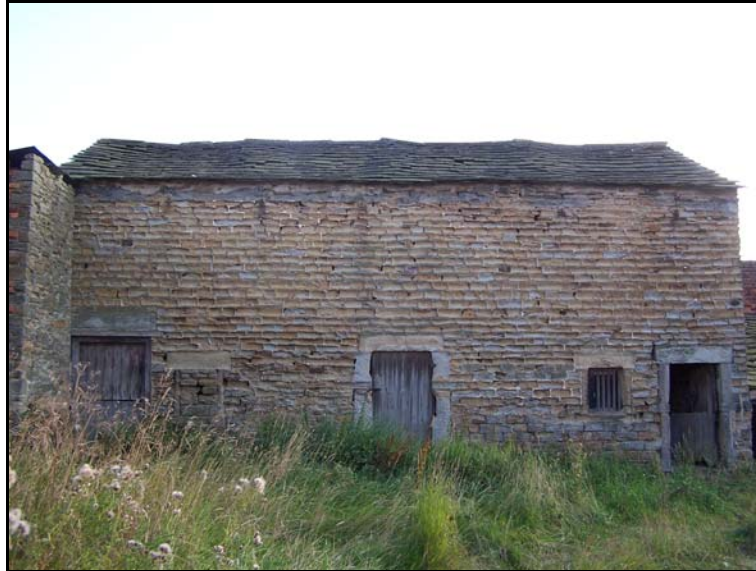
3.3.3. Building 2.

3.3.3.1.1. Building 2 is a two storey, stone built barn with a stone tiled, pitched roof. There are single storey brick outbuildings with stone tiled, sloping roofs constructed onto both ends of the building. The building is currently used for general storage and as a coal shed.

3.3.3.2.1. The limestone walls of the building are in a much deteriorated state with abundant gaps and voids through to the rubble fill although no bat field signs were identified around the exterior of the building during this survey.

3.3.3.2.2. The brick walls of the outbuildings are in a deteriorated state with abundant shallow pointing voids. No bat field signs were identified around the outbuildings during this survey.

3.3.3.2.3. The roof of the building is deteriorating with occasional missing and slipped tiles and a void along the ridge where the roof has rotted providing abundant voids in between the tiles.

3.3.3.2.4. The roofs of the outbuildings are in a much deteriorated state with abundant missing tiles and rotted timbers.

3.3.3.2.5. No bat field signs were identified around the interior of the building during this survey. The 1st floor room of the building displays abundant cobwebs and occasional butterflies.

3.3.3.2.7. A dead jackdaw was identified within the 1st floor room of the building although no used nests were identified at the time of this survey. A currently used swallow's nest was identified within the outbuildings on the northern end of the barn.

3.3.3.3.3. Swallows nests were identified in the outbuildings attached to the building although no swallows were identified around the buildings during this survey.

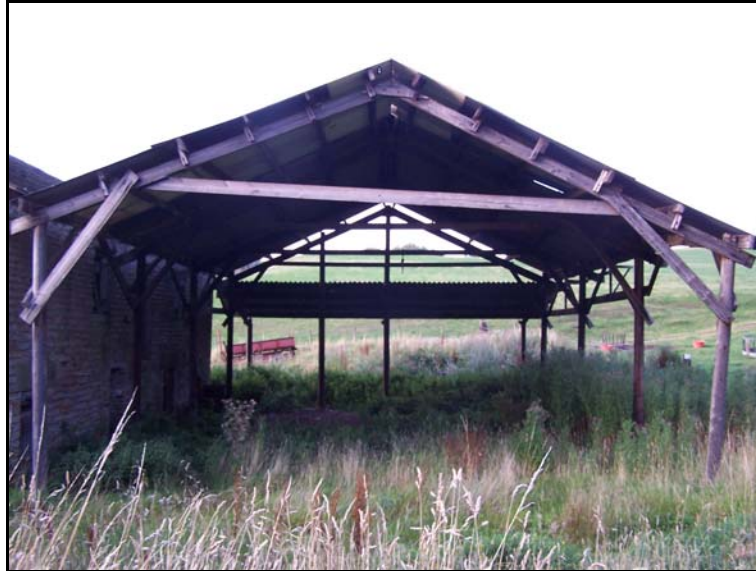
3.3.4. Building 3.

3.3.4.1.1. Building 3 is a two storey high timber framed open barn to the rear of building 1. The roof of the building is single skin corrugated and the building currently stands empty.

3.3.4.1.2. The building comprises a wooden frame with no walls. The interior of the building is open to the underside of the roof sheets.

No bat field signs were identified throughout the interior or exterior of the building during this survey.

3.3.4.3.2. No bat field signs were identified around the interior or exterior of the building during this survey.

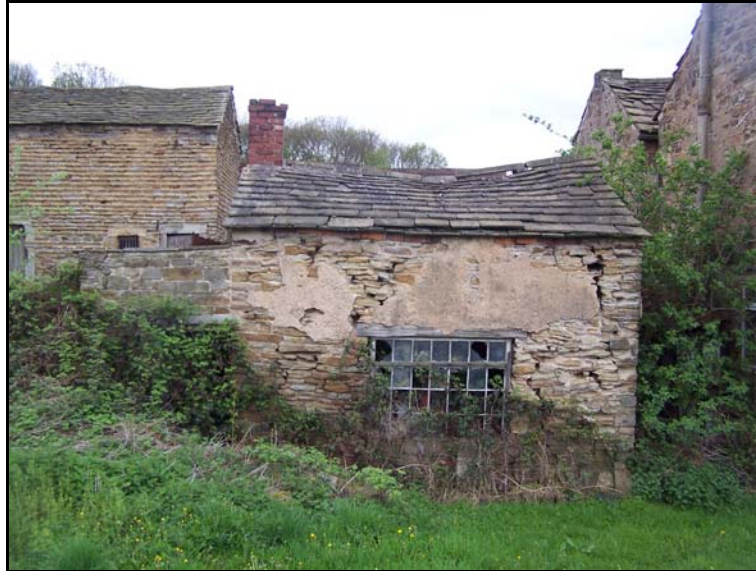
3.3.5. Building 4.

3.3.5.1.1. Building 4 comprises two buildings stood adjacent to each other, a single storey stone constructed shed with a stone tiled pitched roof and a single storey brick shed with a tiled sloping roof. The stone building is currently disused with the brick building being used as a log shed.

3.3.5.1.2. The stone sections of the walls are in a much deteriorated state with abundant cracks and voids and the windows or doors missing or smashed. The brick walls are in a reasonable condition.

3.3.5.1.3. The roofs of the buildings are in a deteriorating state with abundant missing or slipped tiles and signs of distinct sagging in the pitched roof.

3.3.5.1.4. The interior of the stone building is inaccessible due to large amount of vegetation around the doors although it was possible to see through the window. The building is used for storage and has abundant holes in the roof. The brick building is partially filled with logs.

3.3.5.2.2. No bat field signs were identified throughout the interior of the building during this survey.

C1.3.2. No bat roosts or bat activity was identified around Building 4 therefore there are no restrictions in timing with regards to the demolition of this building.

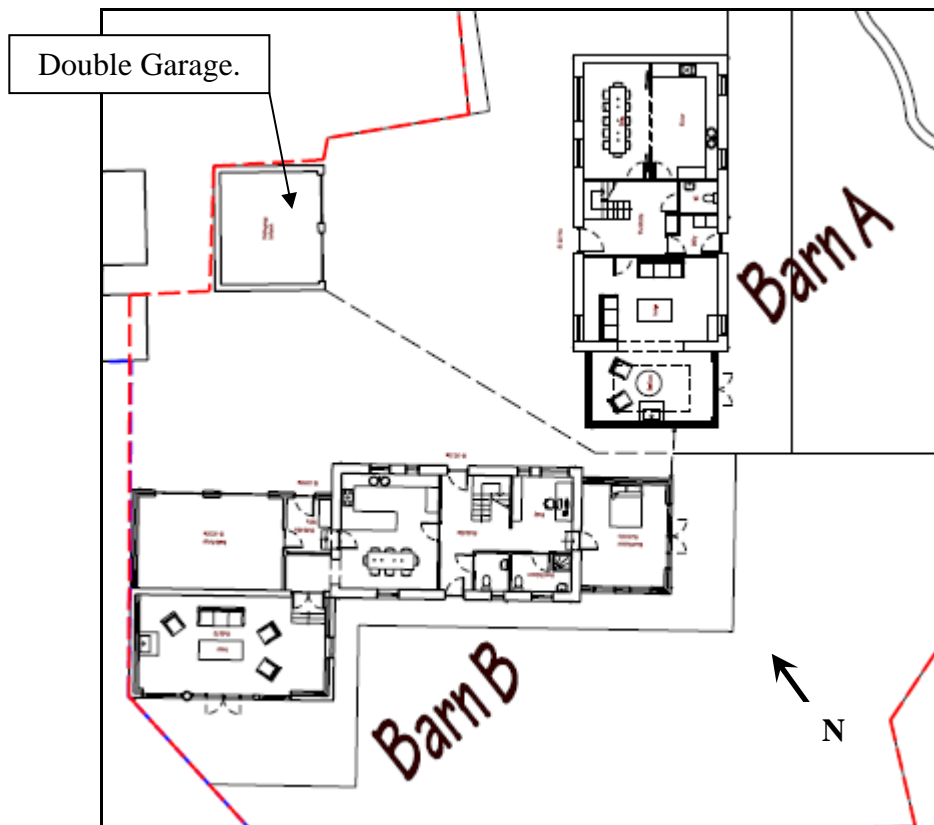
C1.3.3. The plan below shows the location of the double garage in relation to the barns that currently stand on the site.

C1.3.1. Prior to any work on Building 1 being carried out a new detached double garage will be constructed on the site of the current Building 4 and all mitigation

C1.3.4. The garage will be constructed from reclaimed stone with reclaimed stone tiles and ridge tiles. The garage will be approximately 5m x 5m in size with a loft space providing a height of 1.6m from floor to ridge.
