Barnsley Road, Silkstone  
Coal Mining Stability Risk Assessment

LCF/01  
Land at Barnsley Road, Silkstone  
Geological Plan  
July 2017

# CON29M Non-Residential Mining Report

LAND AT BARNSLEY ROAD  
SILKSTONE  
BARNSLEY  
SOUTH YORKSHIRE

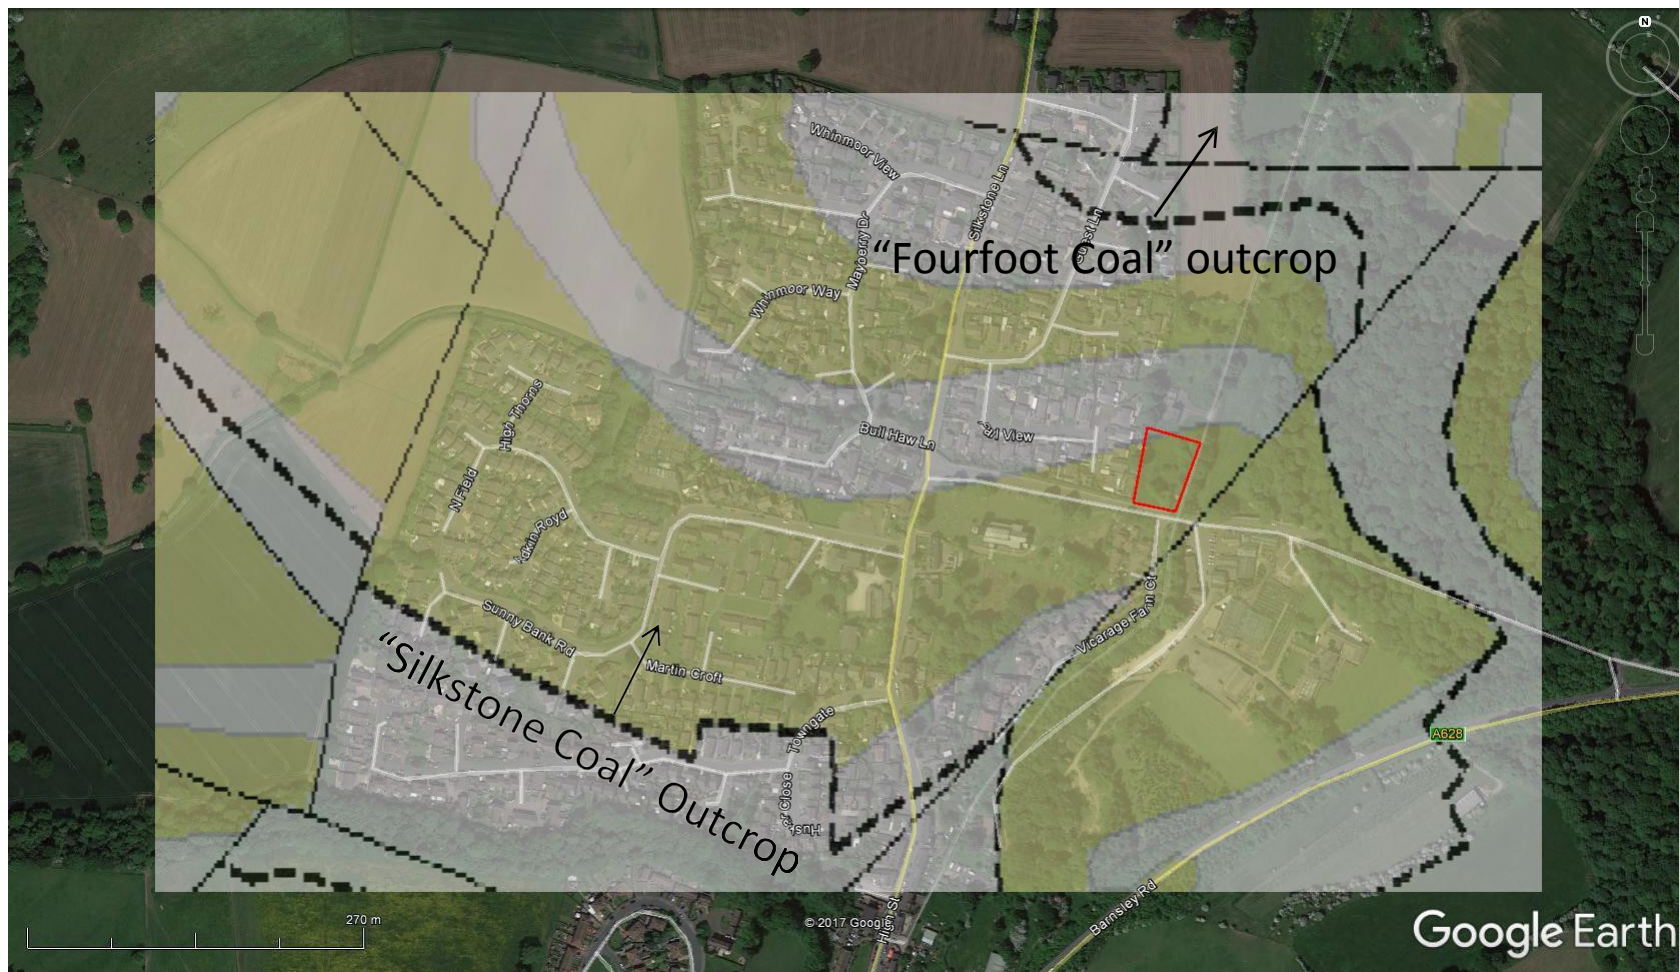
A fault is indicated approximately 17m to the southeast of the site, trending north-northeast – south-southwest, with the downthrow to the south-southeast. The fault may affect the site locally, around the south and southeastern corner. The proposed location for the plots may not be affected by the fault. According to the geological map, the general dip in the area is indicated to be 1 in 10 (approximately 5.74 degrees) to the northeast.

A northeast trending coal seam (Silkstone Coal) outcrops approximately 187m to the south-southeast of the site (91.4m AOD), but curves around as you move westwards for approximately half a kilometre, finishing up with a northwest trend. The general dip of the strata in the area is indicated to be 1 in 9 (6.5 degrees) to 1 in 12 (4.8 degrees) to the north-northeast, but could also be to a northwest direction; as a result the Silkstone Coal seam should underlie the site at a depth of between 15.8m (around 75.5m AOD) to 20.2m (71.2m AOD). The site lies at an elevation of approximately 91.4m to 94.5m AOD (similar elevation to the closest indicated Silkstone Coal outcrop, at the west of Silkstone Beck). The seam is indicated to be between 1.01m and 1.8m

thick, and is known to have been extensively worked in the area. An adit is shown to enter the Silkstone Coal, at 165m to the south-southeast of the site. Other adits and shafts are shown to enter the Silkstone Coal, and other coal seams, in the surrounding area. The Generalised Vertical Section on the geological map indicates that the next shallowest significant seam below the Silkstone Coal is the Blackband Coal, around 59m below. At such a depth, the Blackband Coal is not of concern for ground stability.

A second coal seam (Fourfoot Coal) is conjectured to outcrop at approximately 135m to the north of the site, curving from southeast to northwest trending, from 91.4m to 100m AOD. The general dip of the Fourfoot Coal is shown, in an adjacent fault block to the east, to be 1 in 5 (approximately 11.2 degrees) to the northeast. This direction is away from the property, and as a result the Fourfoot Coal should not underlie the site.
