Arboricultural Impact Assessment & Method Statement

Site Address:	Vernon House Yews Lane Kendray Barnsley S70 3LJ	Client:	Mr Richard Senior
Report Ref:	YLKB02-25	Report Date & Revision:	19th May 2025 Rev III
Author:	Laurence Smith BSc (Hons) Arb, M Arbor A	Signed:	<i>Laurence Smith</i>

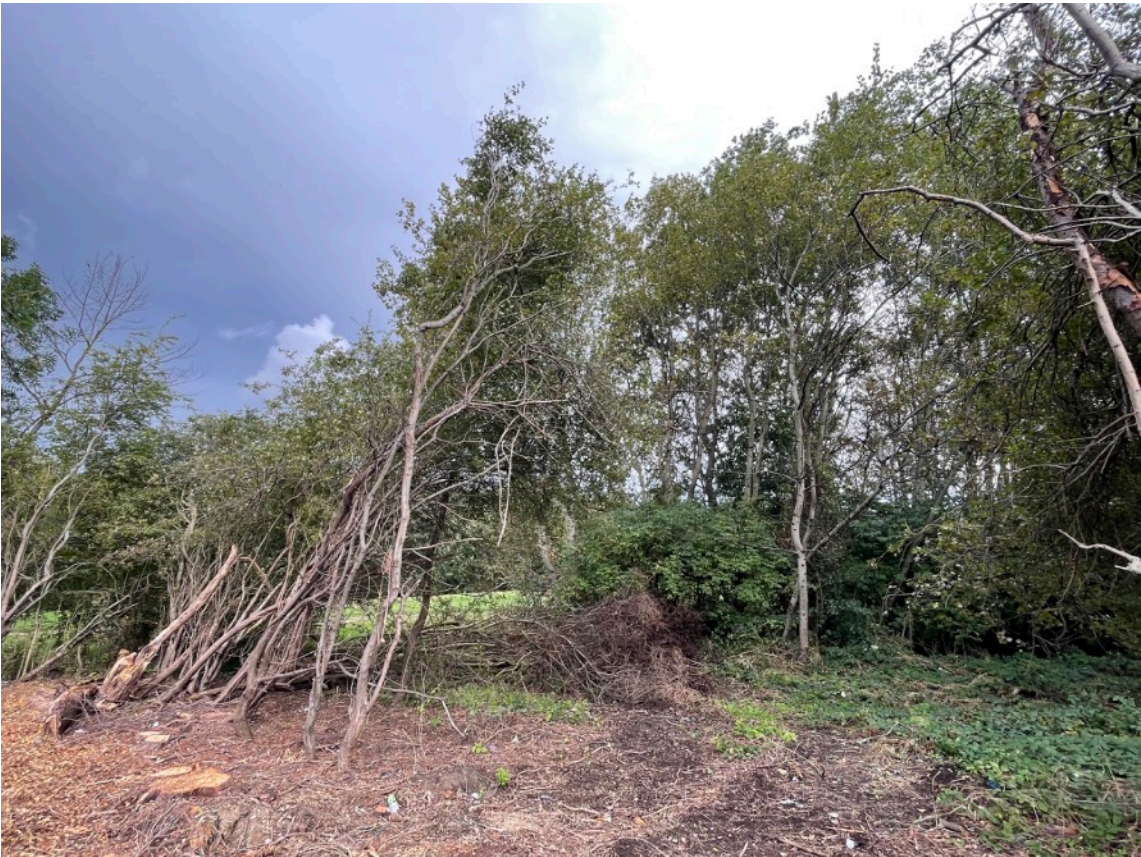
Figure 8. H13 to the left of the image with T14 and G15 in the background.

T14	Young	Aspen (<i>Populus tremula</i>)	8	120	3, 2.5, 1, 2	N/A	N/A	Normal	Tall slim stem with a minor lean to the north.	None	>10	C2	1.4
G15	Semi Mature	Aspen (<i>Populus tremula</i>)	13	250, 280*	6, 6, 6, 6	6 S	3	Normal	End trees of a shelter belt of Aspens which extends further east. Lower deadwood but generally in condition typical of the species.	None	>20	B2	3.8
G16	Semi Mature	Lawson's Cypress (<i>Chamaecyparis lawsoniana</i>)	8	150, 150, 150	2, 2, 2, 2	N/A	Ground level	Fair	The southeastern sides are dead with the only viable canopy at the crown and the opposing side only.	Potential to fell and replace.	>10	C2	2.6
T1942	Semi Mature	Layland Cypress (<i>Cupressus x leylandi</i>)	11	370	3, 3, 3, 3	2 W	2	Normal	Form and health typical of the species.	None	>20	B1	4.4
T1943	Semi Mature	Goat Willow (<i>Salix caprea</i>)	7.5	150, 170	4, 2.5, 0, 4	2 N	3	Poor	Hollowing stems with decay at the base.	Fell	<10	U	2.3
