Princess Theatre, Hoyland

Bat Survey Report

14th June 2026

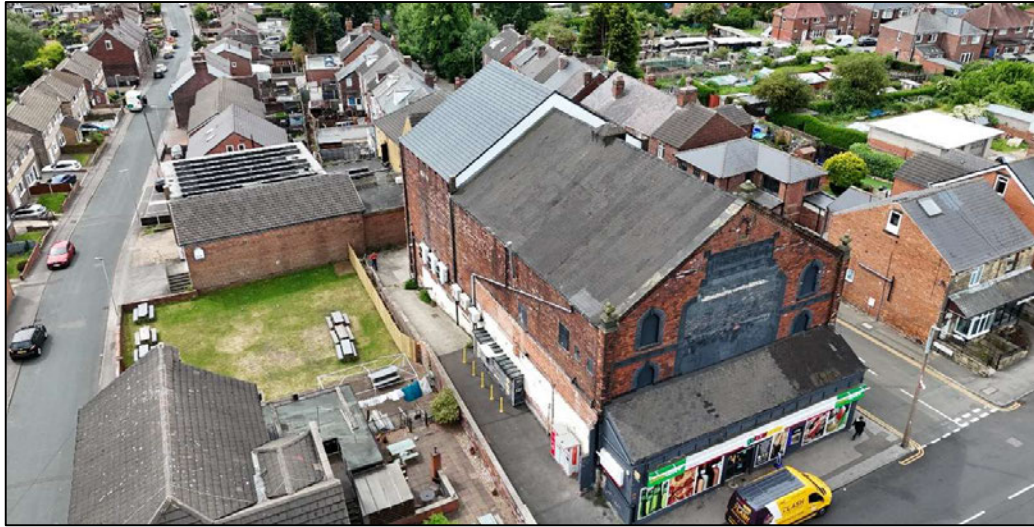
Plate 2. The building viewed from the northeast

- 5.2.1 The former Princess Theatre comprised a large three-storey brick-built building with a stepped dual-pitched roof and a lean-to single storey section on the front elevation (Plate 2). The roof was predominantly covered with Welsh slate although the rear section which was slightly higher was covered with interlocking concrete tiles (having been reroofed in 2025).

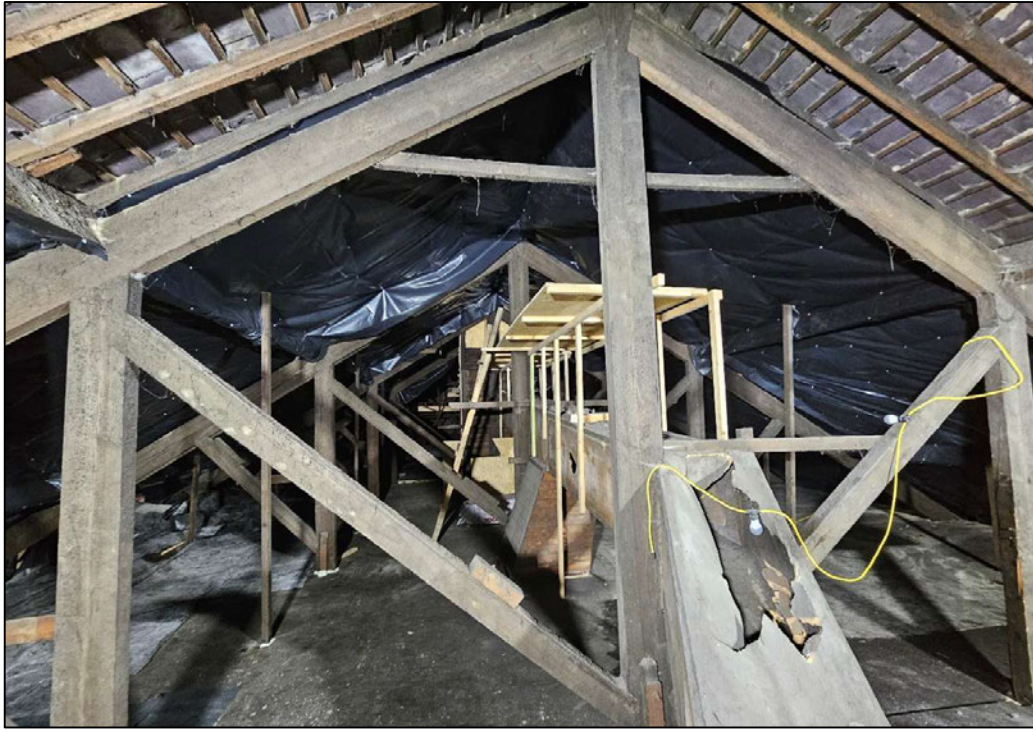
Plate 3. The interior of the roof void viewed from the northern end of the building

- 5.2.2 Coping stones were present on the front gable, with verge capping present on the rear and stepped sections of the roof. Plastic guttering was supported by fascia boards. Bargeboards were present beneath the verge capping on the rear elevation.
- 5.2.3 The roof was supported by a combination of king post trusses, modern W-trusses, purlins, rafters and battens (Plate 3). The reroofed southern section was lined with a breathable roofing membrane. The older sections of the roof had been partially lined internally with plastic sheeting below the rafters and purlins in the winter of 2025/2026 to reduce water ingress. Where exposed sections were still visible traditional torching was visible beneath the slates.

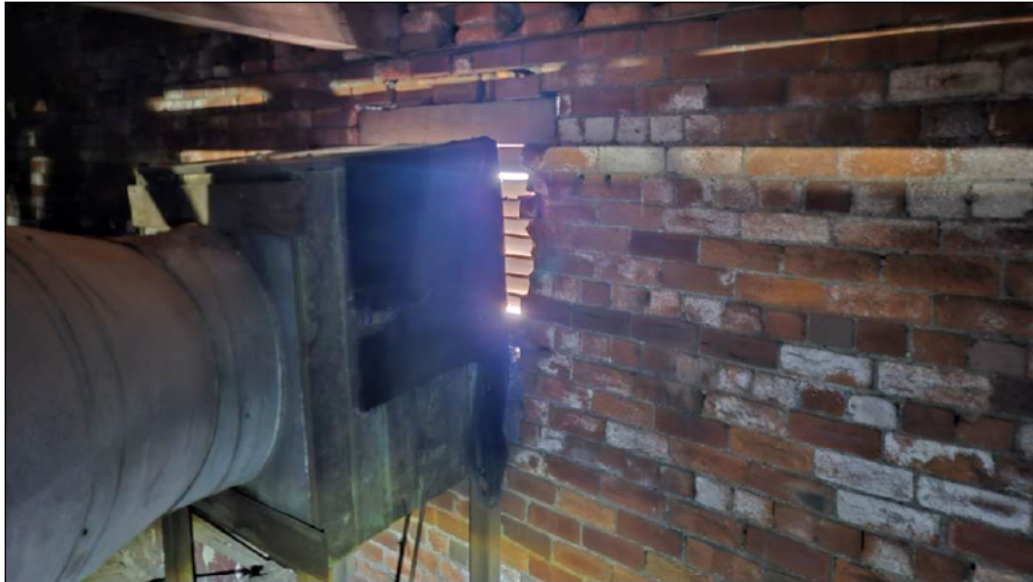
Plate 5. The louvred vent at the southern end of the building

5.2.4 A square timber louvred vent was present on the southern gable, providing ventilation to a series of metal pipes within the building. Internally, a large gap was present between the vent and the associated pipework (Plate 5).

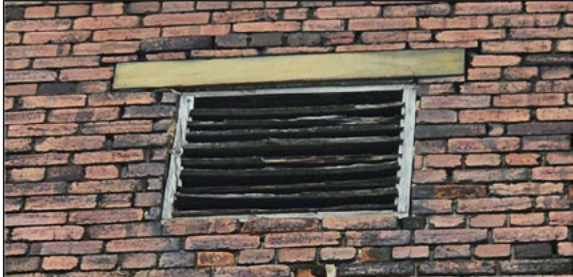
Louvred vent.

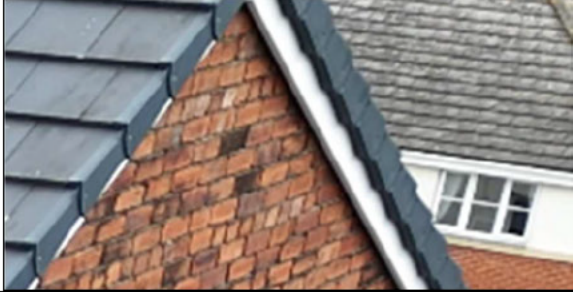
Gap behind barge board.
D

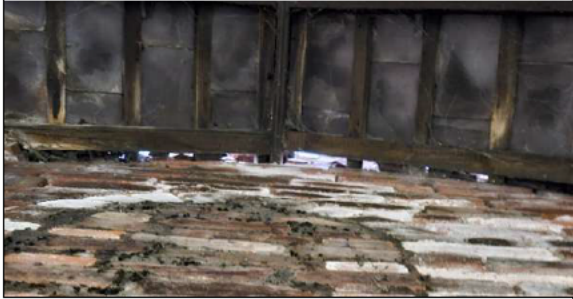
Gap between ridge and coping stones (viewed from inside the roof void).
E	No photo available.	Gap behind fascia.
F

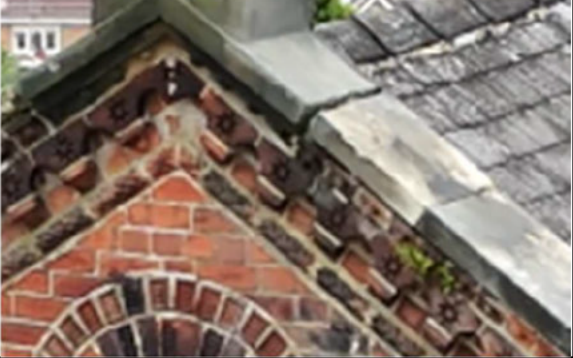
Gap between coping stones.
G

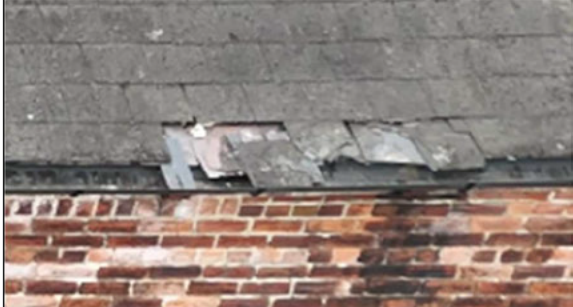
Slipped/missing slate.

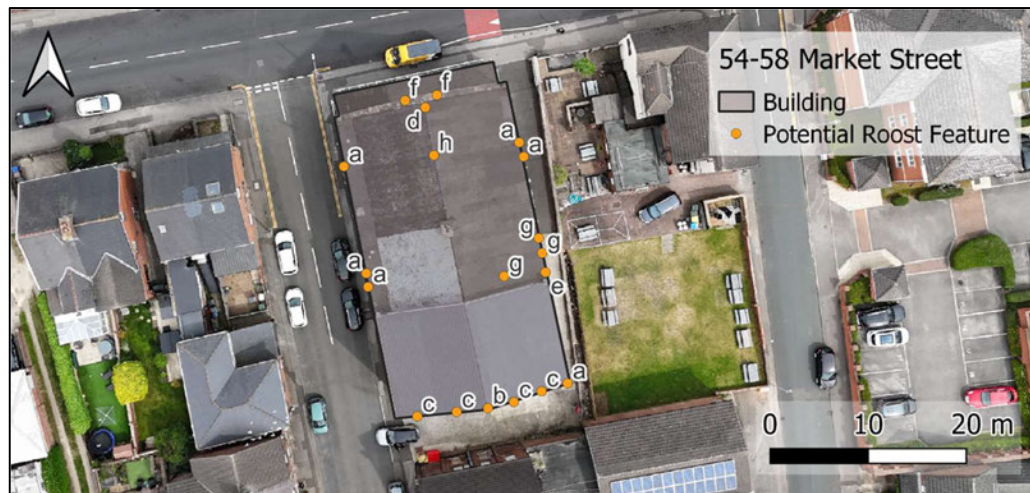
Figure 3. Potential roost feature locations

- 5.2.5 The potential bat roost features present comprised gaps below slipped slates, behind fascias and barge boards, gaps in the masonry, and between coping stones and the ridge. The potential roost features are shown in Table 2, and their approximate locations shown on Figure 3.

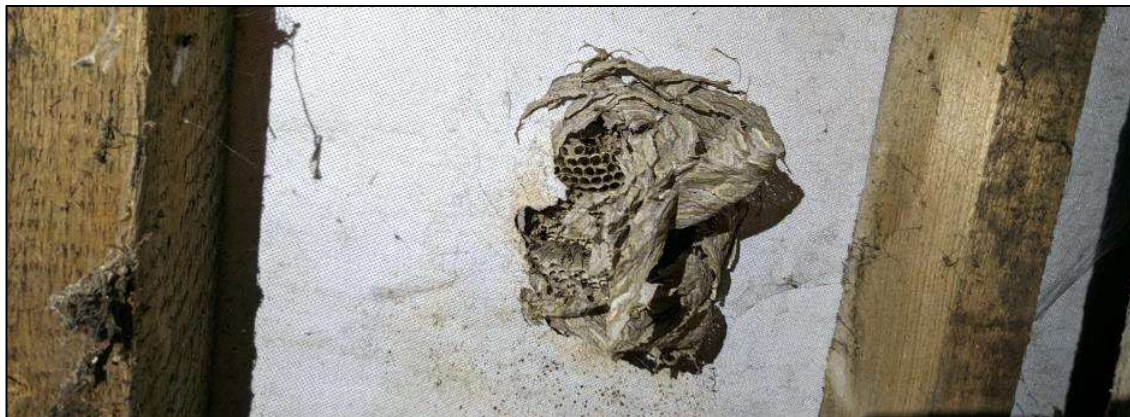
In recent years a fairly substantial proportion of the lofts we have surveyed which had existing breathable felt, were found to have been damaged by wasps (Plate A2.2). The wasps appear to have chewed holes in the felt and formed nests. This doesn't appear to be a problem associated with traditional bitumen coated roofing felt. Any holes within roofing felt are likely to significantly reduce its functionality as a secondary weather barrier. Where bats or birds come into contact with breathable roofing membranes, they can also damage it causing it to leak, they can also significantly reduce the breathability of the felt in that location.

Plate A2.2. Damage to a breathable roofing membrane adjacent to a wasp nest
