**Barnsley Hospital  
Pogmoor Road, Barnsley  
– BS 5837 Tree Survey**

Report Title: **Barnsley Hospital, Pogmoor Road, Barnsley  
Tree Survey Report**

Revision: **V02**  
Issue Date: **August 2013**  
Report Ref: **4684**

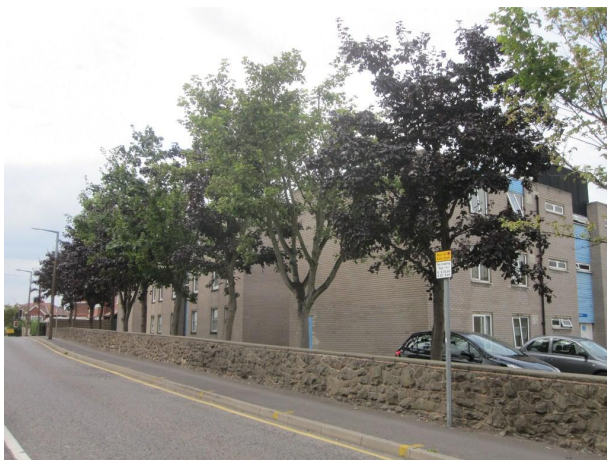
- 3.2.3 The sycamores (T1- T13) along Pogmoor Road form the west section of a long row of red and green varieties having been planted in an alternating pattern. Individually they are of low amenity value, however, as part of a group along a main road designed frontage, they merit a higher amenity value and are therefore classed as Category B trees (moderate value)

**Sycamores T1- T13 along Pogmoor Road**

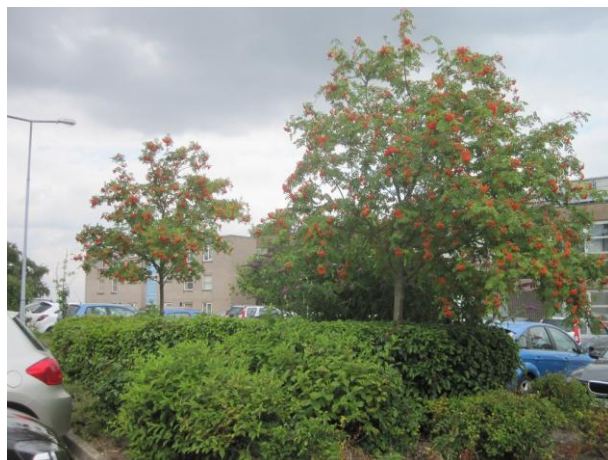
- 3.2.4 The two rowans T14 and T15 are of low amenity value. Norway maple T16 is of low amenity value, however, it has significant symptoms of a *Phytophthora* infection and will require removal. It is therefore "unsuitable for retention" (Category U).

**Rowans T14 and T15 within the car park**

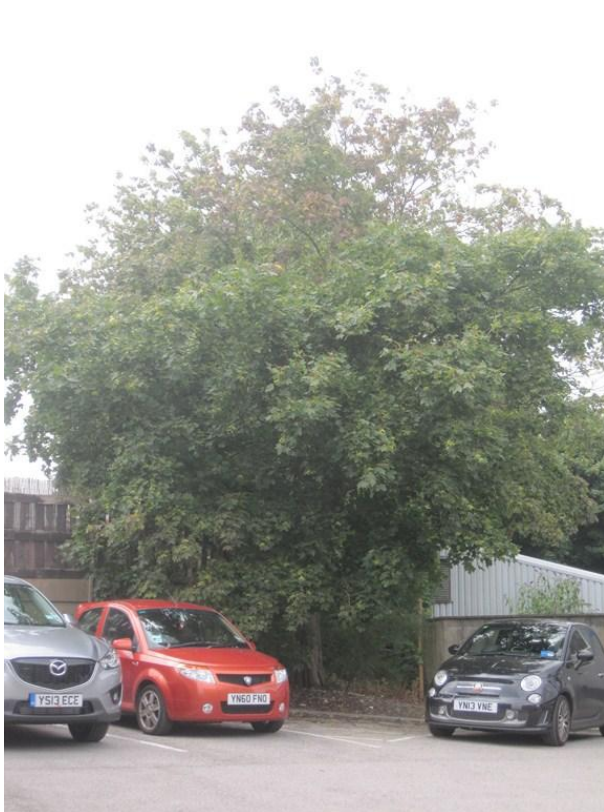
**Norway maple T16**

| Tree No | Species | Ht (m) | Stem Diam cm@ 1.5m (mm) | Canopy Spread (m) N- E- S- W | Height of Crown Clearance | Age Class | Est yrs | Overall Condition | Structural condition | Management Recommendations | BS 5837 Category | RPA Radius (m) | RPA (m <sup>2</sup> ) |
|---|---|---|---|---|---|---|---|---|---|---|---|---|---|
| T16 | Acer platanoides | 8 | 400 | 5.5-6-3-5 | 1.5 | M | 10+ | Fair | Significant symptoms of Phytophthora infection, including bark lesions and rusty red patches on stem. | Remove | U | 4.80 | 72.38 |

- 4.1.1 An Arboricultural Impact Assessment of the proposed site plan has been undertaken to assess the likely impact of the development on existing trees and tree groups. This assessment is based on the development plan provided by the architect (ref: Beaumont and Cowling drawing ref. 3336/20 dated July 2013).
- 4.1.2 The client proposes the demolition of one block of accommodation and to extend the existing car park. The work will also require a temporary site access road off Pogmoor Road into the site.
- 4.1.3 The development plan indicates that all trees within the red line site boundary will be retained, however, T16 should be removed for safety reasons and to prevent the spread of Phytophthora.

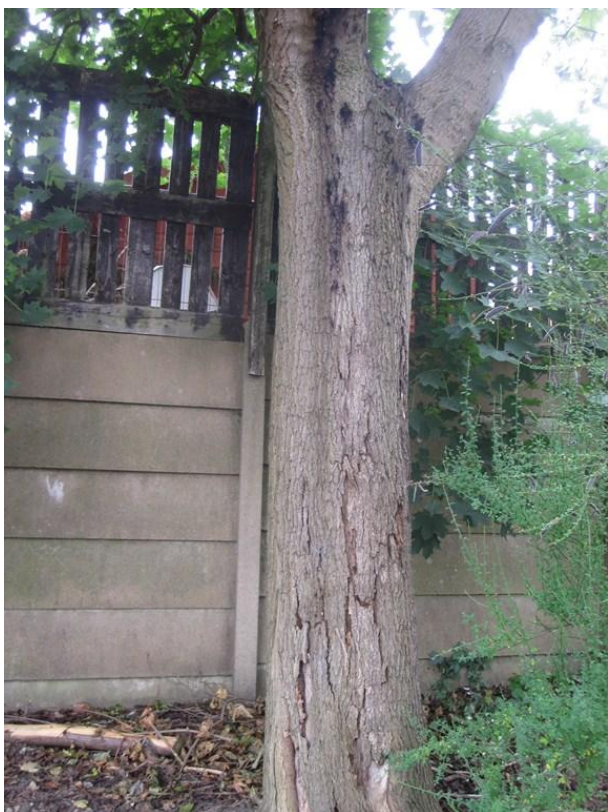
**Bark lesions and rusty patches on T16**
