# **ARBORICULTURAL REPORT & Impact Assessment to BS5837:2012 at:**

***Wilkinson Road,  
Elsecar,  
Barnsley,  
South Yorkshire  
S74 8JS***

Date: February 2019

Reference: AWA2549

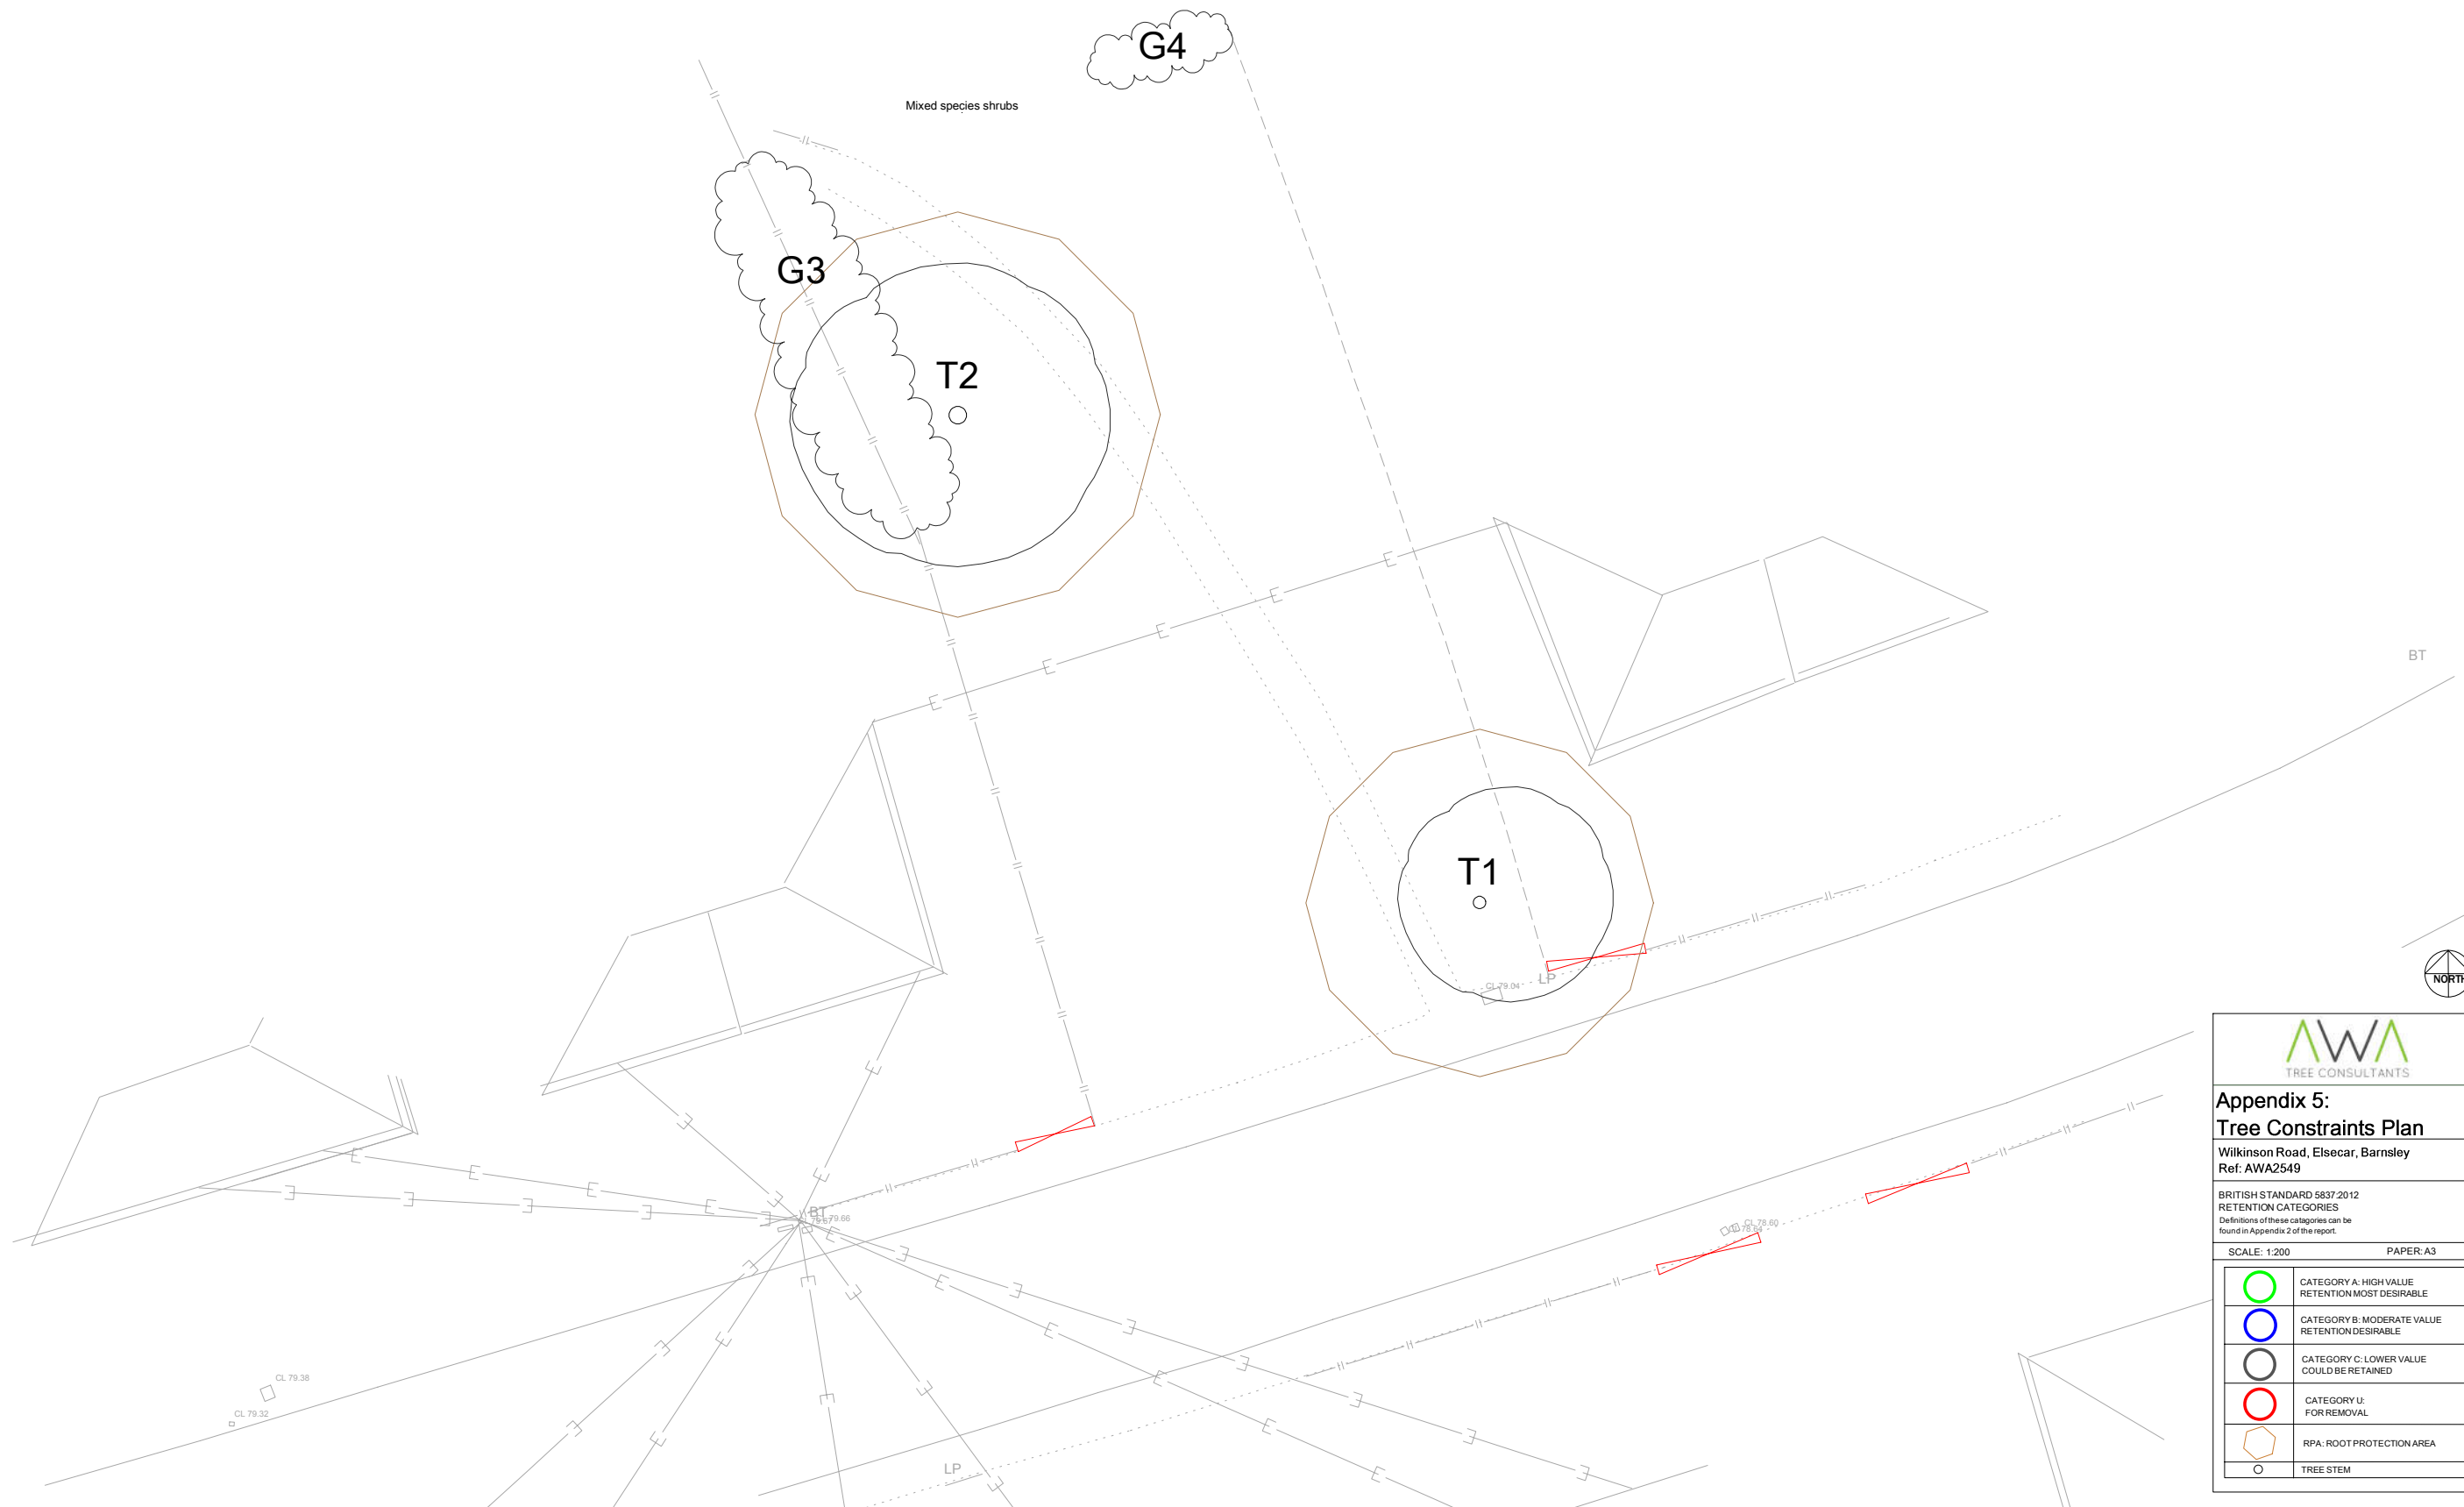
**Appendix 5:**  
**Tree Constraints Plan**  
Wilkinson Road, Elsecar, Barnsley  
Ref: AWA2549

- 3.2.6 The tree Root Protection Area (RPA) detailed on the Tree Constraints Plan

at Appendix 5, has been used as a layout design tool, to inform on the area around a tree where the protection of the roots and soil structure is treated as a priority.

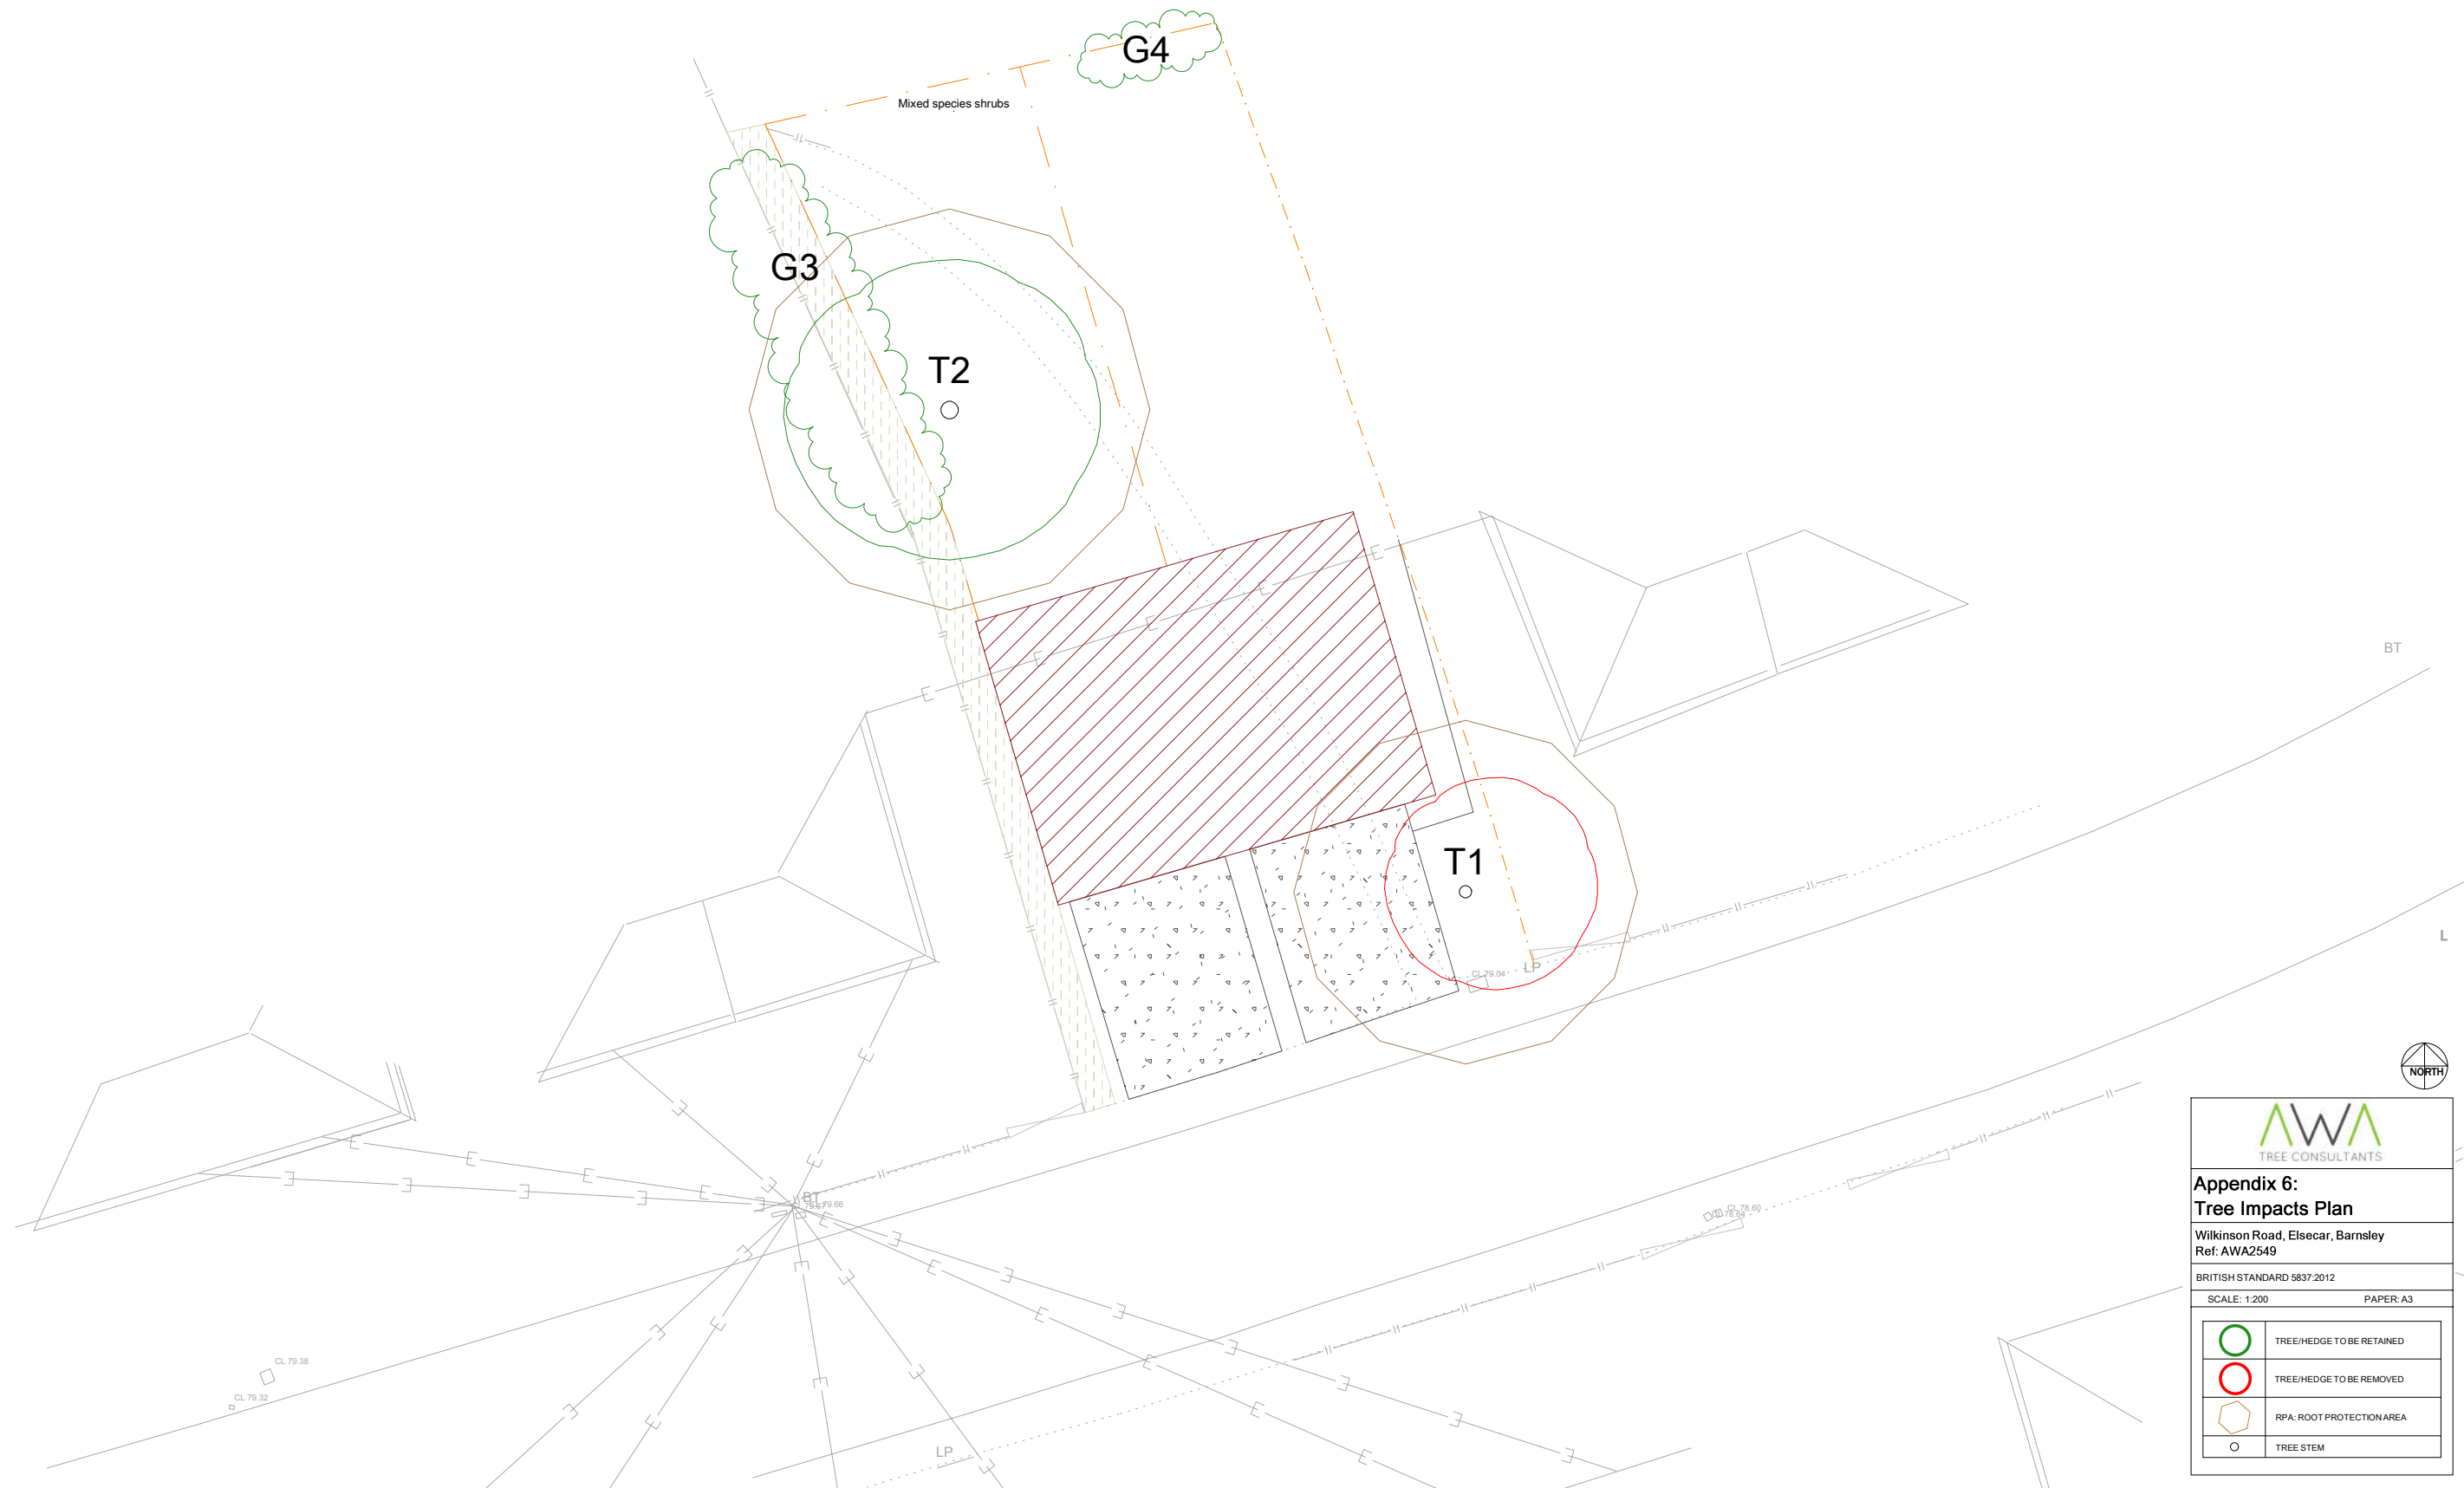
**Appendix 6: Tree Impacts Plan**

- 4.2.1 From assessing the new development proposals, 1 tree will require removal as its retention and protection throughout the development is not suitable.

- 4.2.2 The tree that requires removal is the Maple T1. Its removal will have a moderate loss of amenity in the short term, but it can be easily replaced with new landscape plantings at the site. The tree could also be considered to be situated unsuitably close to the adjacent street light.

- 4.2.3 The Cypress hedge G3 will require minor pruning works to facilitate a proposed new footpath. Much of the crown of the hedge is limited by the boundary fence to a height of 2m, but the southern end of the group has developed beyond the fence and should be pruned back to the fence line. It is likely the hedge will readily tolerate these pruning works and the limited amenity value it currently provides will not be significantly affected.

- 4.2.4 The proximity of T2 to the rear of the proposed development warrants some pruning works. To avoid future nuisance issues, a crown lift of the lower north-eastern limbs to a height of approximately 4.5m and removal of all significant deadwood is recommended.
