## Anderson Tree Care Ltd

### **Tree Impact Assessment,** **Proposed Extension, Burntwood Hall.**

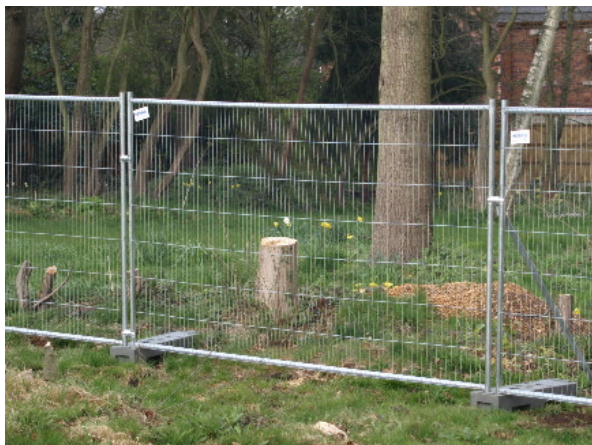
Tree protection fencing.

You have the specification for protective fencing from BS5837 (2005) and the photograph to the left shows some fencing I erected that met with approval from Doncaster Council. Note the panels are braced and the feet are fixed in position to prevent casual removal. It might be an idea to fix notices to the fence panels stating their purpose.
