Application for Variation of Conditions

Site Address: Cannon Hall Museum, Bark House Lane, Cawthorne,
Barnsley, S75 4AT

Additional roofing & drainage works to Cannon Hall.

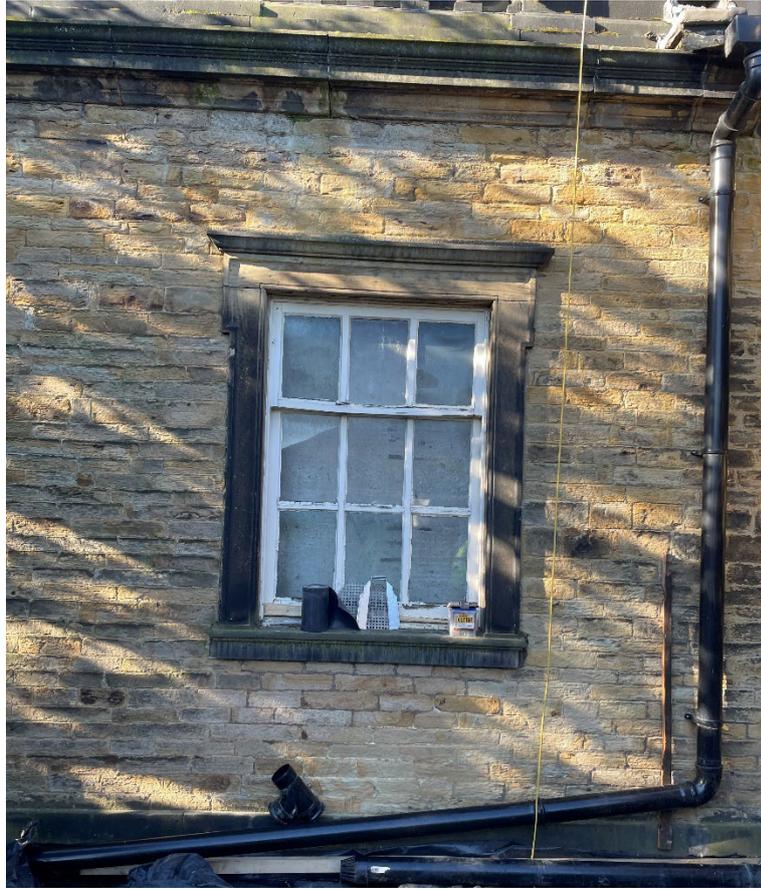
Present proposals retain the existing black UPVC drainage pipes which discharge onto the lower flat roof area.

The existing rainwater goods are not of historic interest. They are likely a 20th century replacement due to their UPVC and felt lined construction. The existing rainwater drainage route runs water onto the lower section of flat roof before it is then discharged into a perimeter gutter, providing a potential source for blockage if debris built up between the newly installed lead bays.

Figure 01: Existing drainage run for element 01.

The existing black UPVC drainage pipes and felt lined timber troughs are removed. A new lead lined trough is installed, extended to the South side of the hall. A new black cast aluminium downpipe and hopper are installed and run down the side of the hall to ground level. A new drainage channel will be installed beneath the path to the south of the hall. New rainwater goods to be Marley Alutec range.

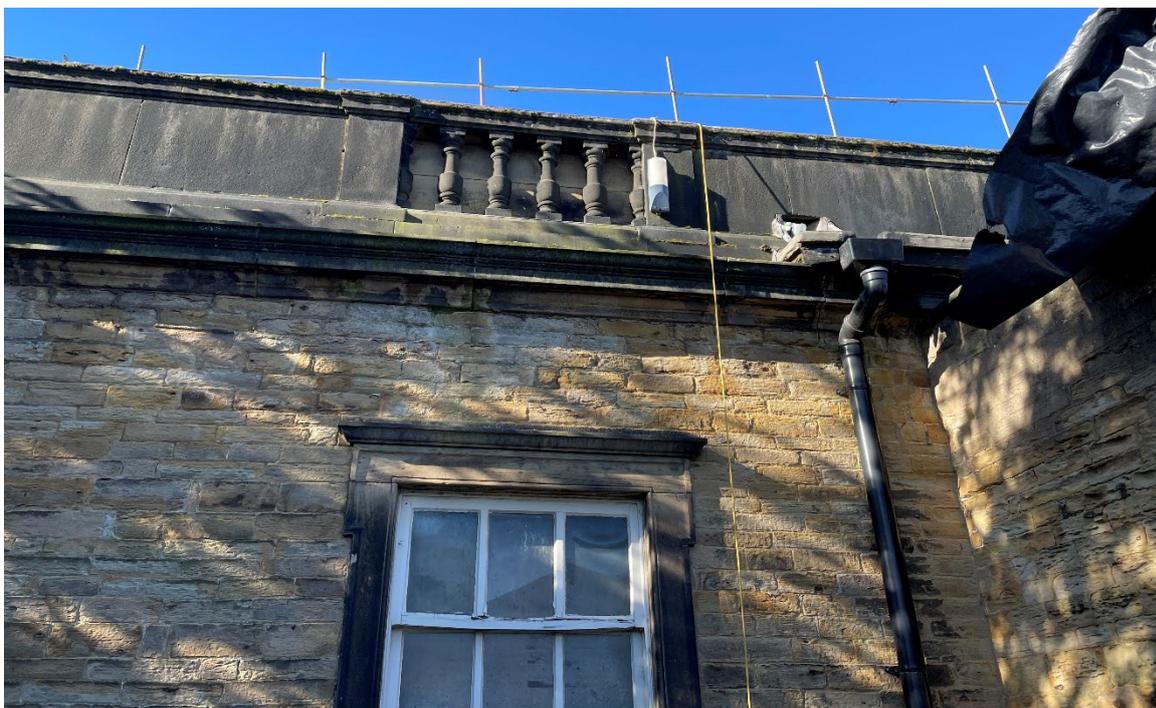
Figure 02: Felt lined Timber gutter and UPVC pipe to be replaced in element 01.

screened by the large tree to the south of the flat roof area. Being lead lined instead of felt lined, this will be a more robust detail than before.

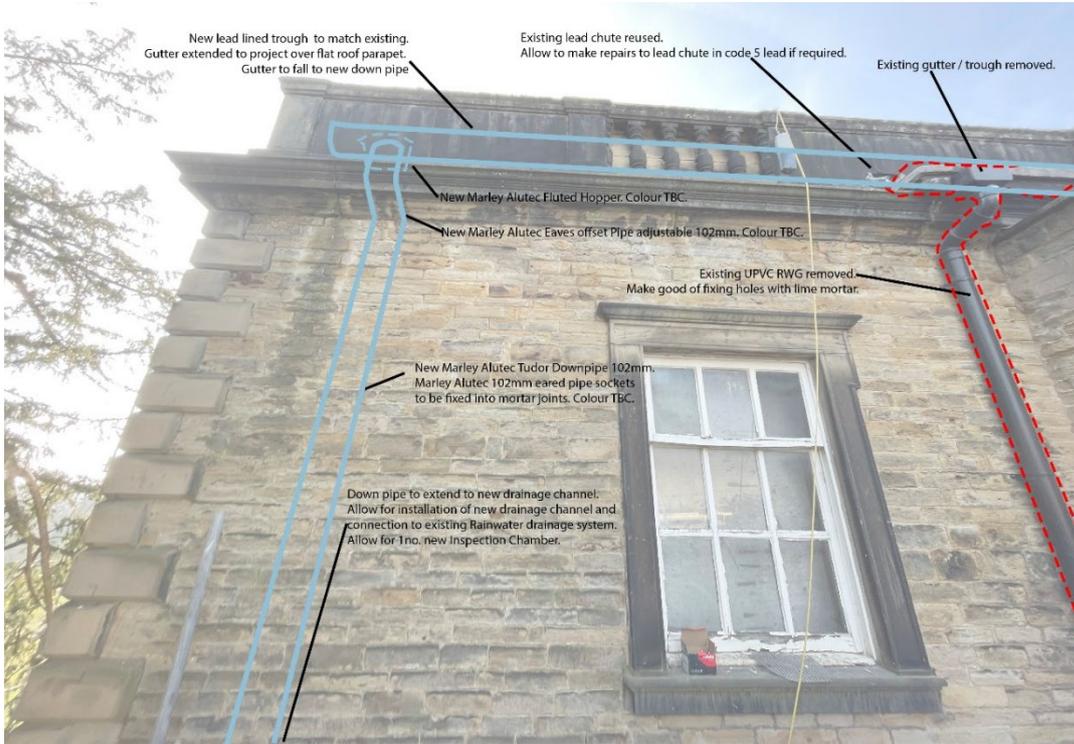
Figure 03: Marked photograph showing element 01's proposals.

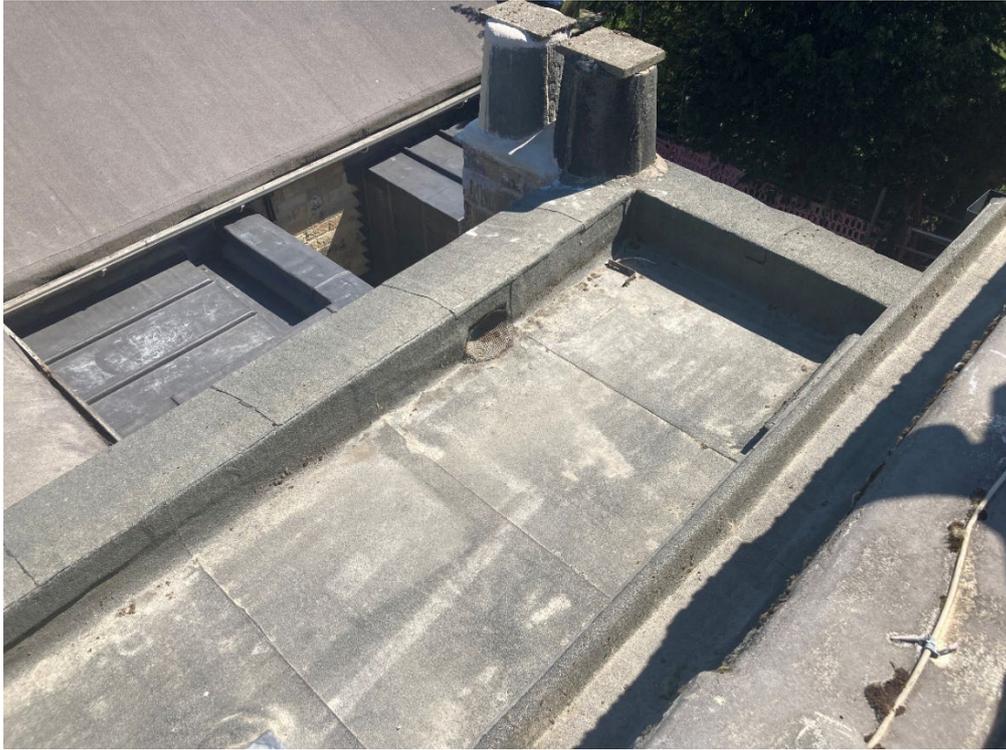
The existing felt roof covering is not historically significant and likely of a mid-20th century date. Its appearance visually harms the building, not being in keeping with its character. This roof is likely to be failing, causing potential decay to historic fabric below it.

Figure 05: Felt roof section to be re-roofed in lead.

The existing felt roof covering and flashings are replaced with a traditionally detailed code 8 lead roof, as per the other sections re-roofed. New lead flashings will be installed to the roof parapet.

The proposed new lead roof is more robust and traditionally detailed, making it a better match for the building's character. This will allow it to better safeguard the structure from future decay.

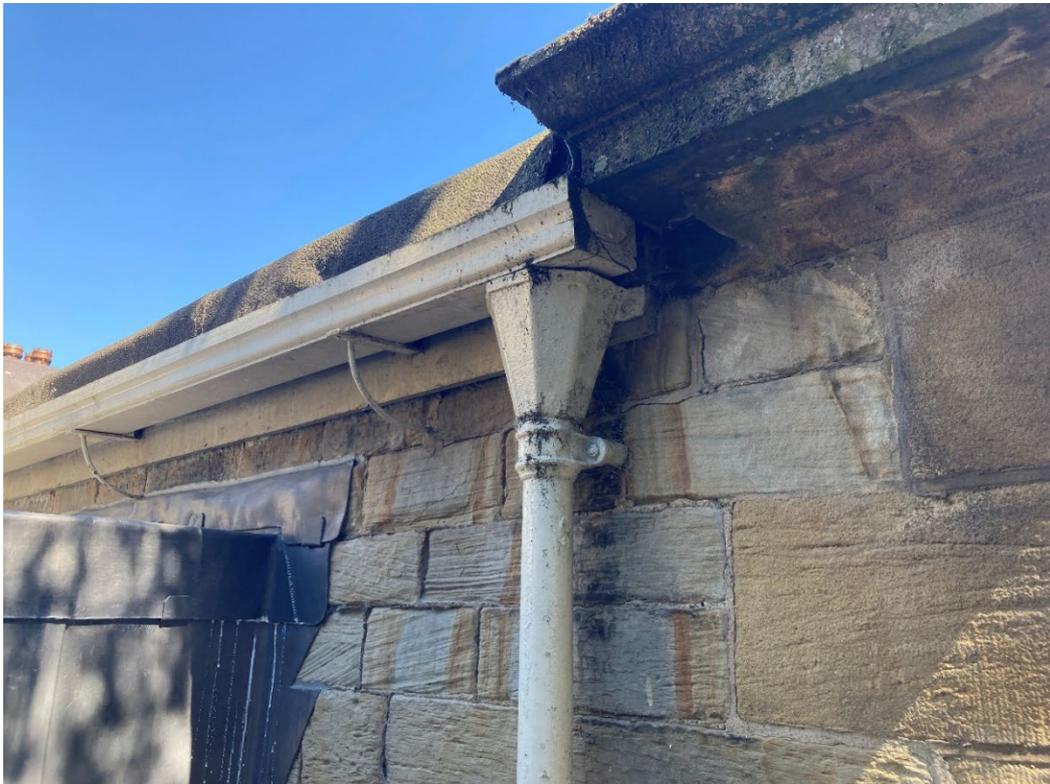
The existing element is cracked from rust damage and allowing water to leak onto the roof. It is desirable to replace this element to allow water to be managed and not cause further decay to the historic fabric.

Figure 06: Cracked Cast Iron Hopper and Downpipe to be replaced with Cast aluminium.

An existing cracked cast-iron hopper and downpipe is replaced with a new black, cast aluminium down pipe and hopper, with a new pipe shoe and brackets. New rainwater goods to be Marley Alutec range.

The proposed elements are to use the same specification previously used in this area of the hall, being sensitive to its historic character. All brackets and fixing will be within mortar joints, minimising damage to the masonry.

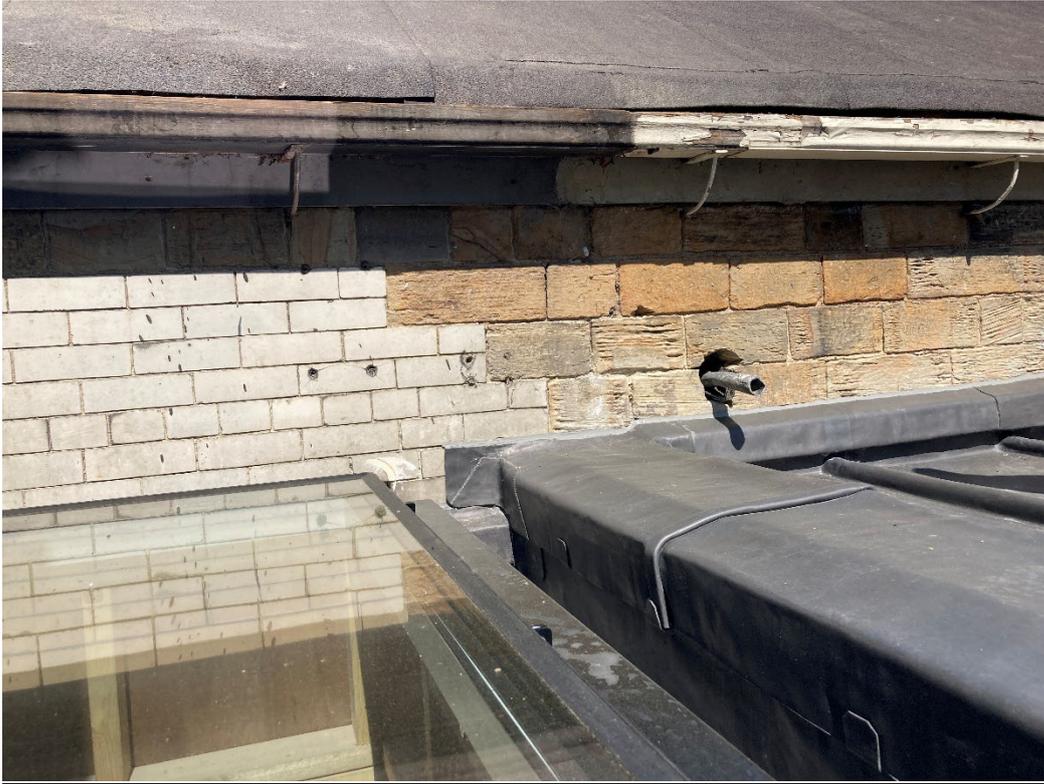
The pipe is no longer in use and an indent repair will ensure infill an opening into the building's skin. The stonework will be in the approved match to the existing.

Figure 07: Redundant pipework above lower flat roof to be removed and opening to be infilled with stone indent.

An existing redundant lead downpipe above the infilled lightwell is to be taken out and the stonework to be infilled with a stonework indent.
