Job  
**10674 Oughtibridge Mill  
Demolition and Remediation**

Title  
**Figure 3.3  
Tree Protection Plan  
Sheet 3 of 4**

Title  
**Figure 3.4  
Tree Protection Plan  
Sheet 4 of 4**

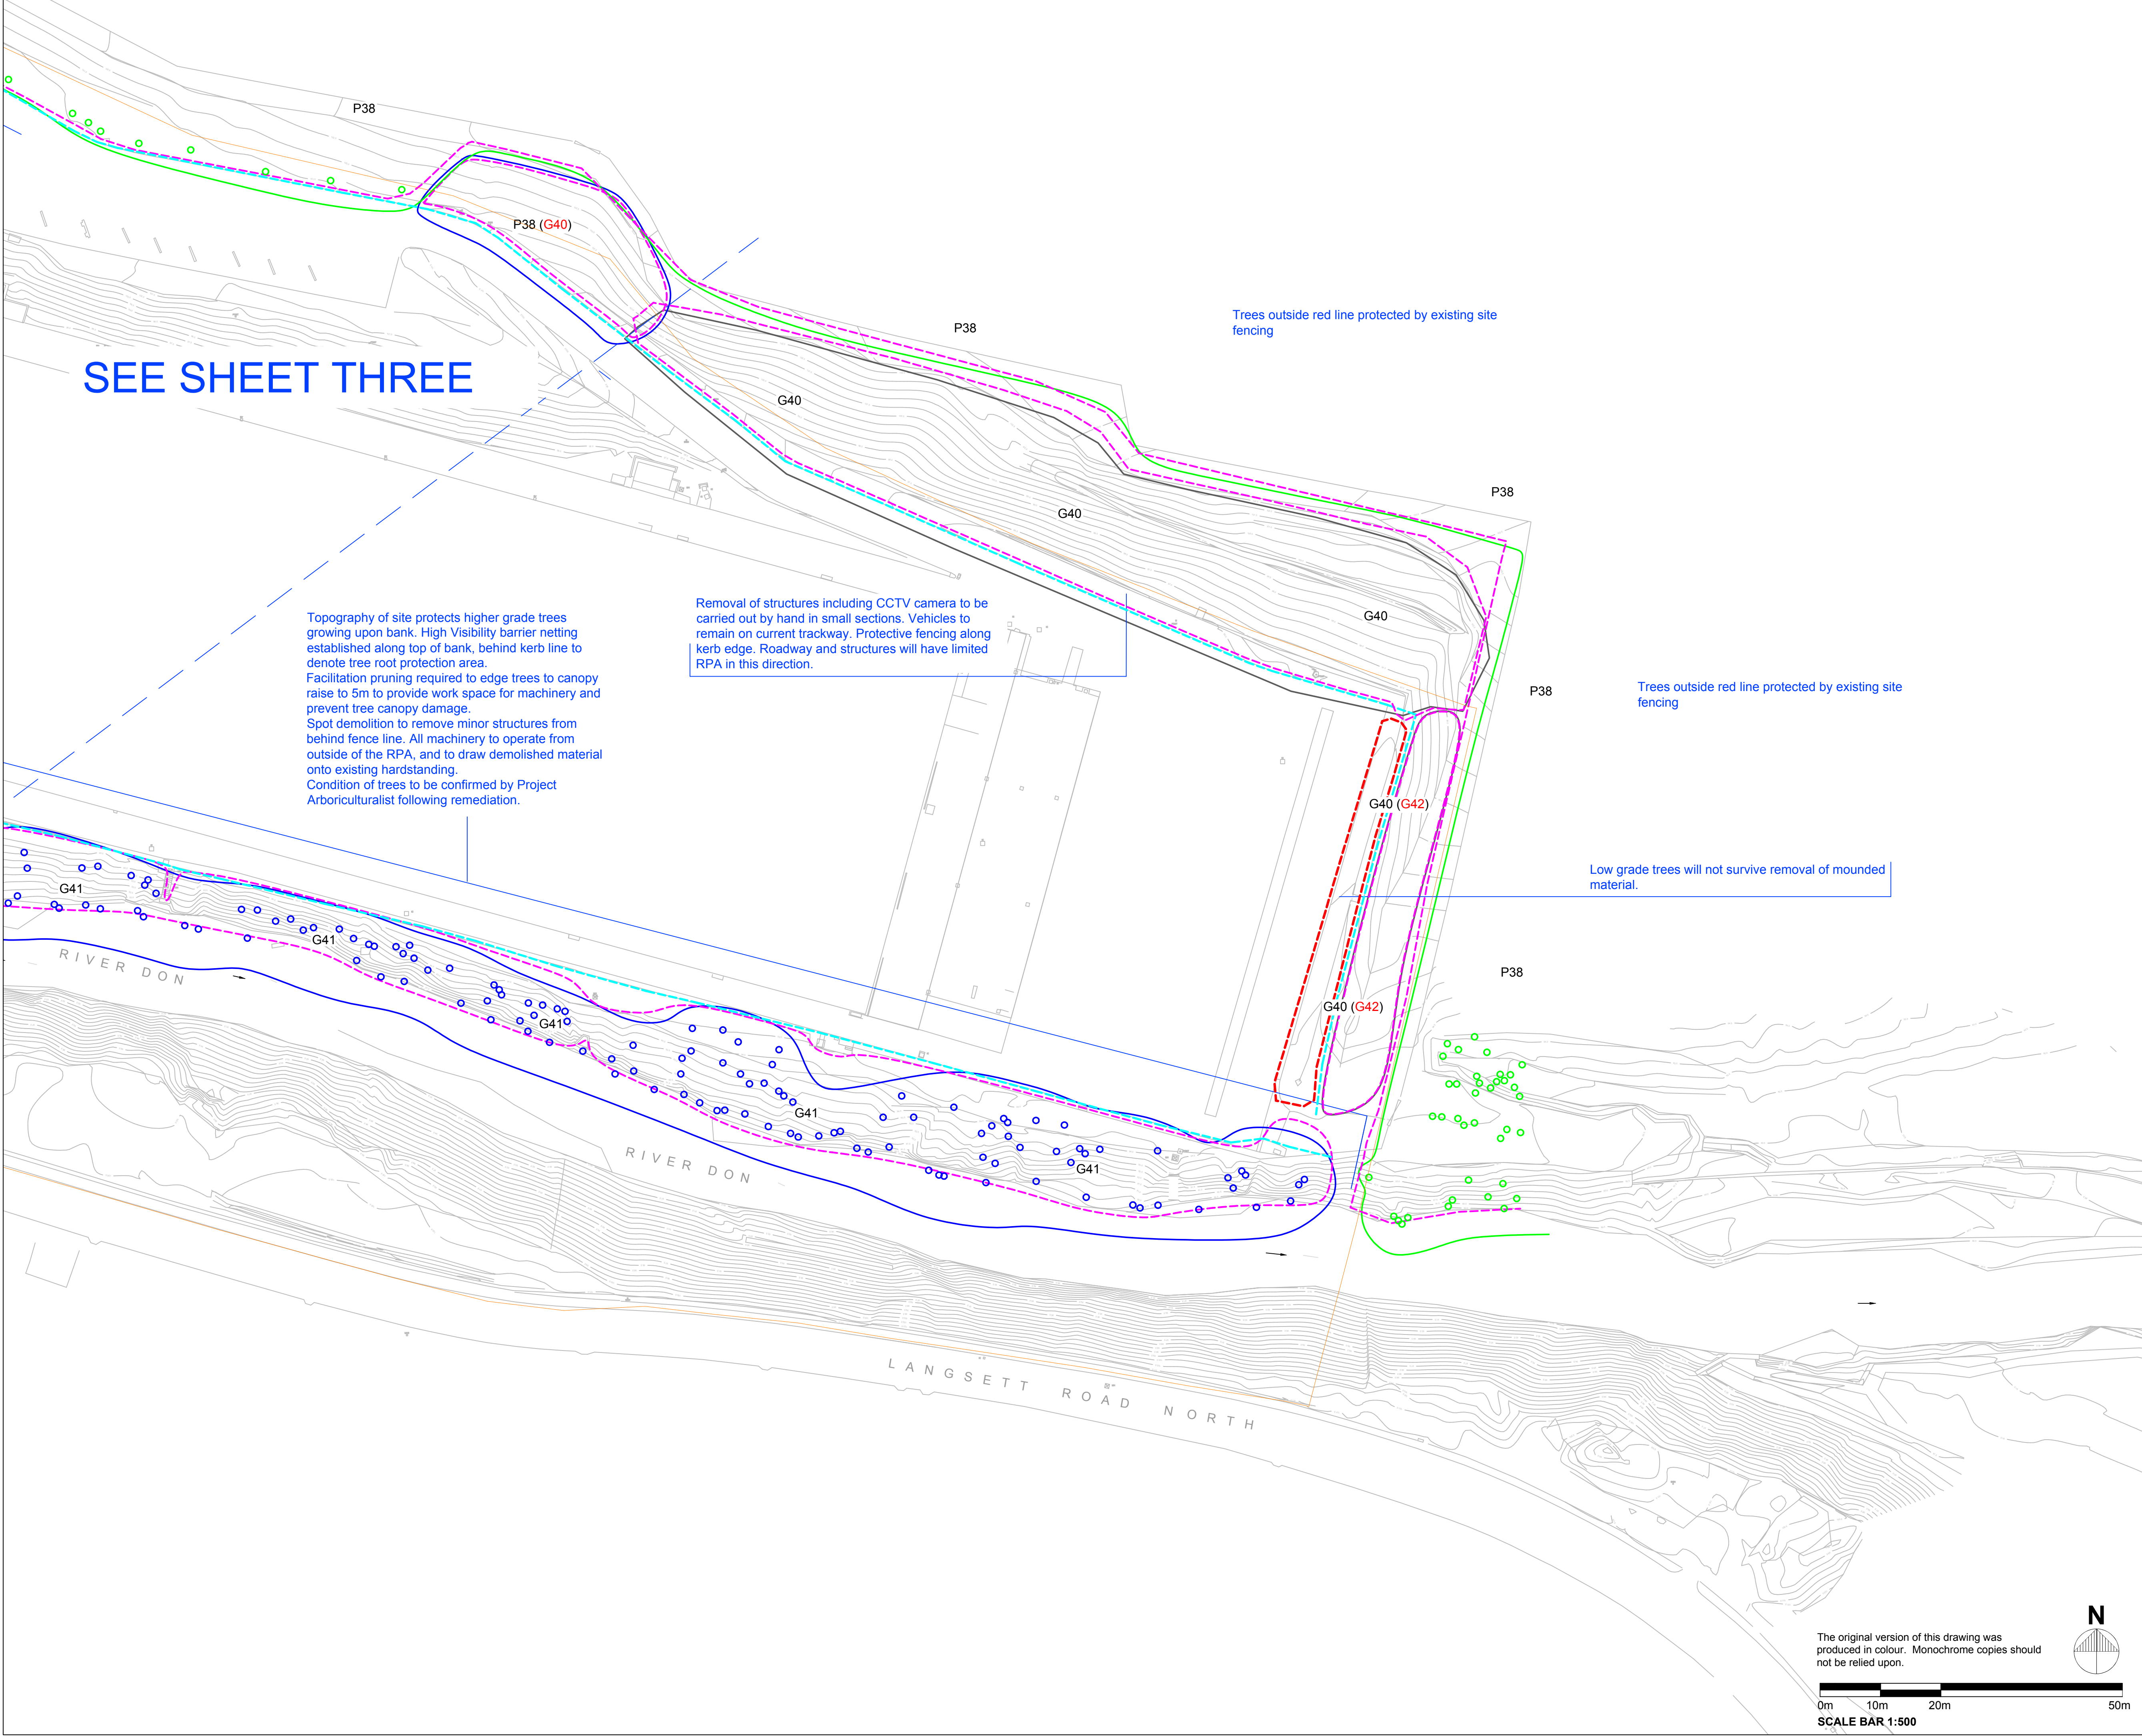
Topography of site protects higher grade trees growing upon bank. High Visibility barrier netting established along top of bank, behind kerb line to denote tree root protection area. Facilitation pruning required to edge trees to canopy raise to 5m to provide work space for machinery and prevent tree canopy damage. Spot demolition to remove minor structures from behind fence line. All machinery to operate from outside of the RPA, and to draw demolished material onto existing hardstanding. Condition of trees to be confirmed by Project Arboriculturalist following remediation.

Removal of structures including CCTV camera to be carried out by hand in small sections. Vehicles to remain on current trackway. Protective fencing along kerb edge. Roadway and structures will have limited RPA in this direction.

Trees outside red line protected by existing site fencing

Low grade trees will not survive removal of mounded material.
