**LOWER WHITELEY FARM, CROW EDGE.  
BAT SURVEY.**

**OS Grid Ref:- SE 191 044.**

**Ref No:- 140838**

**Date: 25<sup>th</sup> August 2014.**

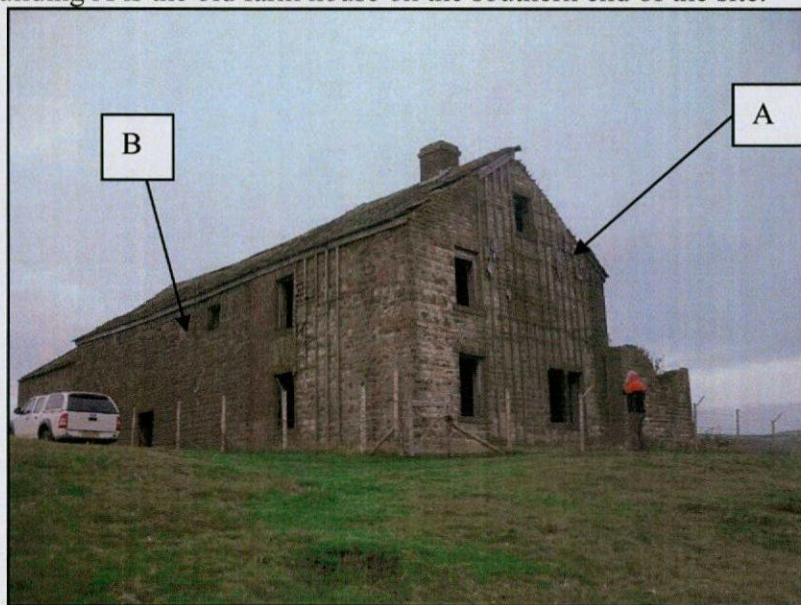
3.3.1.1. Building A is the old farm house on the southern end of the site.

3.3.1.2. The building is constructed with close fitting coursed stone external walls with random stone on the inside and a rubble fill. The external walls are in remarkably good condition for the state of the building although there are a number of open joints where the pointing is missing. The building appears to have been tile clad at some point in time but all that remains are the timber lathes that fixed the cladding to the stone walls. All windows and doors are missing and open.

3.3.1.3. The roof of the building is supported on a king post timber frame. The roof covering is stone slates with no lining and is in a poor state of repair with numerous missing and displaced slates.

3.3.1.4. Internally the middle floor has rotted and is mostly missing and the entire building is very wet as a result of being open to the elements.

3.3.1.6. No bats or bat field signs were identified anywhere inside or outside this building.

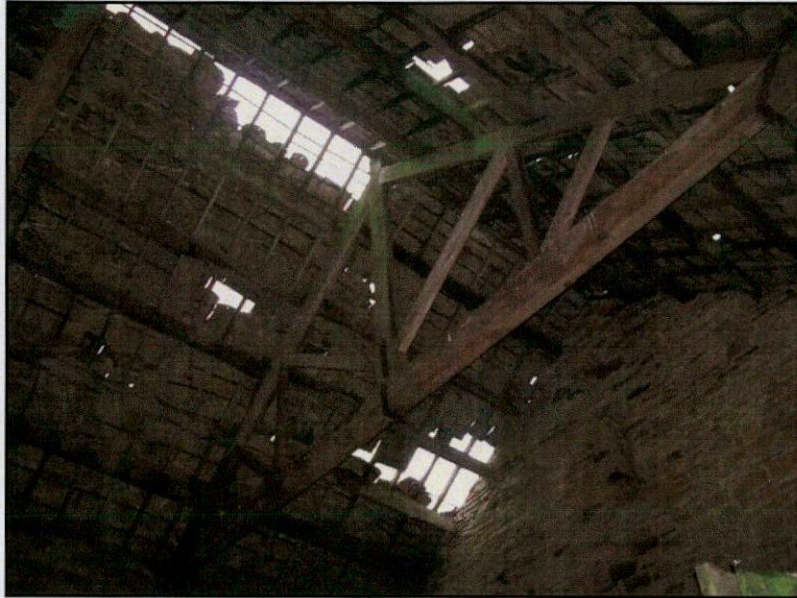
3.3.2.3. The roof of the building is supported on a king post timber frame. The roof covering is stone slates with no lining and is in a poor state of repair with numerous missing and displaced slates and with the majority of the ridge tiles loose or missing, as shown in the photograph below.

3.2.2.4. The inside walls of the building are in a fairly good state of repair although the building is very wet as it is so exposed to the weather.

3.3.2.5. No bats or bat field signs were identified anywhere inside or outside the building.

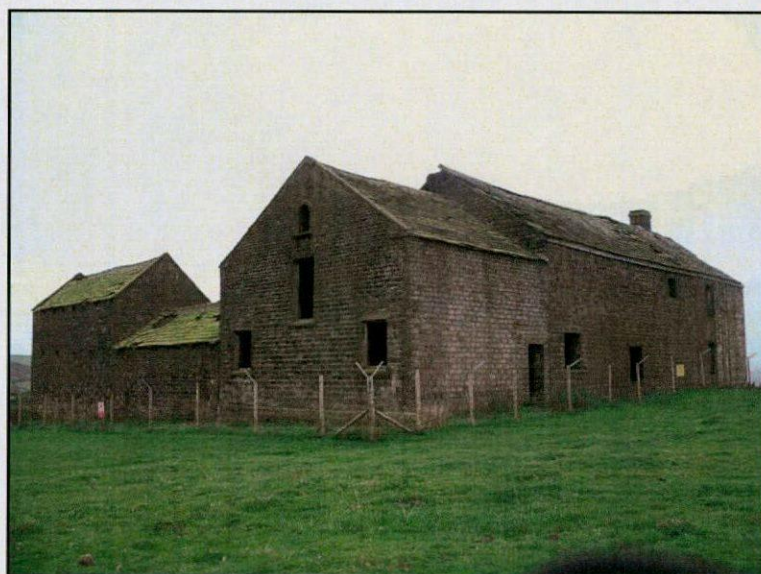
3.3.3.1. This appears to have been a two storey store built onto the northern end of the barn.

3.3.3.2. The construction of the building is the same as above with solid coursed stone walls and a pitched slate roof, as shown below.

3.3.3.4. The walls are generally in a good state of repair although there were a number of openings where the pointing is missing.

3.3.3.5. There are large holes in the roof where there are missing or slipped slates although most of the ridge tiles remain in place.

3.3.3.6. Internally the building is very wet and the middle floor has rotted and it was unsafe to access the upper floor.

3.3.3.7. No bats or bat field signs were identified inside or outside this building.

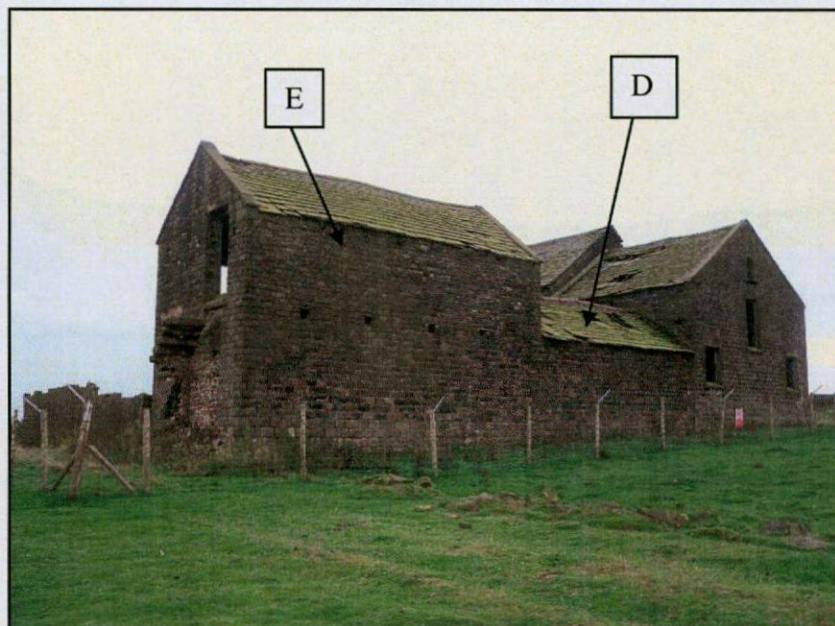
3.3.4.2. The construction is similar to the other buildings with solid stone walls and a pitched, stone slate roof. The front of the building is open to provide access for farm machinery.

3.3.4.3. The roof is supported on a traditional purlin and rafter timber frame and there is no lining under the roof slates.

3.3.4.4. The roof is in a poor state of repair with missing and displaced roof slates.

3.3.4.5. No bats or bat field signs were identified anywhere inside or outside this building.
