ARBORICULTURAL REPORT & Impact Assessment to BS 5837:2012 at:

***Woodlands Lodge,
106 Hawshaw Lane,
Hoyland,
Barnsley,
S74 0HH***

Prepared for: *White Agus*

Reference: *AWA7313*

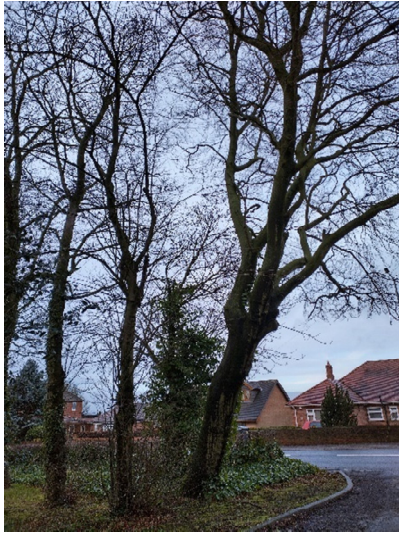
- 3.2.7 The highest value trees on site are the 4 retention category 'B' trees. These include: Beech T1, Sycamore T4, Norway Maple T6 and Lime T23. These trees are all in good condition with good long-term prospects. These trees also provide moderate amenity value within the site and have the potential to develop into higher value trees in time.

Photo 1: T1 and T2 from southeast.

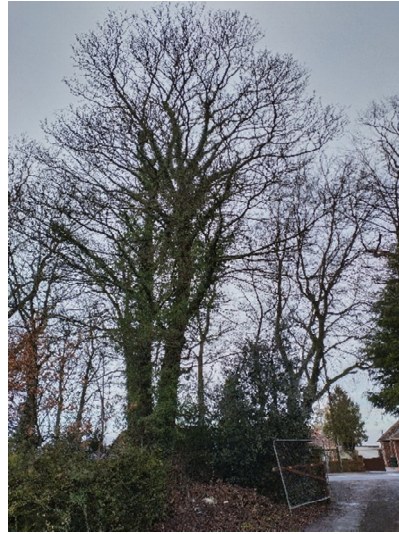
Photo 2: T3 and T4 from southeast.

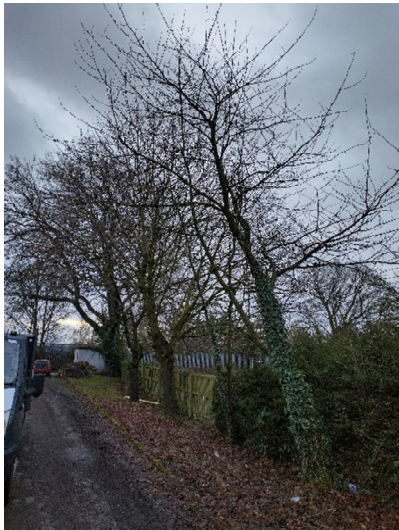
Photo 3: T5 – T8 from northeast.

4.2.3 T6 and T7 require removal to facilitate the alterations to the existing access drive. T6 is a retention category 'B' Norway Maple, and T7 is a retention category 'C' Cherry.

4.2.4 T6 could be retained if specialist 'no-dig' construction methodology was used to construct the driveway.

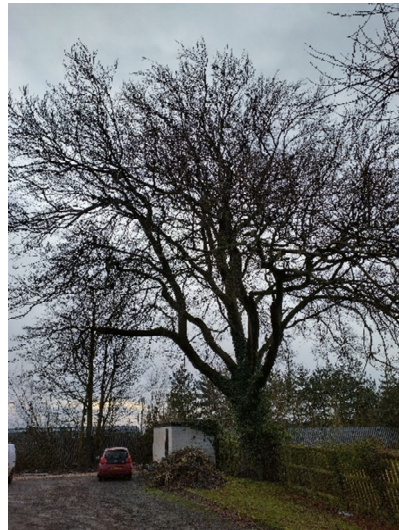
- 3.2.8 Mature Beech T8 has high visual amenity, however it has been classified as Category C due to the presence of decay fungus *Meripilus giganteus*, and evidence of declining physiological condition, which together reduce the tree's long-term retention value and life expectancy. Given the presence of a significant decay fungus, a separate detailed tree risk assessment, undertaken in accordance with recognised tree risk assessment methodologies, is recommended to inform any future management decisions. This would allow the tree's structural condition and risk profile to be considered independently of its BS 5837 retention categorisation. The remaining trees within the site are of particularly low value and should not pose any significant constraint on the development potential of the site.

Photo 4: T8 from northeast.

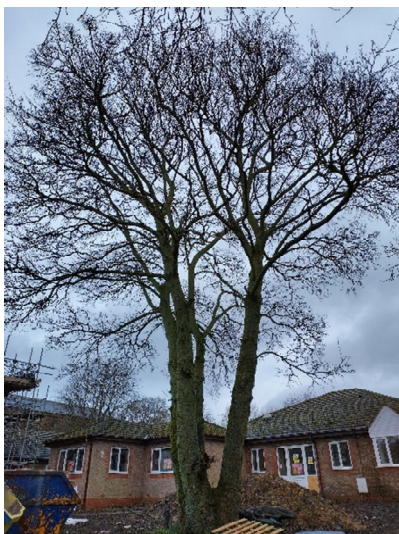
Photo 5: T12 from south.

4.2.5 T12 requires removal due to the proposed play area and associated equipment proposed within T12's RPA. T12 is a retention category 'C' Sycamore.

4.2.6 T12 is an early-mature Sycamore with moderate amenity that has been classed as a retention category 'C' tree. At the time of survey, we also noted that a significant proportion of the southern root area had already been excavated and exposed, with additional storage and ground disturbance within the Root Protection Area. These factors are likely to have adversely affected the tree's rooting environment and long-term stability.

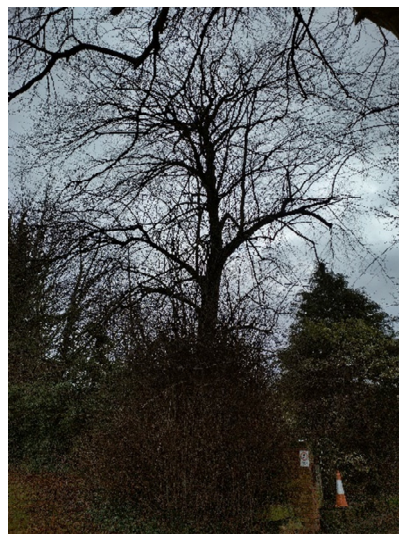
Photo 6: T23 from north.

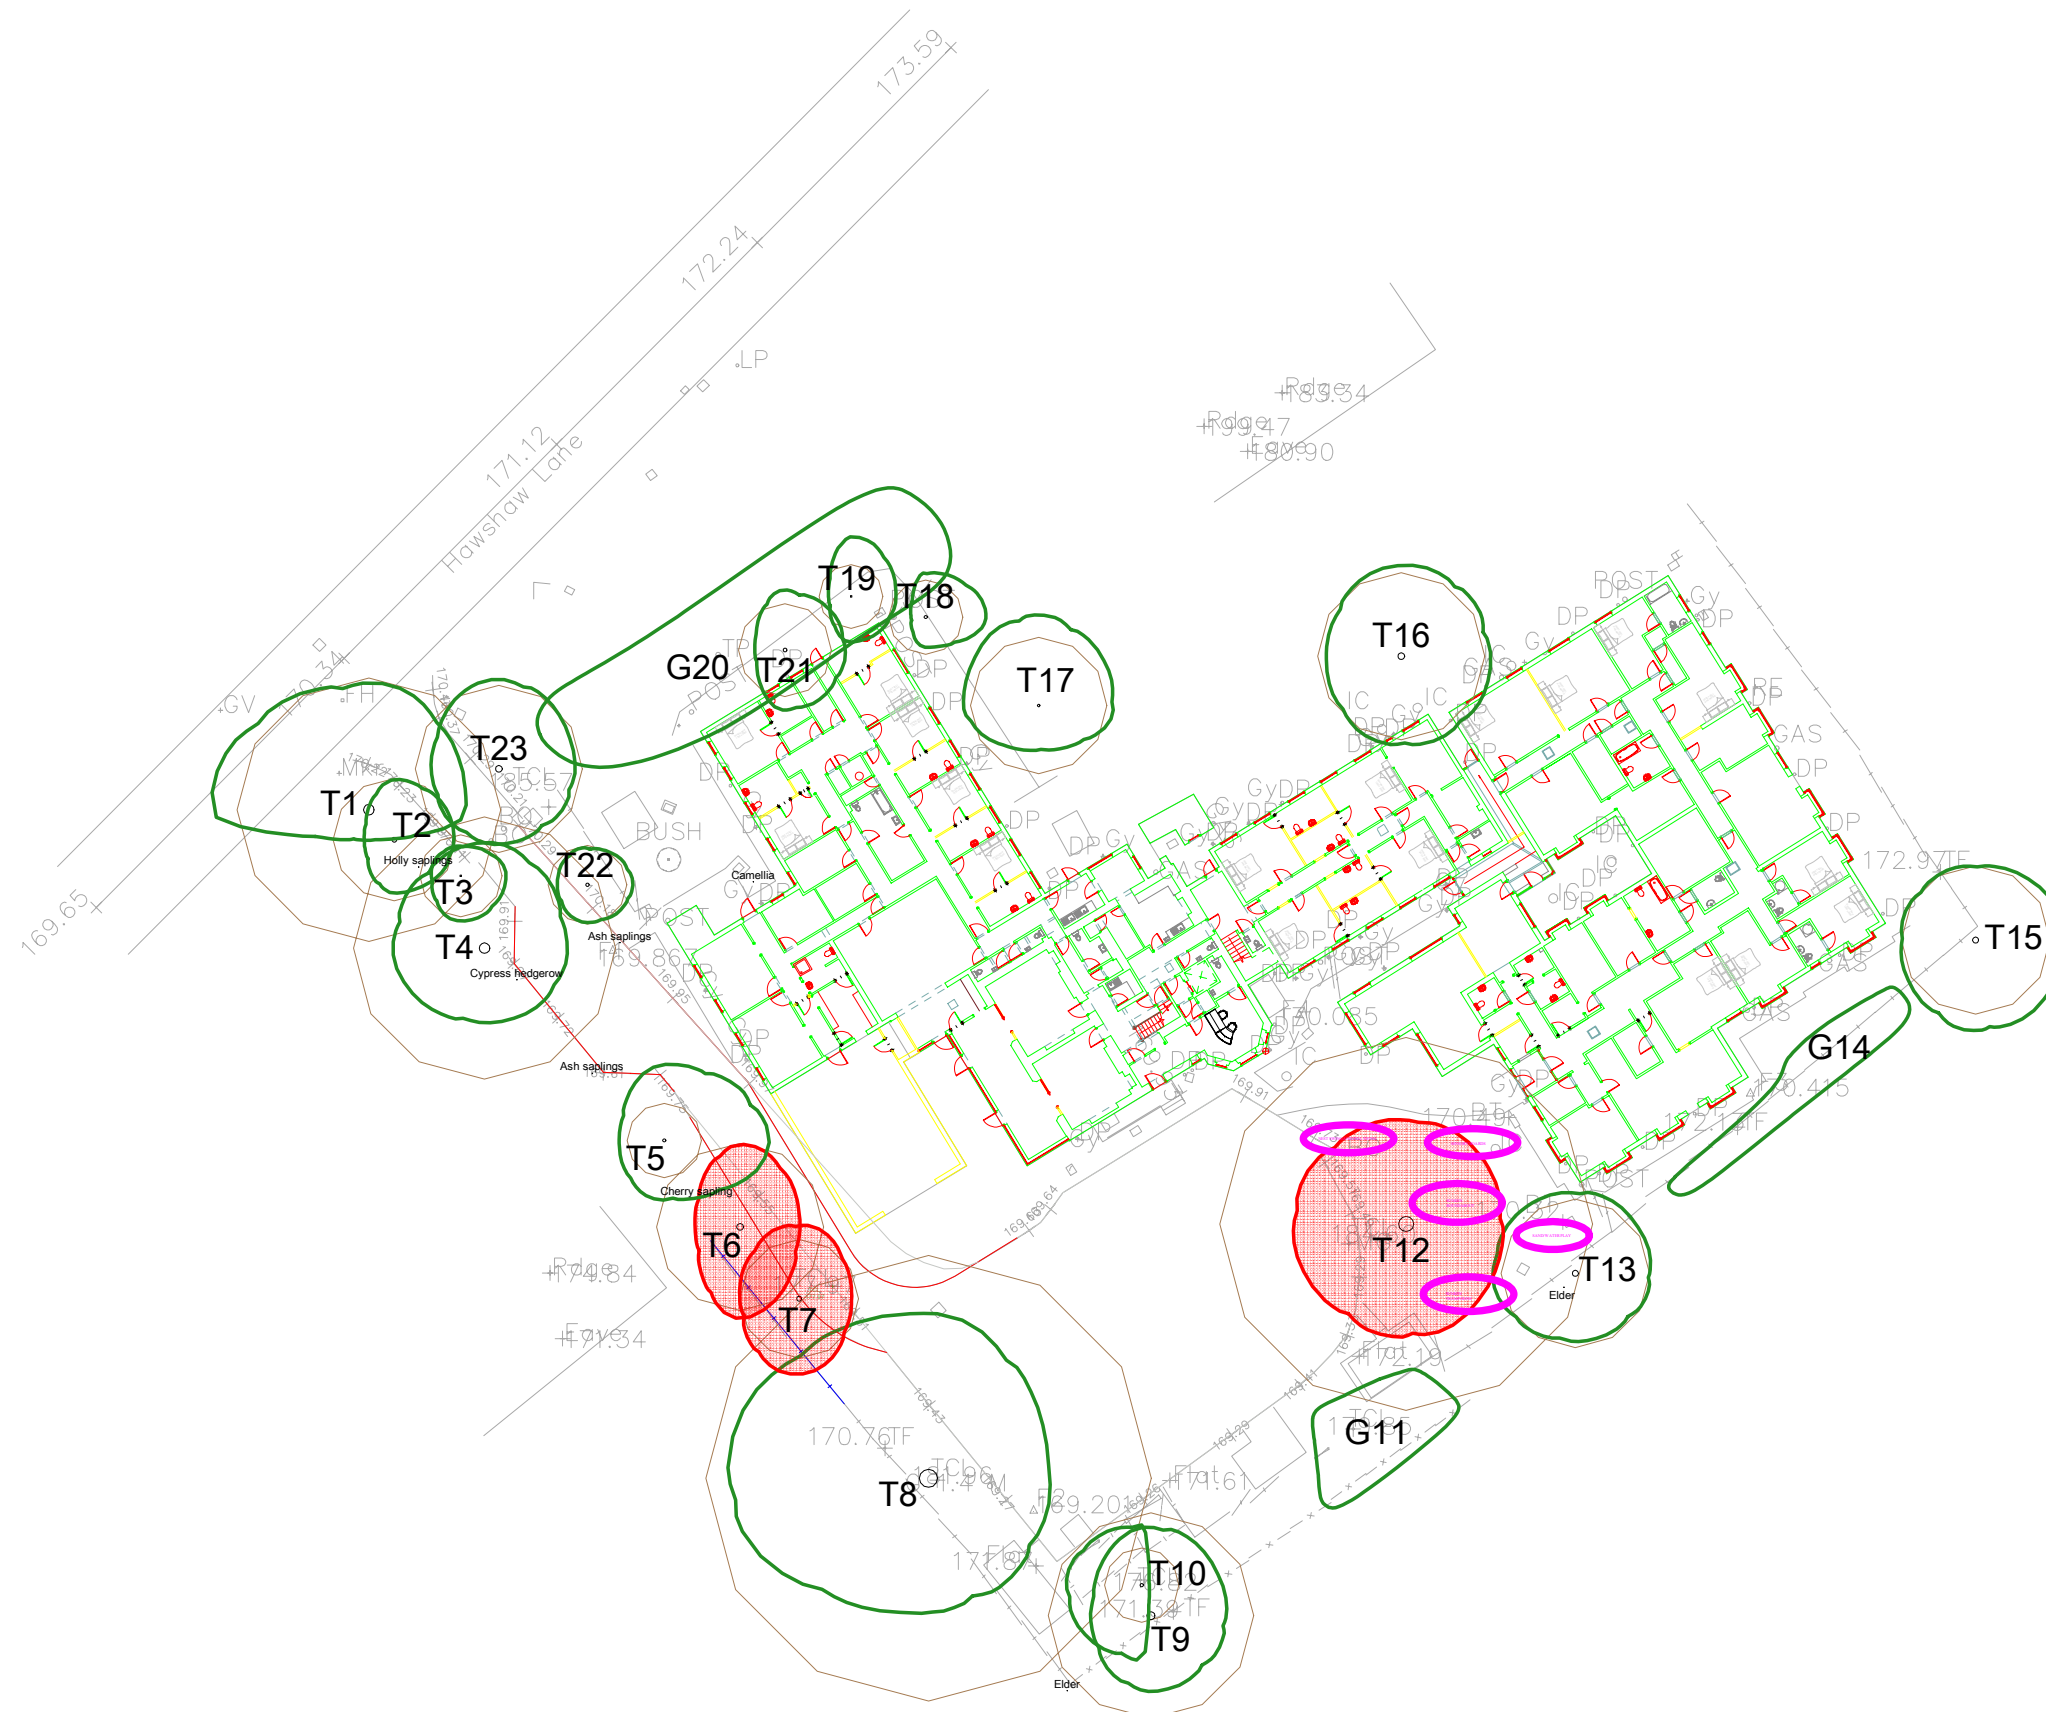
**Appendix 6:
Tree Impacts Plan**

4.2.1 From assessing the new development proposals, 1 moderate value tree and 2 low value trees will require removal to facilitate the development as it is situated in the footprint of the development. No trees will require pruning works.

4.2.2 The trees that require removal to facilitate the development are T6, T7 and T12.
