ARBORICULTURAL REPORT & Impact Assessment

to BS 5837:2012 at:

Cross Keys Lane, Hoyland, Barnsley 574 0QA

Reference: AWA5912

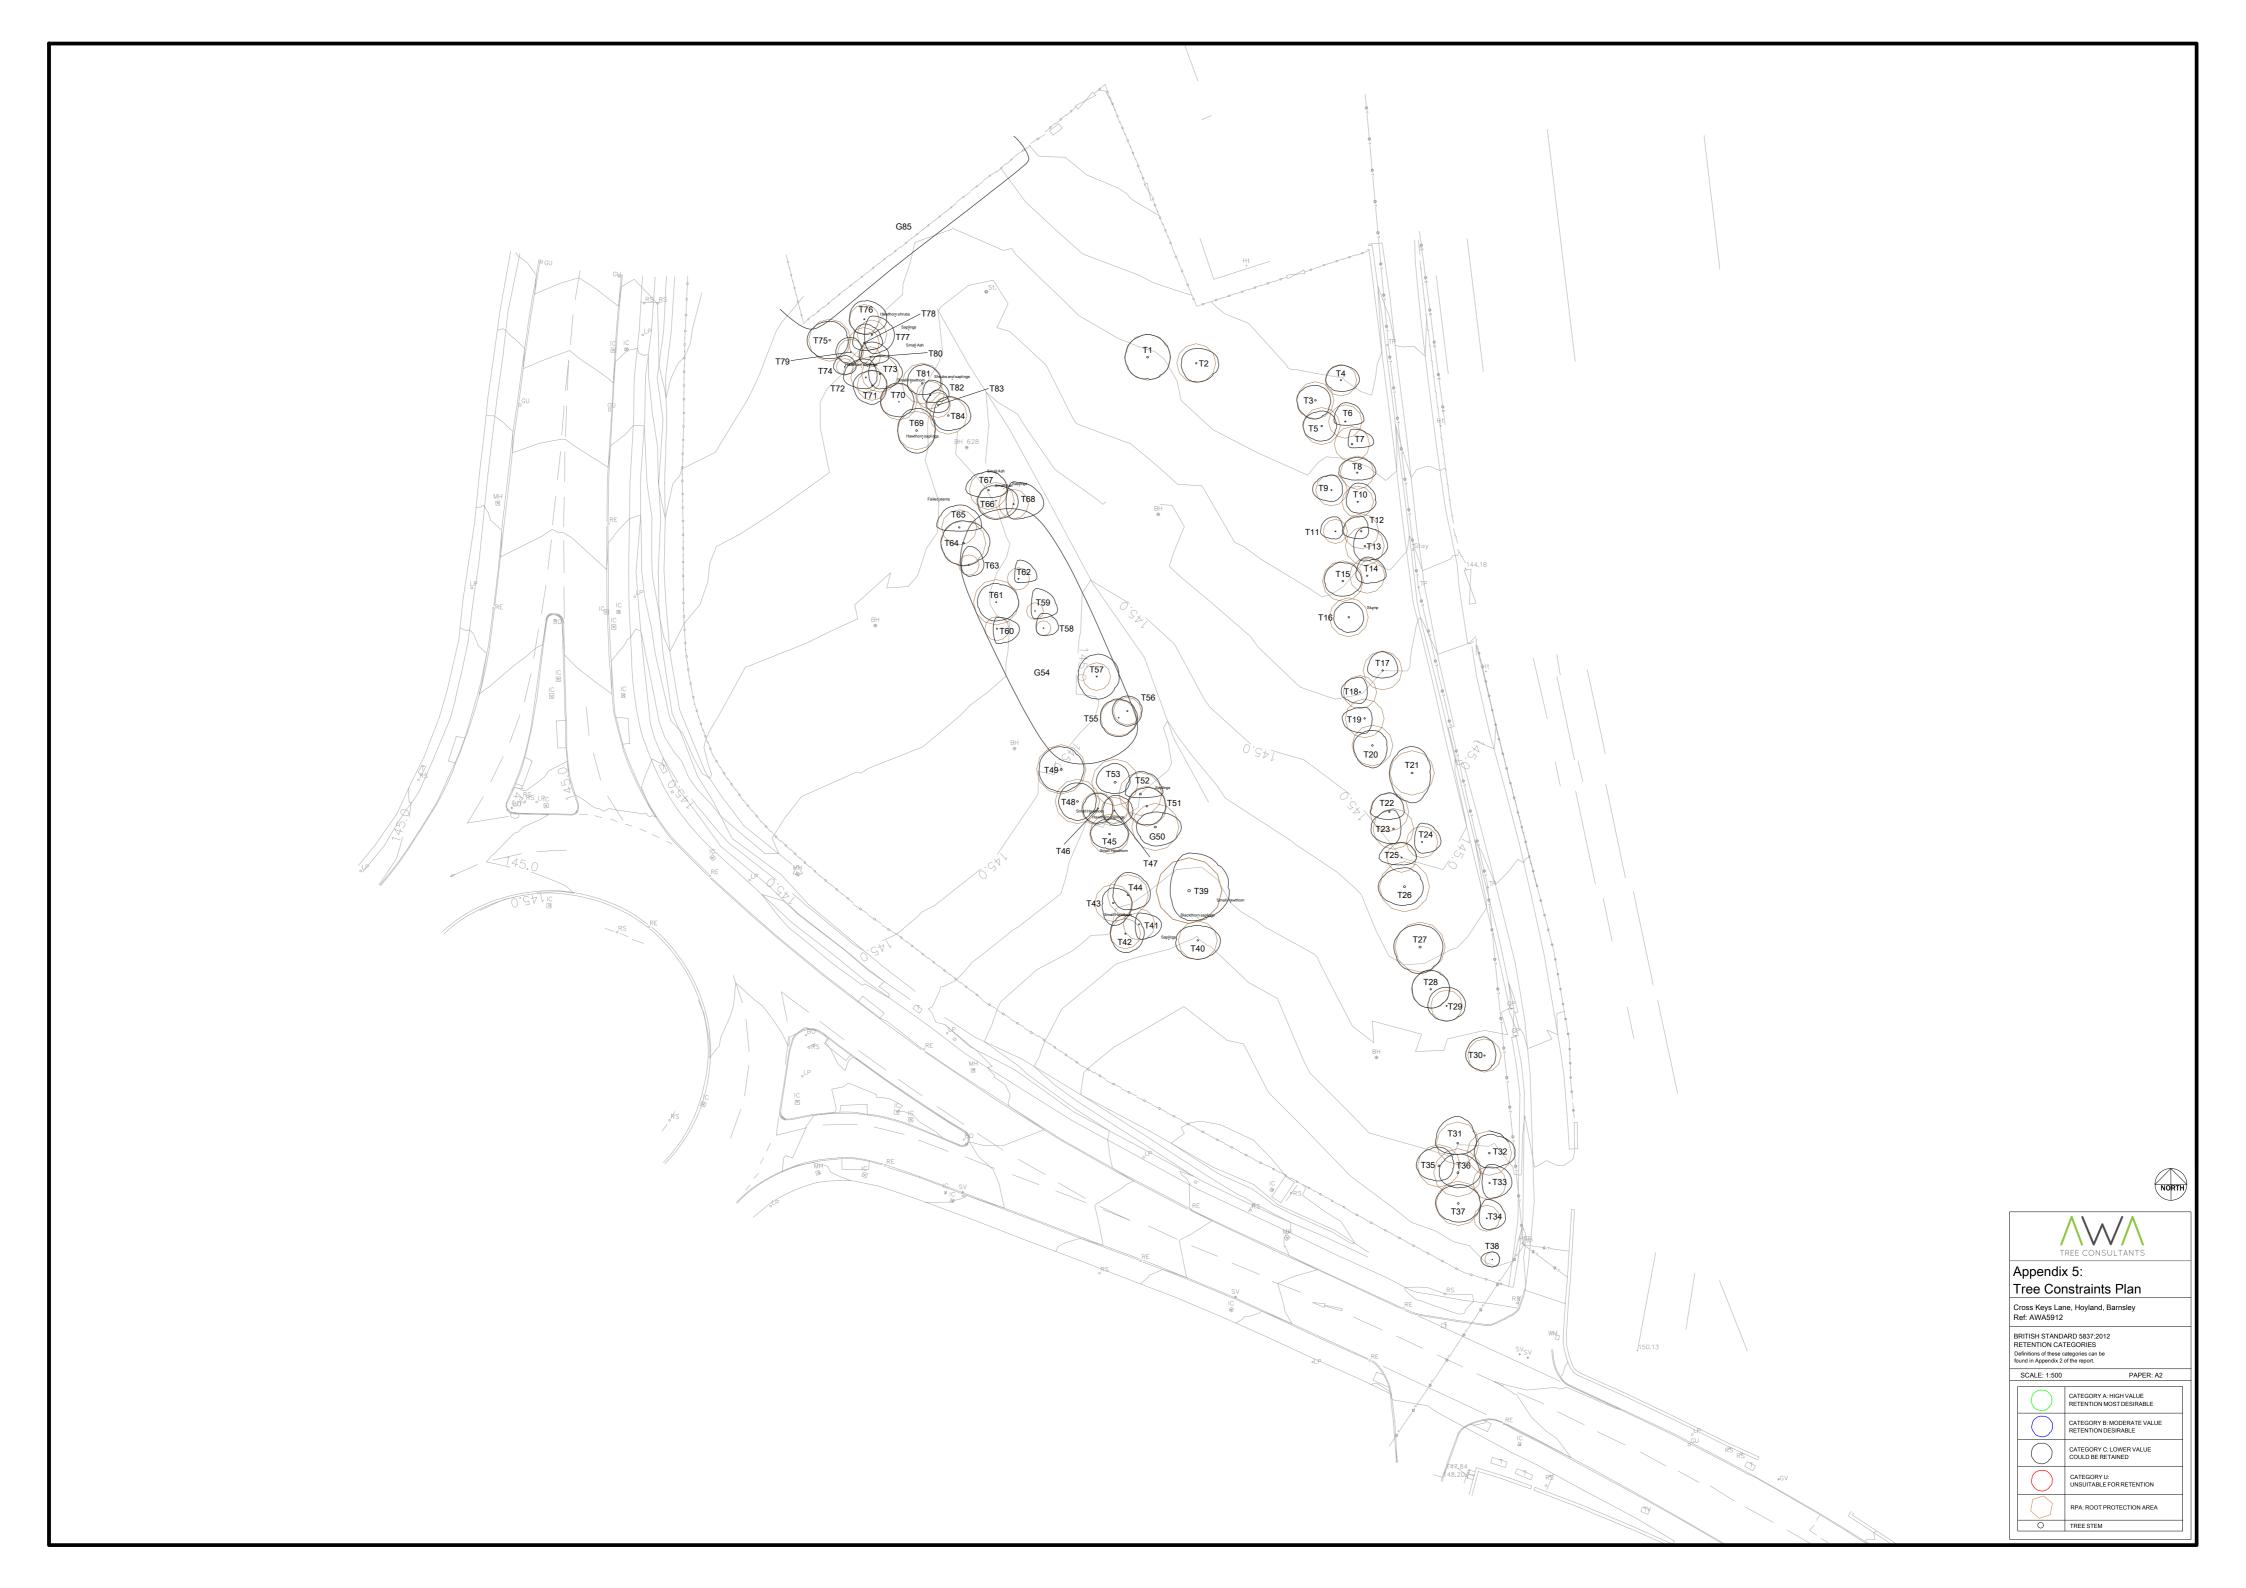
- 3.2.6 The tree Root Protection Area (RPA) detailed on the Tree Constraints Plan at Appendix 5 has been used as a layout design tool, to inform on the area around a tree where the protection of the roots and soil structure is treated as a priority.

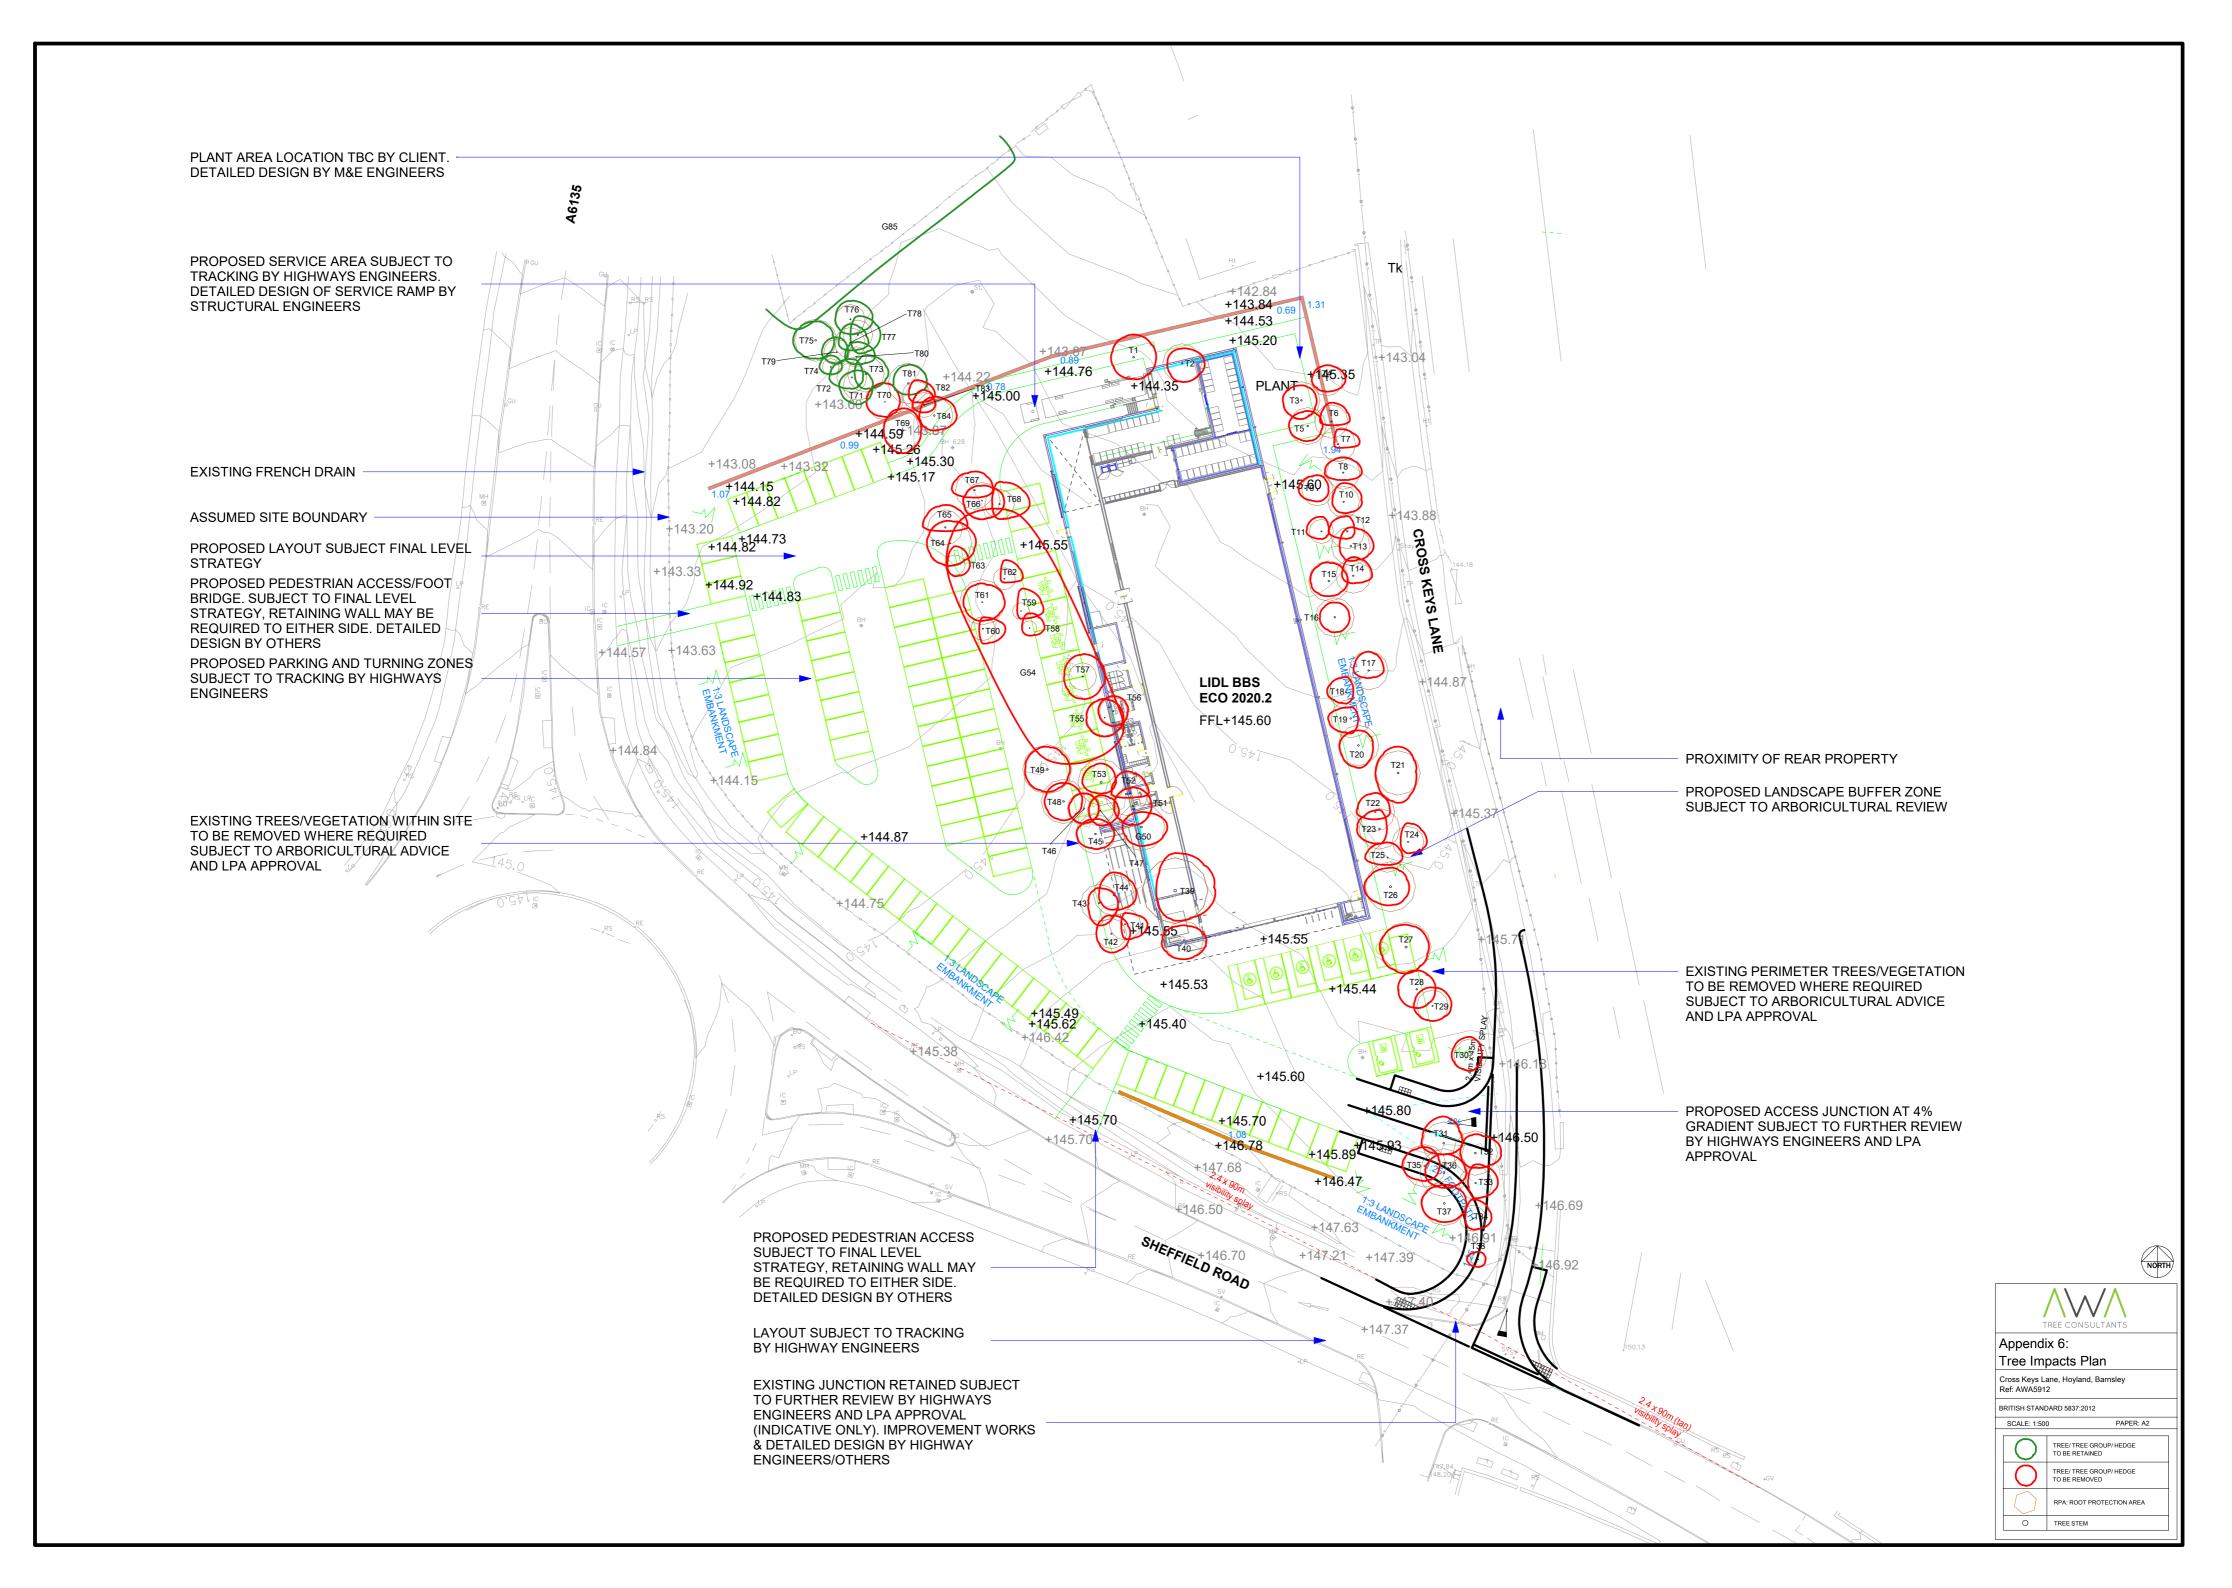
- 4.2.1 From assessing the new development proposals, 73 trees or tree groups will require removal to facilitate the development as they are situated in the footprint of the development or their retention and protection throughout the development is not suitable.
- 4.2.2 The trees or tree groups that require removal to facilitate the development are T1 to T70, T82, T83 and T84.
- 4.2.3 The trees or tree groups requiring removal have been identified in red on the attached Tree Impacts Plan at Appendix 6.
- 4.2.4 The trees that require removal are all young to semi mature trees of lower value, retention category 'C'.
- 4.2.5 While the collective removal of the trees will have some negative impact at the site in the short term, new tree plantings at the site will help mitigate for the tree removals and will improve the quality of site's tree cover in the longer term.

- 4.3.1 The tree Root Protection Area (RPA) detailed on the Tree Plans at Appendix 5 and 6, has been used as a layout design tool, to inform on the area around a tree where the protection of the roots and soil structure is treated as a priority.
- 4.3.2 No significant negative indirect impacts on the retained trees have been identified.

4.4.1 The retained trees may require protection by fencing in accordance with BS 5837: 2012, during the development phase. If required by the Local Planning Authority, an associated Arboricultural Method Statement, detailing protective fencing specifications and construction methods close to the retained trees can be provided.
