# ARBORICULTURAL IMPACT ASSESSMENT

Land At Pear Tree Farm Brierley  
S72 9JR

28 October 2025

REF: 0514 Rev. D

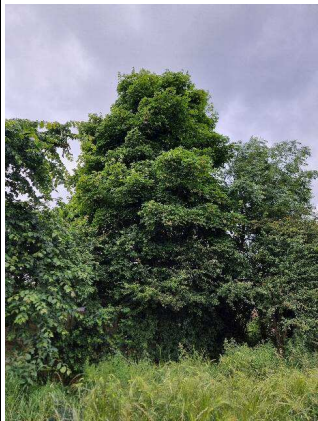
T2	SYCAMORE <i>Acer pseudoplatanus</i>

14m	5m	5m	5m	5m	4m	2.5m.South.5m	Semi-Mature (SM)	Tree is situated offsite and access was restricted to inspect. Physiological condition appears good. Tree is situated on raised ground.	No preliminary work recommended	550mm (Yes)	6.60	137	20-40 Years	B2
T3	SYCAMORE <i>Acer pseudoplatanus</i>

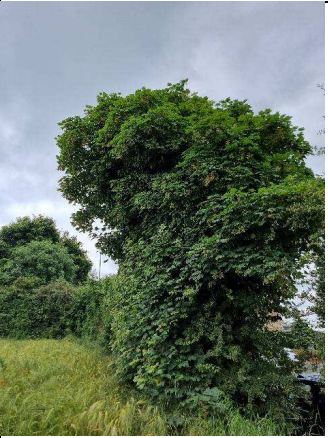
12m	3m	3.5m	4m	3.5m	0.5m	2m.South.2m	Mature (M)	Tree is situated on lower ground level than the site directly adjacent to road. It is multi stemmed below 1.5m and all are significantly ivy clad. Approximately five stems at present. The diameters were estimated. Epicormics are present around the main stem and tree is merging into hedge.	Recommendations: sever ivy and inspect unions	671mm (Yes)	8.10	204	20-40 Years	B2

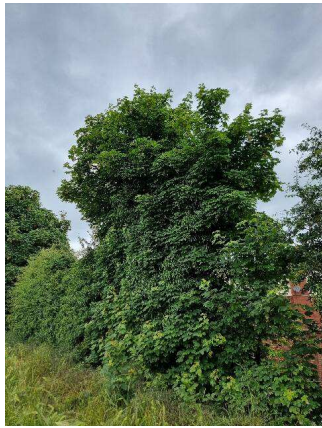
T4	SYCAMORE <i>Acer pseudoplatanus</i>

10m	3m	3m	3m	3m	0.5m	1m.South.1m	Semi-Mature (SM)	Tree is situated directly adjacent to the road within a hedgerow. It has 2 main stems joined at the base but appears to have had a break out or stem removed historically. Tree is heavily ivy clad limiting inspection. All measurements estimated. Physiological condition appears good	Recommendations: sever ivy and inspect unions	390mm (Yes)	4.80	72	10-20 Years	C2
T5	COMMON ASH <i>Fraxinus excelsior</i>

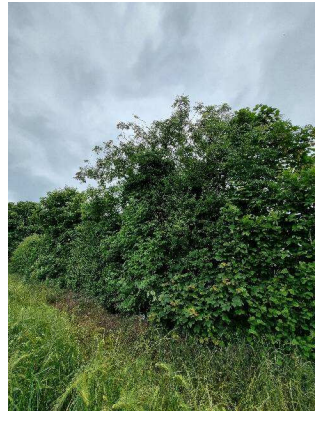
8m	3.5m	4.5m	2.5m	4m	1m	1m.South.1m	Semi-Mature (SM)	Tree is situated adjacent to the road and is situated on the edge of a banking. The tree is heavily ivy clad limiting inspection. Minor dieback is present in the crown and ivy is smothering the tree. Physiological condition is fair. recommendation sever ivy and reinspect unions.	Recommendation: sever ivy and reinspect unions	400mm (Yes)	4.80	72	10-20 Years	C2

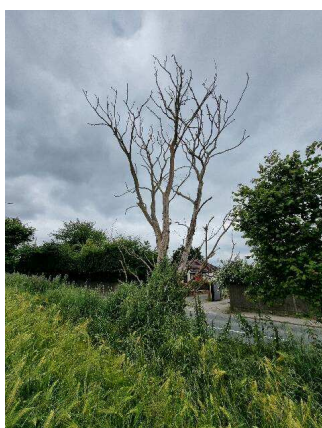
T6	UNKNOWN

10m	3m	3m	3m	3m	2m	1m.South West.2m	Dead (D)	Tree is situated directly adjacent to the road. It is dead and is leaning towards the road. recommendation remove tree	Recommendation: Remove tree	300mm ( )	3.60	41	<10 Years	U

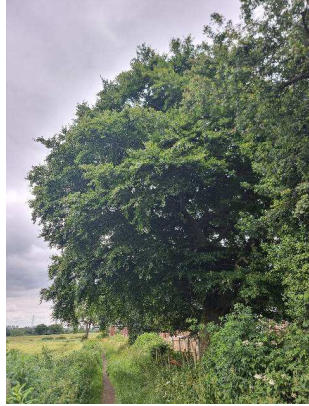
16m	11m	10m	9m	11m	2.5m	3m.North East.5m	Mature (M)	A large mature tree situated adjacent to public footpath. Numerous broken stubs are present with cavities within the crown. Physiological condition good. Tree is very prominent within the skyline of the local area and has high arboricultural value	0	1150mm (No)	13.80	598	40+ Years	A1
T11	SYCAMORE <i>Acer pseudoplatanus</i>

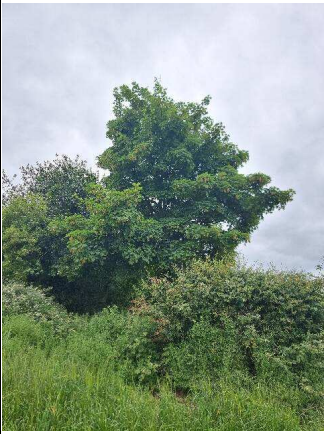
11m	3.5m	4.5m	5m	3.5m	2m	2.5m.South.4m	Semi-Mature (SM)	Tree is growing on an edge of a group of trees which are situated in the offsite church grounds. The tree is onsite. Future growth can be expected of this tree. Physiological condition is good.	No preliminary work recommended	400mm (Yes)	4.80	72	20-40 years Years	B2
T12	SYCAMORE <i>Acer pseudoplatanus</i>

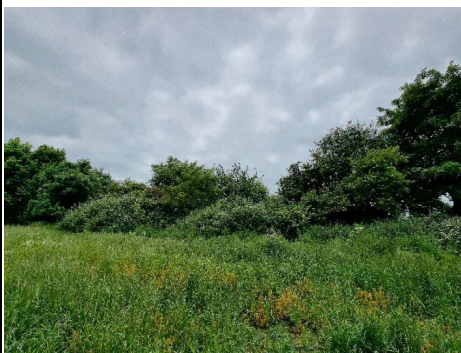
3m	14m	Semi-mature to mature	A Group of offsite trees situated in neighbouring church grounds. Species consist of Cherry ( <i>Prunus avium</i> ), Ash ( <i>Fraxinus excelsior</i> ) and Sycamore ( <i>Acer pseudoplatanus</i> ). The group borders the site and sections overhang the site. Size is variable. The maximum stem diameter was estimated as 400mm. Physiological condition appears good and groups provides good amenity and screening value within the local area.	No preliminary work recommended	400mm	1m	20-40 Years	B2

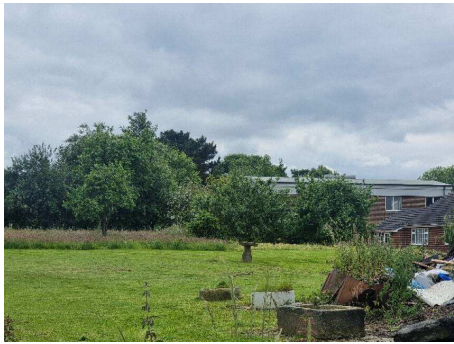
G3	A group of three Apple <i>Malus</i> spp. trees

4m	5m	Mature	A group of three trees. maximum 5. minimum height 4.average diameter 250mm. physiological condition good	No preliminary work recommended	250mm (average)	1.4m	10-20 Years	C2

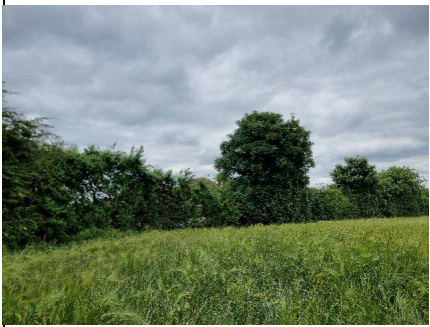
HAWTHORN <i>Crataegus monogyna</i>	70%	3m	8m	2m	Semi-mature	A hedgerow , which runs down the boundary of the field. Larger Sycamore and ash trees are present emedded within the hedge. Physiological condition good. Hedge has screening and wildlife value	No preliminary work recommended.	100mm	20-40 Years	B2
		COMMON ASH <i>Fraxinus excelsior</i>	10%									
		ELM - WYCH ELM <i>Ulmus glabra</i>	10%

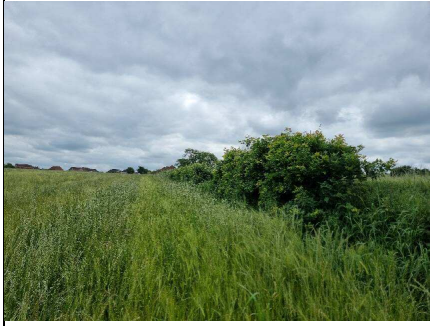
PENDUNCULATE OAK <i>Quercus robur l.</i>	30%	1.5m	2.5m	2m	Semi- mature	A hedgerow which runs through the site which appears to have been maintained historically. The hedge varies in height and consists mostly of these species . The hedgerow is broken and gaps are present in places. Hedge has screening and wildlife value	No preliminary work recommended.	150mm	10-20 Years	C2
		SYCAMORE <i>Acer pseudoplatanus</i>	40%									
		HAWTHORN <i>Crataegus monogyna</i>	30%									
		0	0									
		0	0									
H3

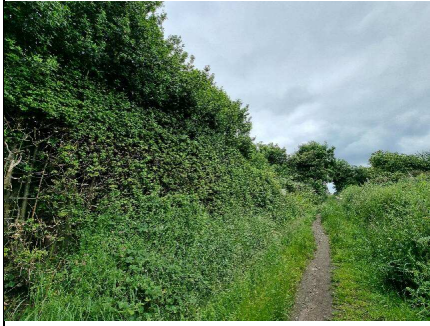
HAWTHORN <i>Crataegus monogyna</i>	50%	2m	7m	4m	Semi-mature	A broken hedgerow extending down the boundary, consisting mostly of Hawthorn Holly. Lower sections have been maintained and cut back from public footpath. Physiological condition appears generally good d	No preliminary work recommended.	90mm	20-40 Years	B2
		HOLLY <i>Ilex aquifolium</i>	50%

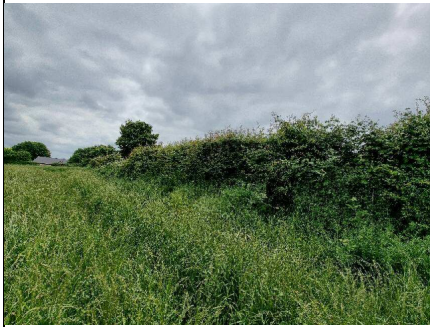
HAWTHORN <i>Crataegus monogyna</i>	0.5	1.6m	2.5m	2m	Semi- Mature	A hedgerow consisting mostly of Hawthorn and Sycamore with brambles present. Other ground vegetation also presnet. Hedge has some screening and wildlife value.	No preliminary work recommended.	90mm	20-40 Years	B2
		SYCAMORE <i>Acer pseudoplatanus</i>	0.5									
		0	0									
		0	0									
		0	0

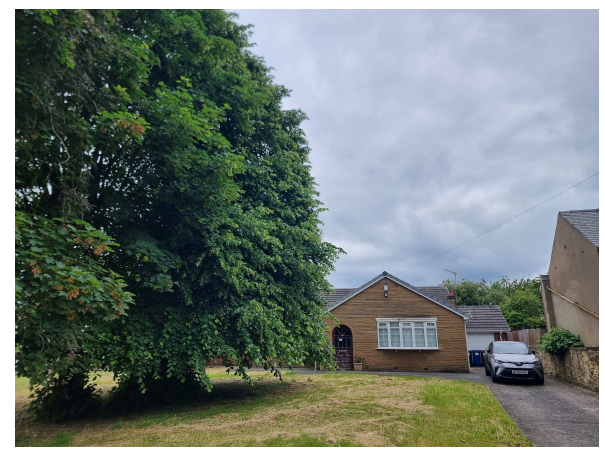
Looking north towards T14:

Some overspill encroachment may occur into these RPAs as a result of excavation for traditional strip footing foundations. This may result in root severing/ damage occurring.

Access would be required within the RPAs of T14 in order to excavate for the foundations and accommodate scaffolding

To lessen the likelihood of root damage occurring, Air excavation should be used to excavate for these sections of foundations closest to the RPAs of T14.

Temporary ground protection is required in these areas. This will minimise compaction damage to the soil within RPAs, by spreading the loading of traffic on the soil.
