# **ARBORICULTURAL REPORT**

# **IMPACT ASSESSMENT**

*Land at*  
**Paddock Road**  
**Staincross**  
**Barnsley**  
**S75 6LG**

Reference: AWA4554

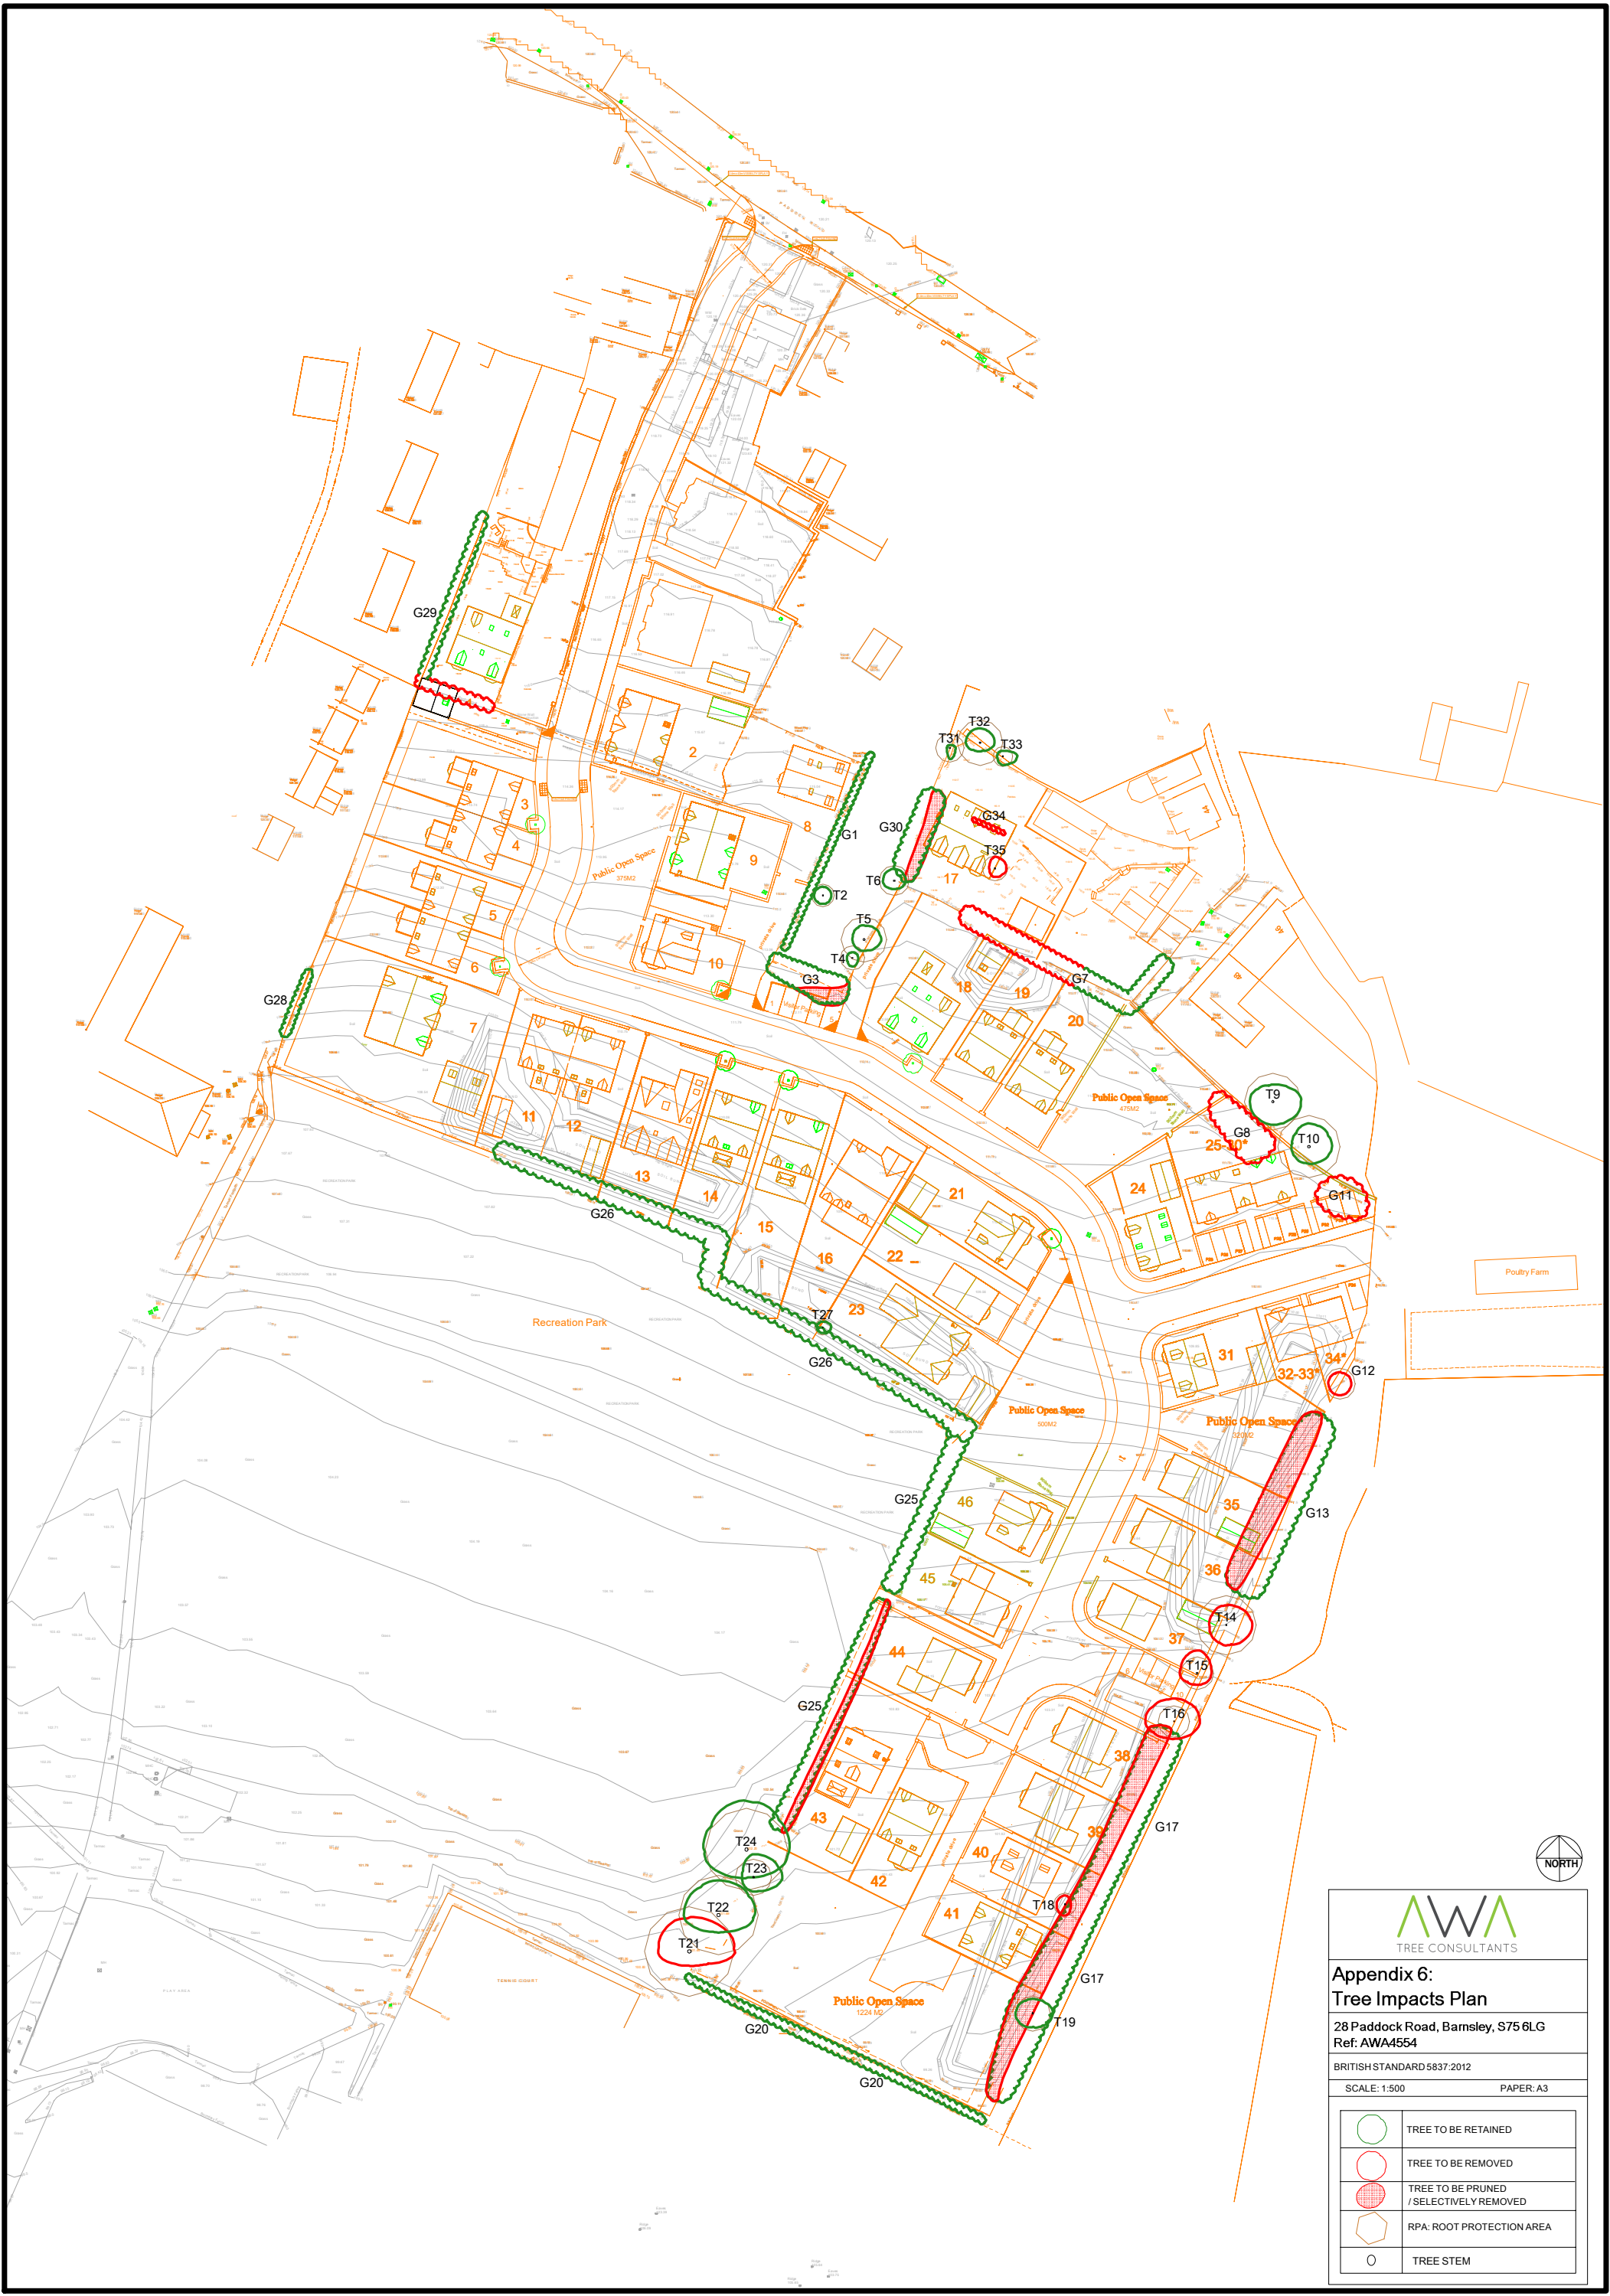
**Appendix 6:**  
**Tree Impacts Plan**  
28 Paddock Road, Barnsley, S75 6LG  
Ref: AWA4554

- 4.2.1 From assessing the new development proposals, 9 trees, tree groups or hedges will require removal to facilitate the development as they are situated in the footprint of the development or their retention and protection throughout the development is not suitable.
- 4.2.2 The trees that require removal to facilitate the development are T14, T15, T16, T18 and T35.
- 4.2.3 The tree groups/hedges that require removal to facilitate the development are G8, G11, G12 and G34.
- 4.2.4 From assessing the new development proposals, 8 trees, tree groups or hedges will require pruning or selective removal to facilitate the development as they are situated in the footprint of the development or their retention and protection throughout the development is not suitable.

- 4.2.5 The trees/ groups/ hedges that require removal to facilitate the development are G3, T5, G7, G13, G17, G25, G29 and G30.
- 4.2.6 The trees to be removed or pruned are all lower value, retention category 'C'.
- 4.2.7 Due to the low value of the trees to be removed the removals will have only a negligible negative arboricultural impact.
- 4.2.8 The trees to be pruned will readily tolerate the work with little long term negative impact.

- 4.3.2 The new development encroaches close to and into the edge of the RPA of T5 and T6. Construction within the RPA, can have negative impacts on tree roots. However, the encroachment is very minor, and the detailed RPA for these trees is likely to be a slightly exaggerated representation of the trees actual rooting area. As such, it is unlikely that significant roots will be within these areas and the retained tree should remain largely unaffected by the works, provided care is taken during construction.
