CHRIST CHURCH, ARDSLEY

## ARBORICULTURAL IMPACT ASSESSMENT AND ARBORICULTURAL METHOD STATEMENT

November 2024

Revision A – 14th November 2024

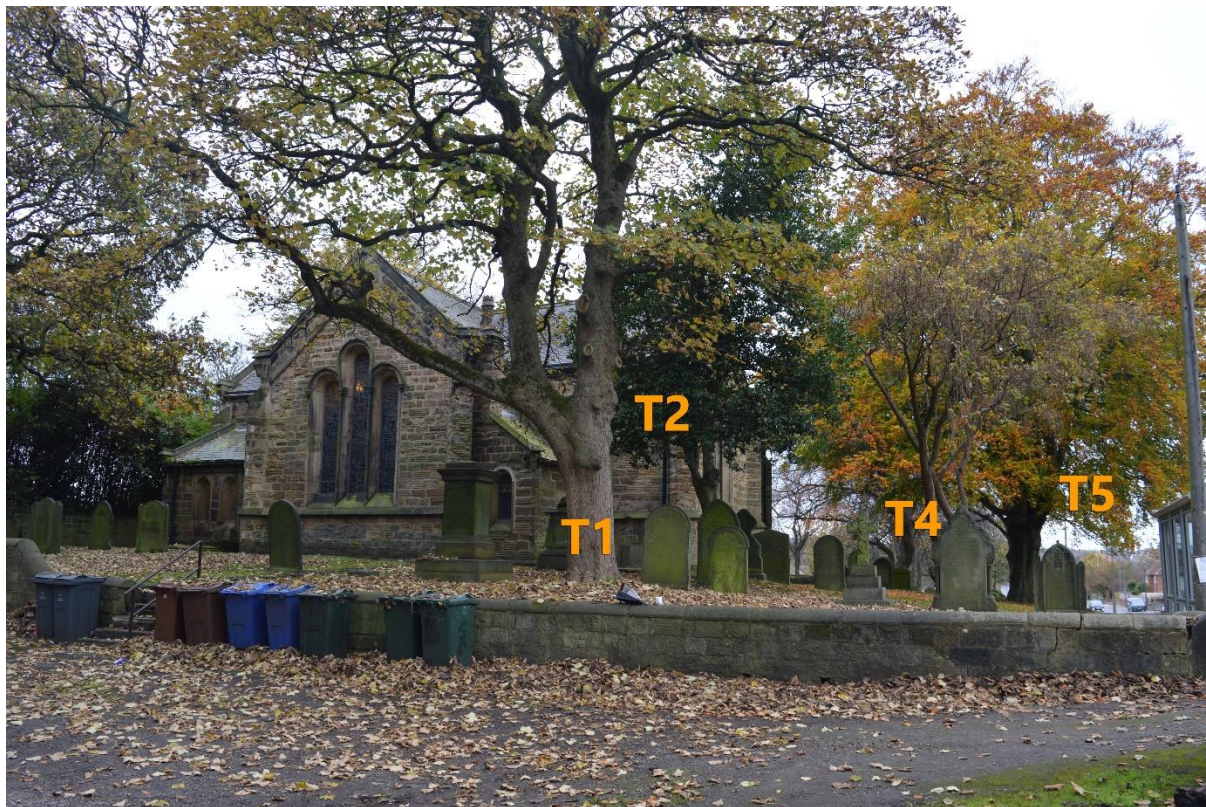
*T1, T2, T4 and T5 as seen from adjoining car park and associated retaining wall.*

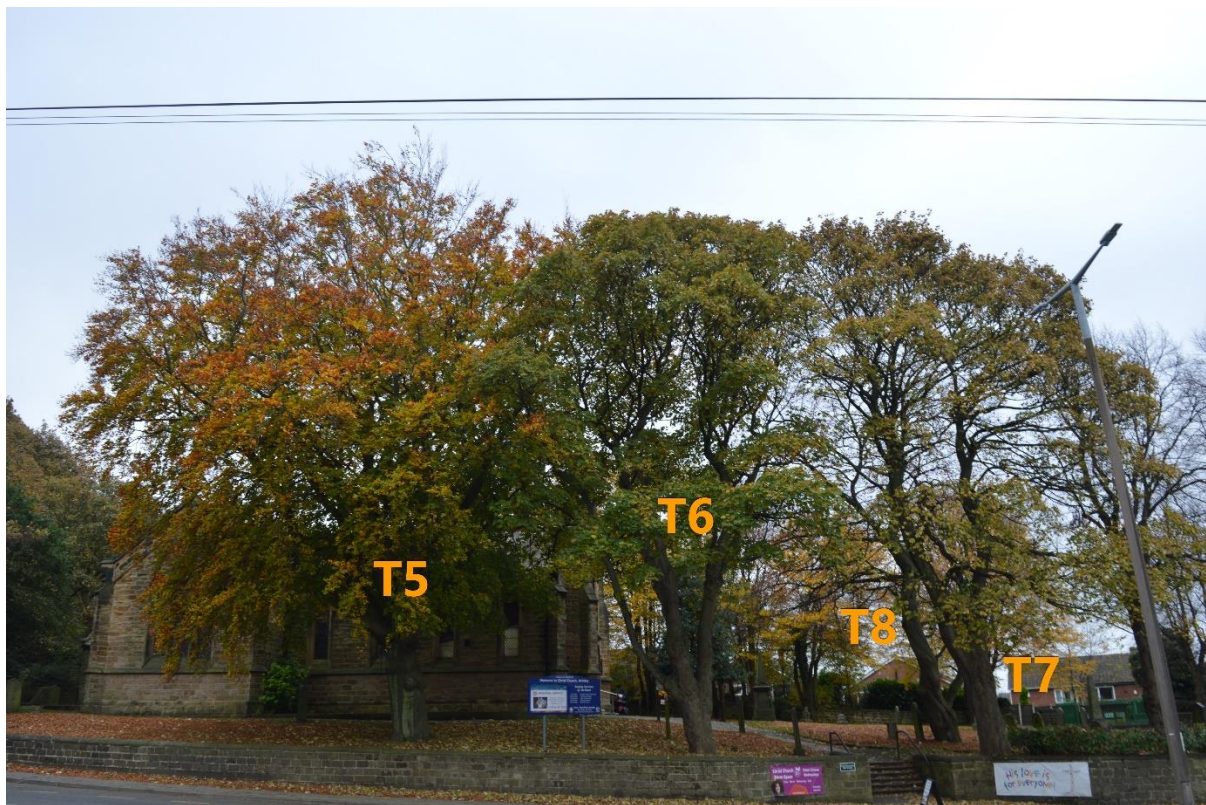
*T5, T6, T7 and T8 as viewed from the A635.*

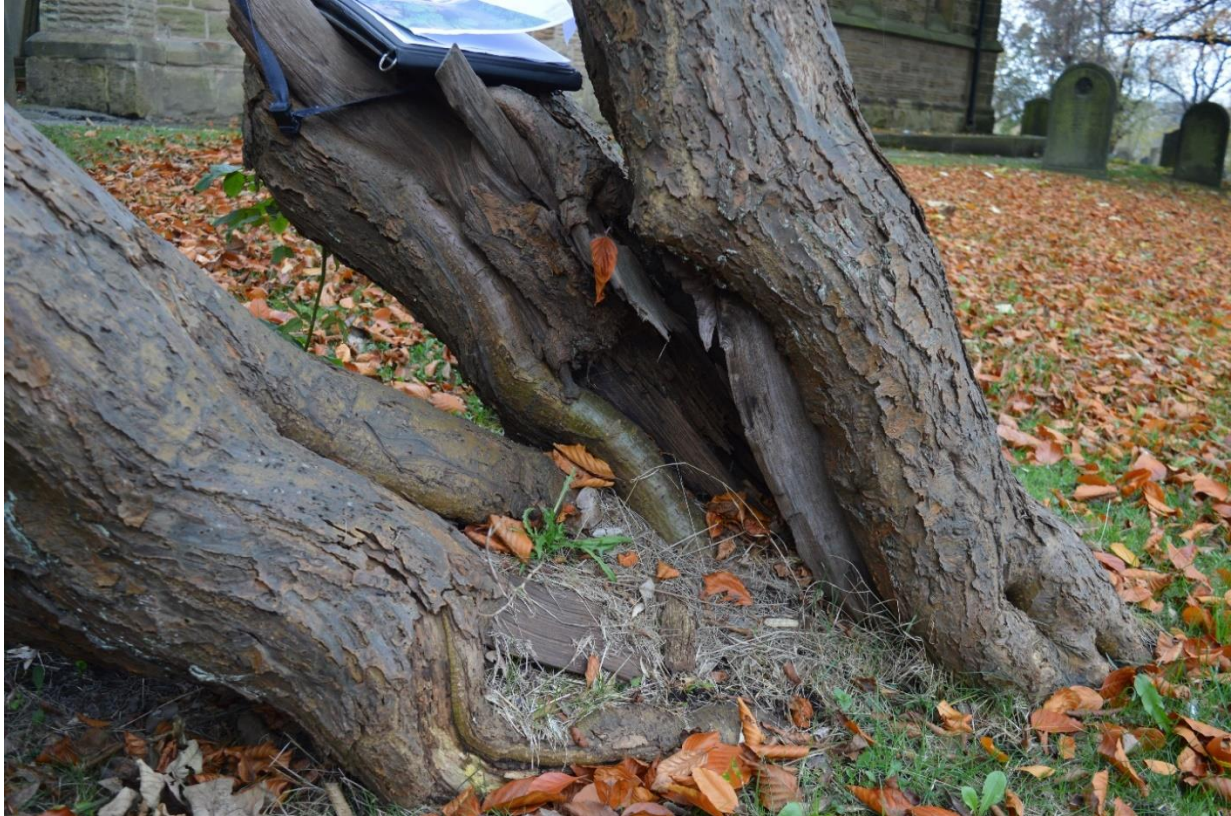
| NO | TREE SPECIES<br>Common Name | TREE SPECIES<br>Scientific Name | HEIGHT<br>m | SPREAD<br>m | Clear stem<br>(m) | DIA<br>mm | N | CAT. | Life Stage | Life exp yrs | NOTES |
|---|---|---|---|---|---|---|---|---|---|---|---|
| T4 | Common Laburnum | Laburnum anagyroides | 9 | 8 | 0 | 350 | N | C1 | Early-Mature | 10+ | Multistemmed at base, Major cavity from base to 5m, Previous pruning work, Slitting at base |

*Cracking in base of T4 – Common Laburnum.*

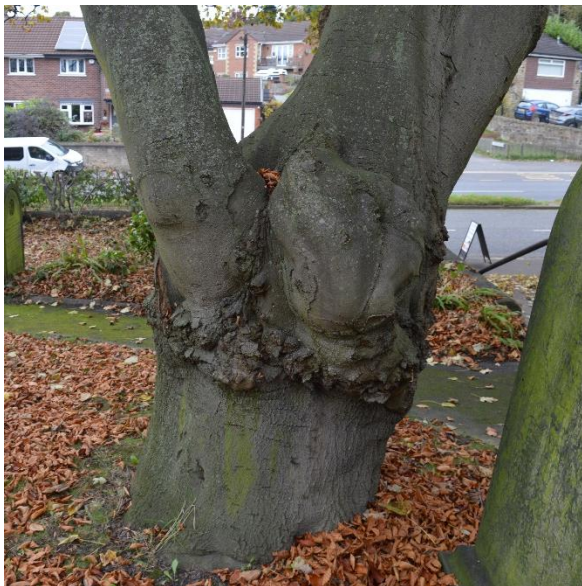
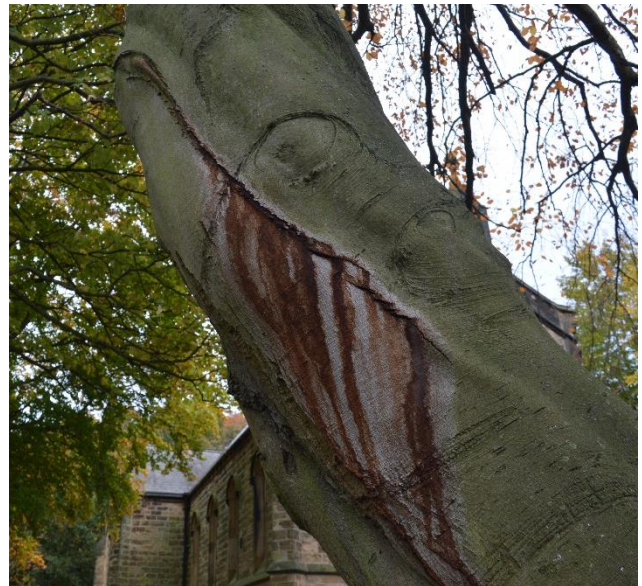
| NO | TREE SPECIES<br>Common Name | TREE SPECIES<br>Scientific Name | HEIGHT<br>m | SPREAD<br>m | Clear stem<br>(m) | DIA<br>mm | N | CAT. | Life Stage | Life exp yrs | NOTES |
|---|---|---|---|---|---|---|---|---|---|---|---|
| T8 | Copper Beech | Fagus sylvatica 'Purpurea' | 16 | 15 | 1.5 | 810 | N | B1 | Mature | 20-40 | Potential previous girdling at 0.5m, Bleeding canker from 2-3m northern limb. |

*Condition of T8 – Copper Beech*

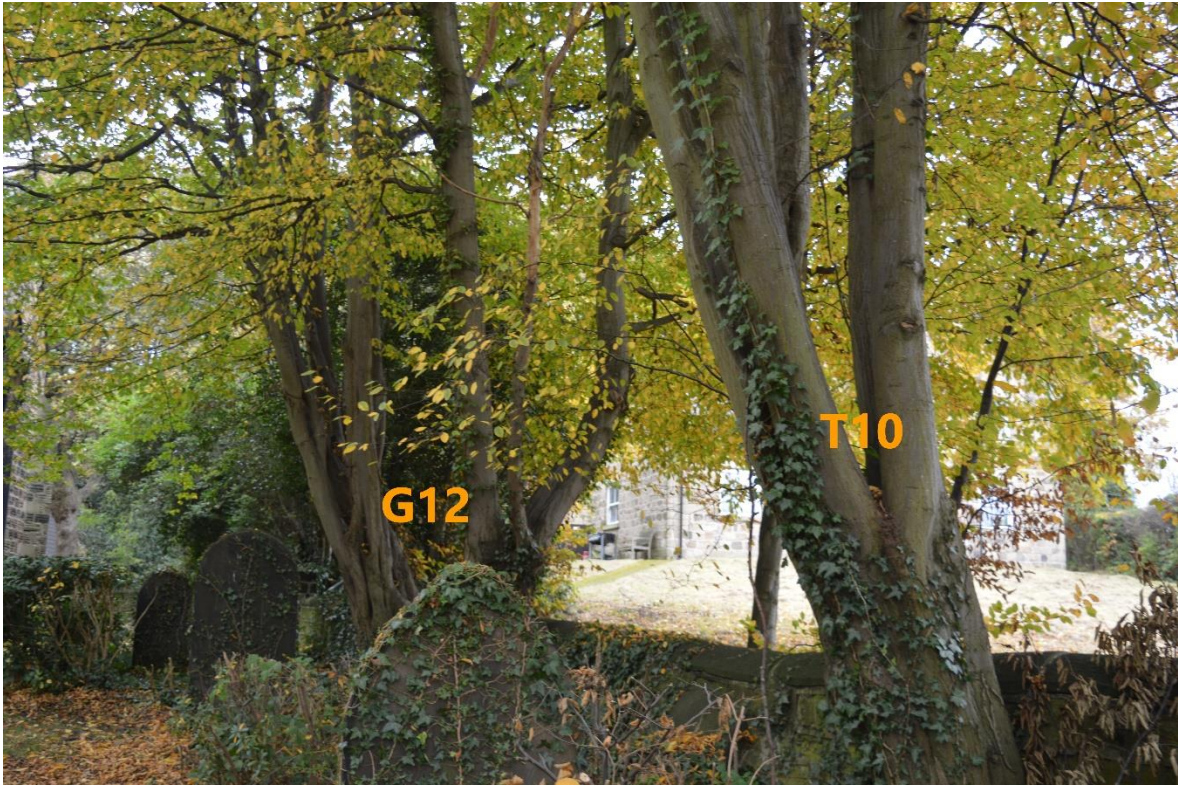
| NO | TREE SPECIES<br>Common Name | TREE SPECIES<br>Scientific Name | HEIGHT<br>m | SPREAD<br>m | Clear stem<br>(m) | DIA<br>mm | N | CAT. | Life Stage | Life exp yrs | NOTES |
|---|---|---|---|---|---|---|---|---|---|---|---|
| T10 | Hornbeam | Carpinus betulus | 15 | 13 | 1 | 600 | N | C2 | Early-Mature | 40+ | Ivy covered stem, Rooting against stone wall, Slight lean, Previous pruning work |
| G12 | Hornbeam | Carpinus betulus | 13 | 13 | 1.5 | 600 & 900 | | C2 | Early-Mature | 40+ | 2 no., Ivy covered stems, Rooting against wall, Previous pruning work |

*T10 and G12 rooting against stone wall.*
