# COAL MINING RISK ASSESSMENT

UNIT 9A, MAPPLEWELL BUSINESS PARK

HAYWOOD ENGINEERING SERVICES

**Reference:** 19-092-REP-001

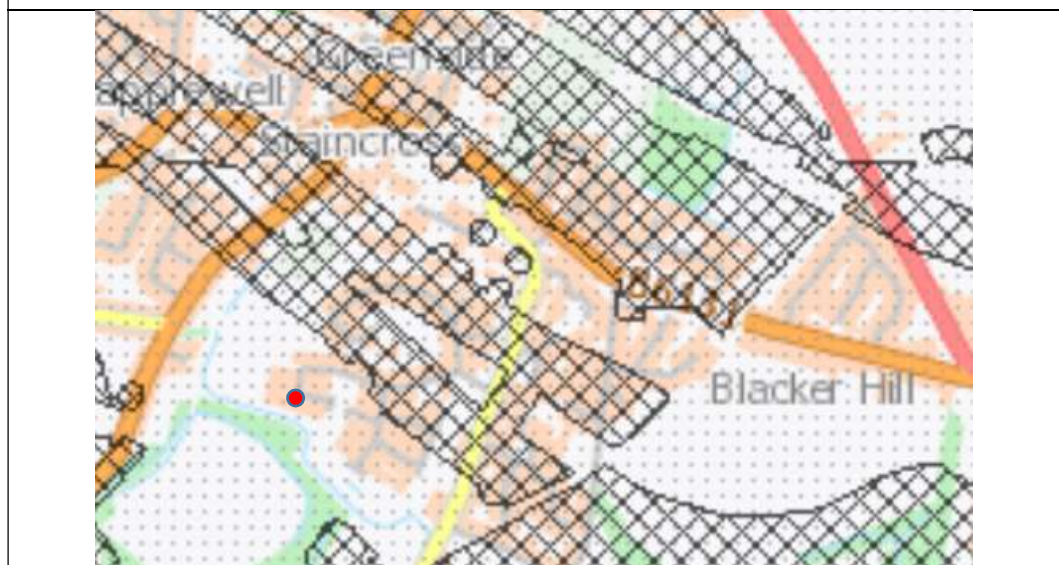
**Figure 1.2. – Unit 9A, Mapplewell Business Park – Indicating Site is Situated in a Development High Risk Area**

- 1.1 This report has been prepared in support of a full planning application for a proposed development to be situated within a Development High Risk Area to the rear of Unit 9A, Mapplewell Business Park.
- 1.2 This Coal Mining Risk Assessment has, therefore, been prepared by Matrix Consulting Engineers, on behalf of Heywood Engineering Services Ltd, to support the planning application (See Figure 1.1).

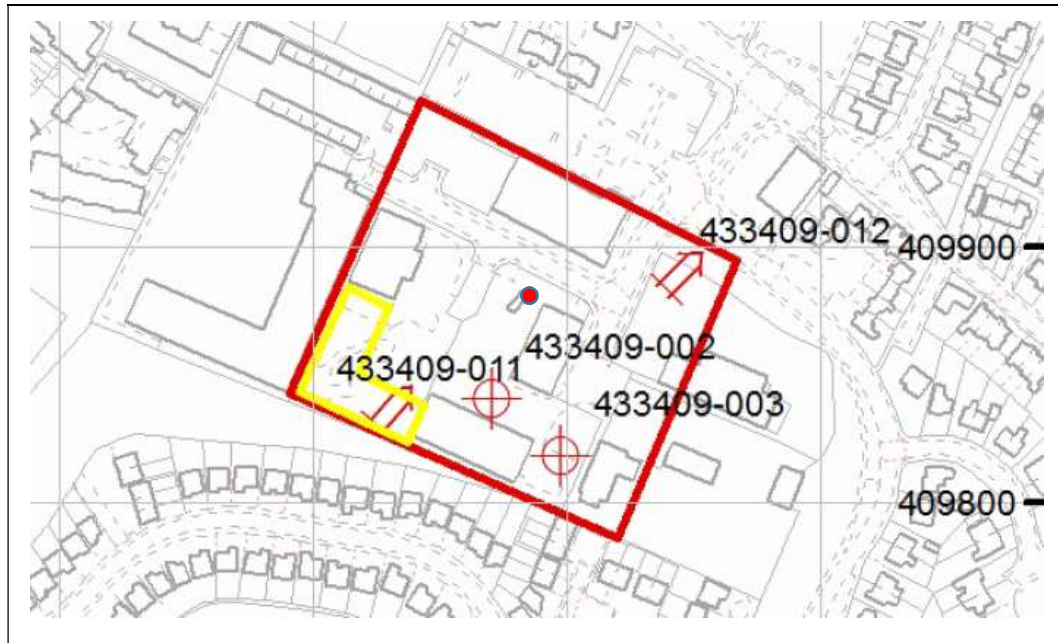
**Figure 4.3 – Location of Mine Entries**

1. The area has been extensively mined, as can be seen from Figure 4.3, with numerous entries surrounding and within the site. These features are associated with the North Gawber Colliery, with both working shafts and adits being referenced on plan.

2. Given the depth of the superficial deposits reported in the vicinity, the North Gawber Colliery Lidgett Downcast Shaft (Reference 4334409-002), North Gawber Colliery Barnsley Upcast Shaft (Reference 4334409-003) and the North Gawber Colliery No.2 Adit (Reference 4334409-012) are all sufficiently distant from the site not to pose any risk to the proposed development.

3. The North Gawber Colliery No.1 Adit (Reference 4334409-011), which is a horizontal or near horizontal mine entry, however, is recorded as being:
  - a. Approximately 3m in width.

- b. Positioned directly beneath the southeast corner of the proposed building
  - c. Capped using a concrete plug in 1988.
4. The Mine Entry Risk Assessment, however, concludes that, with respect to North Gawber Colliery No.1 Adit (Reference 4334409-011):

- a. *The main building (as shown on the plan) is within the area likely to be affected if coal mining subsidence was to occur because of ground movement. The statistical risk of the main building being damaged by subsidence especially given the information recorded in the treatment details above however is very small.*

- ii A GPR or slit trench survey should be undertaken to establish the location of the North Gawber Colliery No.1 Adit, on the southeast corner of the site
- iii During these investigations, tests should be undertaken and records kept relating to: the nature and depth of the superficial deposits, the depth of any rock head, the nature and thickness of rock cover to any coal seams, the thickness of any coal seams and any evidence that the coal seams have been worked, such as broken ground or voids.

- 5.8 In order to mitigate the effects of differential settlement associated with building over the remediated North Gawber Colliery No.1 Adit (Reference 4334409-011), foundations should be adopted that span across this feature, utilising either pads or piles. Should it be confirmed that piles are required to bridge the adit, whereas, pad foundations may be adopted elsewhere, then suitable movement joints should be provided in the superstructure and substructure, to mitigate the effects of differential settlement.

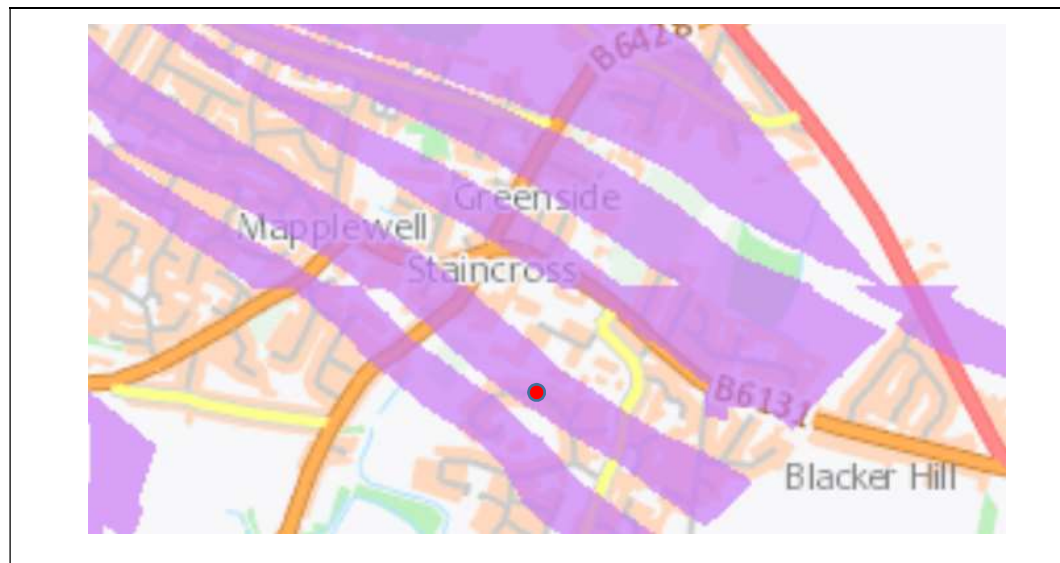
**Figure 4.4.1 – Extent of Probable Shallow Mine Workings**

1. This relates to unrecorded coal workings that exist at or within 30 metres of the ground surface.
2. The site is within an area where it is believed there is coal at or close to the surface, which may have been worked at some time in the past. The risk of shallow mine workings existing at or close to the surface, which may affect the development, must, therefore, be considered possible (See Figure 4.4.1).
3. Given the depth of the Barnsley Coal seam recorded beneath the site, at 89 m, and the information presented on the mine abandonment plan (See Figure 4.4.3) this means the seams that may have been worked, at shallow depth beneath the site, are the Kent's Thick and Kent's Thin seams, which have maximum thicknesses of 1.9m and 2.6 m, respectively, and are described as being a 'good household coal'.

4. The records suggests, therefore, that the coal seams which outcrop on the southern boundary and to the south west of the site, and dip beneath the site, are the Kent's Thin and Kent's Thick seams, and that it is these seams, which the adit in the southeast corner of the site, provides access to. (See Figure 4.4.2 and 4.4.3). The seams outcropping to the Northeast of the site are probably the Beamshaw Seams, Abdy Seam, Two Foot Coal Seam and, possibly, the Meltonfield Seam, the majority of which are also described as good household coal and are likely to have been worked from the surface.

- 5.5 Given this, we would make the following recommendations for intrusive investigation works, in accordance with the guidance provided in CIRIA Special Publication 32, *Construction Over Abandoned Mine Workings*, though the exact scope of the investigation should be established by means of a detailed Phase 1 Desk Top Study:

- i A group of 3No investigatory boreholes should be undertaken, down to a depth of 26 m below bedrock level, as this will establish whether 10 times the

5.7 Should it be established that worked coal seams exist beneath the site, with rock cover less than ten times the seam thickness, then, dependent on the nature and depth of the workings, measures should be adopted to ensure that the buildings will not be damaged by the effects of shallow mine workings. These include:

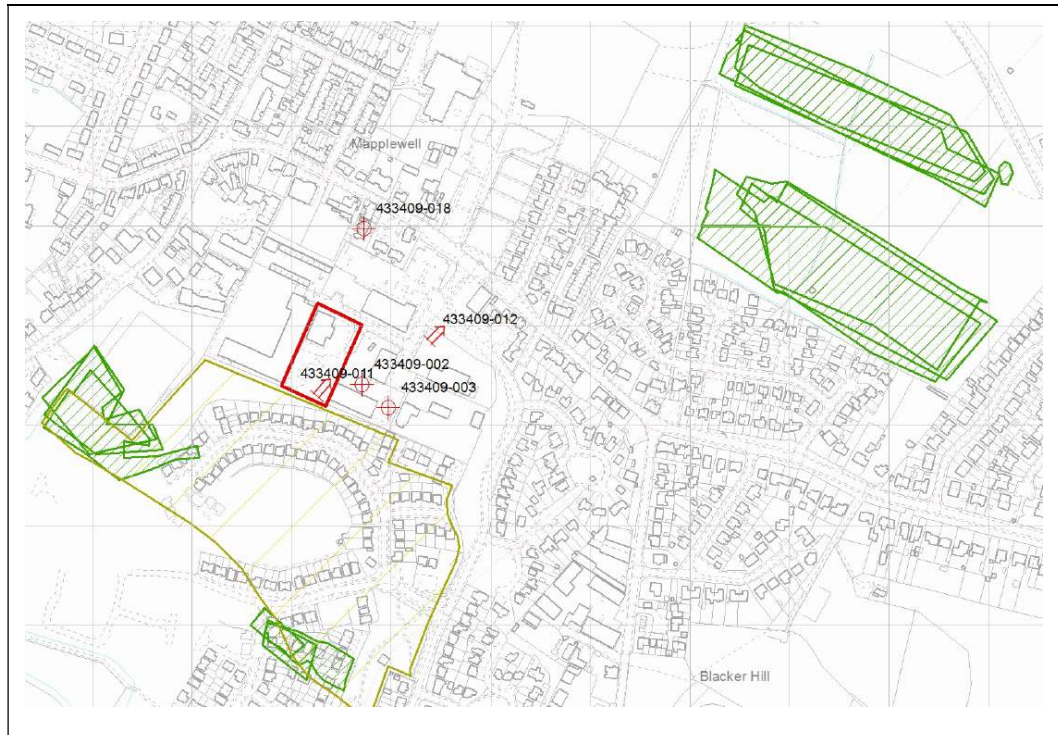
**Figure 4.6 – Records of Open Cast Workings**

- No licenses have been issued by the Coal Authority, either within, or within 200 metres, of the enquiry boundary in relation to the undertaking of surface coal mining, underground coal mining or underground coal gasification
