CROSS STREET, WOSBOROUGH

ARBORICULTURAL IMPACT ASSESSMENT AND ARBORICULTURAL  
METHOD STATEMENT

September 2026

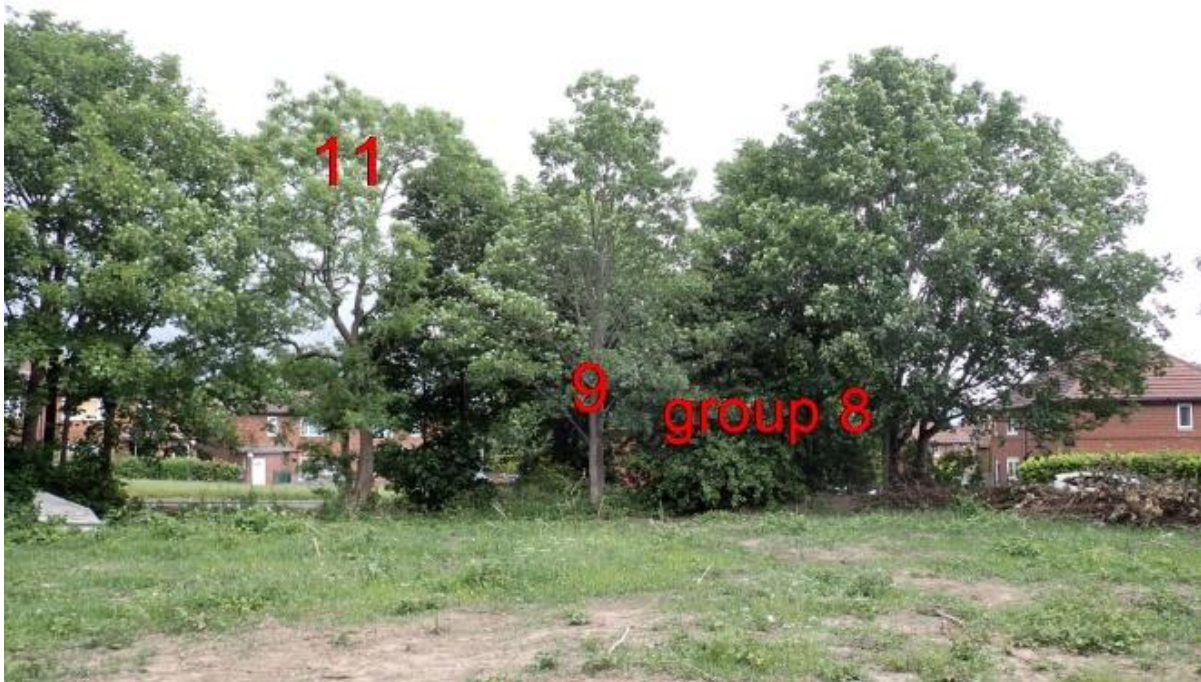
Photograph 1.

The site appears to have suffered a lot of fly tipping over many years. Although it is unlikely that this has greatly affected any single tree, the machine that has scraped off the site has clearly caused damage to the roots of trees.

Photograph 1 is a view of the north east corner of the site, taken looking northeast wards. I've included this photo to try and show the scraped ground. It's not clear here but there were some significant tree roots damaged when this was done. They can be seen in this photo, looking rather like sticks on the ground, but they are in fact roots.

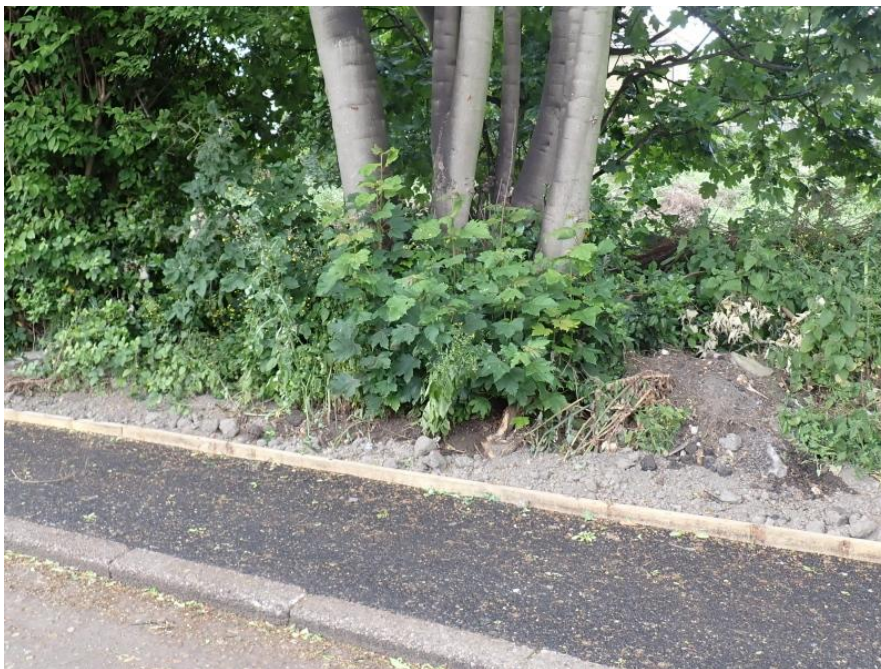
Photograph 2.

Photograph 2 shows the base of tree 6, Sycamore coppice growth. It also shows what appears to be a new pavement. The installation of this pavement must have caused significant damage to nearby trees.

From what I could tell from the photos on Google's street view facility, there might have once been a pavement between the site and the road, but it seems that this was considerably overgrown and the new pavement must have been installed by digging out for a new sub-base.

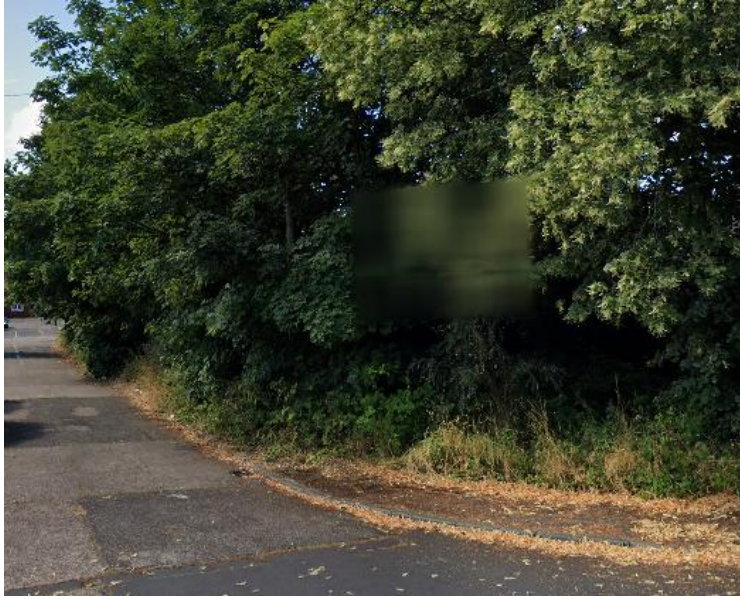
Photograph 3.

Photograph 3 is a screen grab from Google showing the site edge in August 2024. This is looking south down Cross Street.

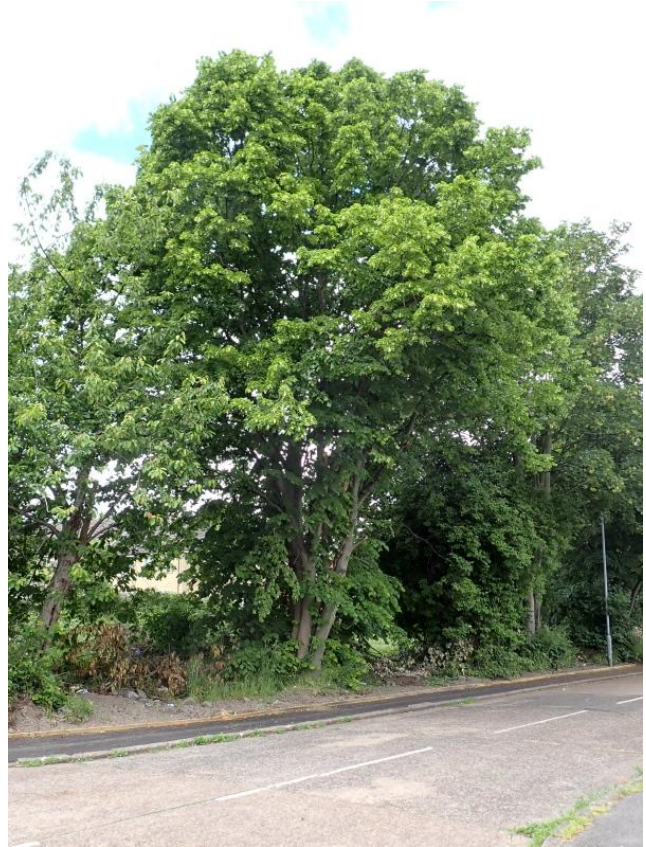
Photograph 4.

Photograph 4 is a view looking roughly north west from the end of Cross Street, and showing tree 5. This tree probably suffered root damage from the construction of the pavement.

Tree 5 is coppice growth as with tree 6. It's likely that these trees were cut down and then allowed to regrow from the stump. Coppice management of trees is an underappreciated ability of broad-leaved trees. There are numerous examples of coppiced trees along the UK's highway verges, and even in gardens.

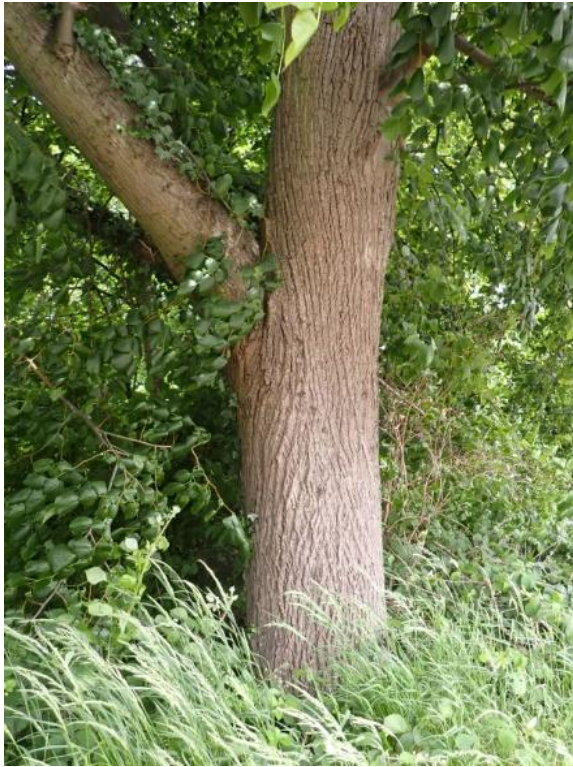
Photograph 5.

Photograph 5 shows the trunk of tree 3, a Lime tree. My presumption is that the two Limes on the site are the same cultivar, planted at the same time. There are two species of Lime native to the UK and unsurprisingly, a hybrid between the two. The hybrid is known as Common Lime and as the name suggests, more commonly found than either of the parents. (Broad-leaved Lime and Small-leaved Lime.)

This is a Common Lime and seems to be a selected cultivar, I'm not sure which, but I don't think it is essential to investigate this any further for this report. Tree 3 is a decent specimen but the large branch, to the left in photo 5, seems to be growing with included bark, which is a potential weakness.

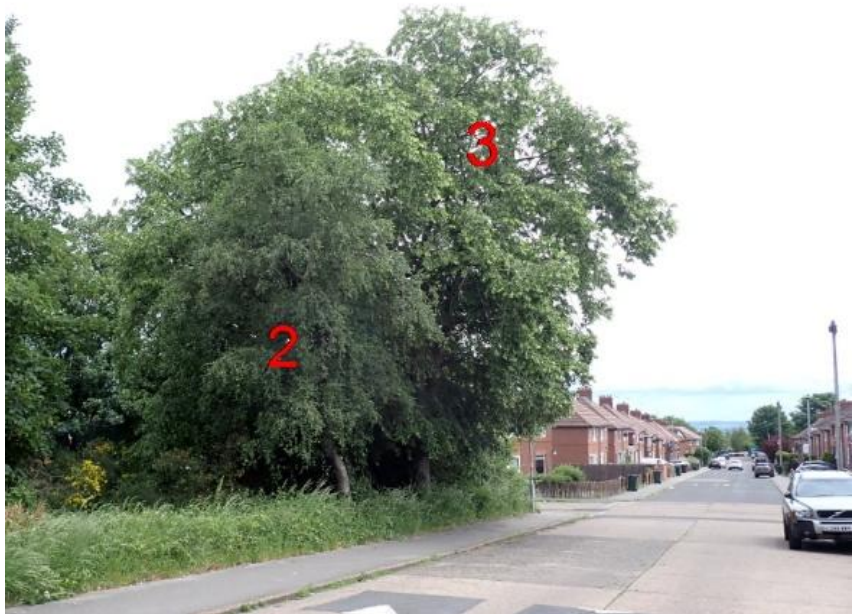
Photograph 6.

Photograph 6 is a view looking east along Overdale Avenue. Tree 2 is the Birch rather dominated by tree 3.

Tree 2 is indicated for removal to create parking spaces. Birch is not a long-lived species and growing in the position it is, even if there was not a development proposal, this tree would probably have only a short future life. The fly-tipping at its base will not have improved its prospects.

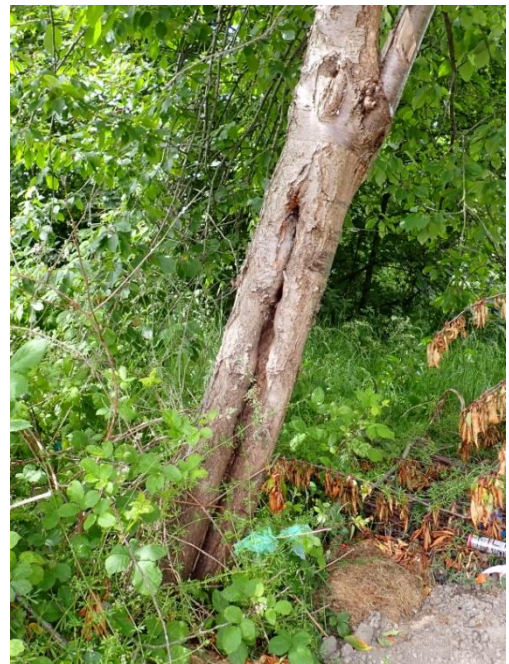
Photograph 8.

Photograph 8 is a view of the trunk of the Cherry tree in group 4, which is damaged and decayed. The Holly tree in the group is also almost dead.

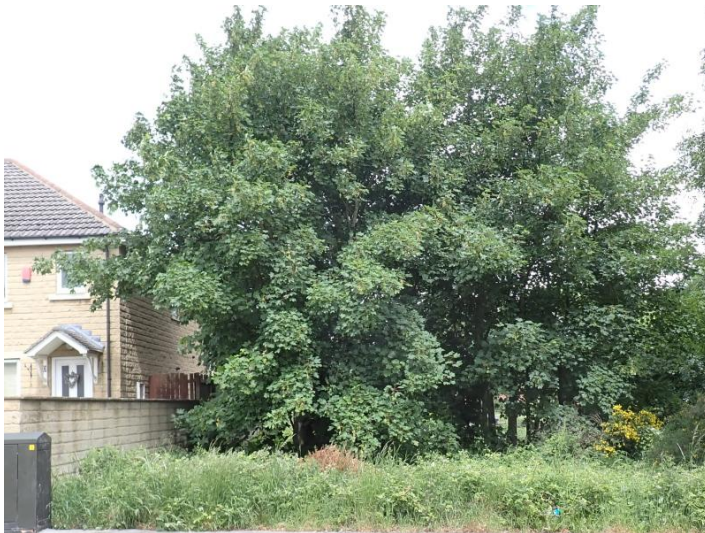
Photograph 9.

Photograph 9 shows tree group 1, taken looking roughly north. Even if these trees were not indicated for removal, it's likely that the occupants of the neighbouring property would be seeking some work to reduce the crowding of their house.

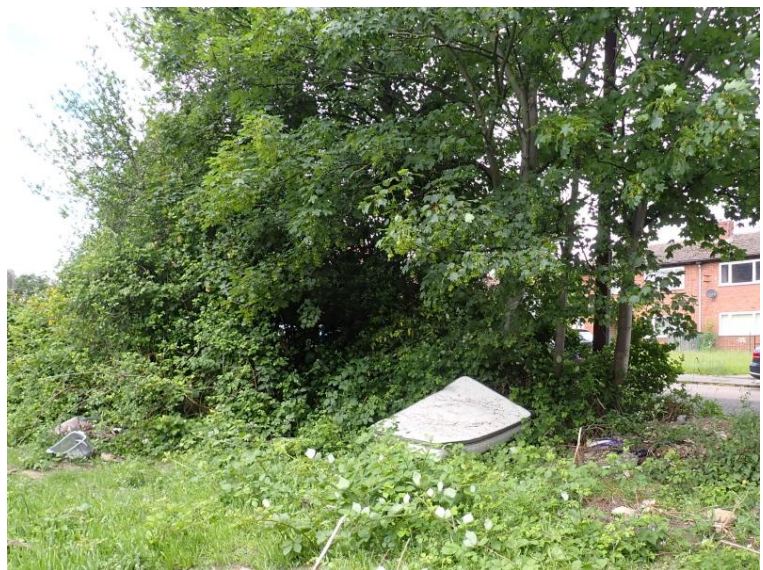
Photograph 12.

Photograph 12 shows group 12 in the north west corner of the site, with more fly tipping. The proposal calls for these trees to be removed.

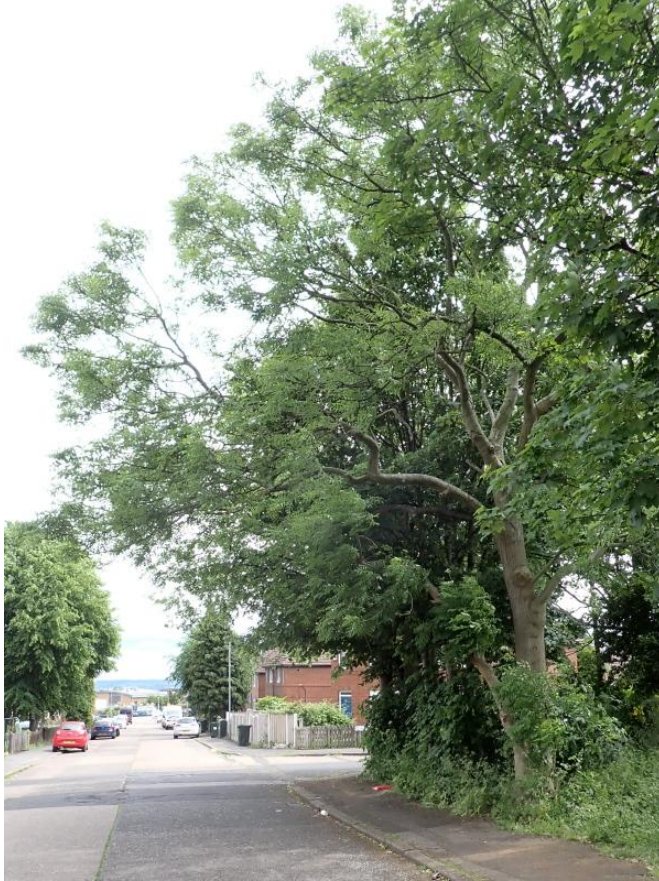
Photograph 13.

Photograph 13 is a view looking east down Underwood Avenue and shows tree 11, the Ash with a long branch reaching over the road. There's another low branch that seems to have been inexpertly pruned. This tree is also indicated for removal.
