# **ARBORICULTURAL REPORT & Impact Assessment to BS5837:2012 at:**

*Land at  
**Heysham Green  
Barnsley  
South Yorkshire  
S71 2RP***

Date: *February 2019*

Reference: *AWA2581*

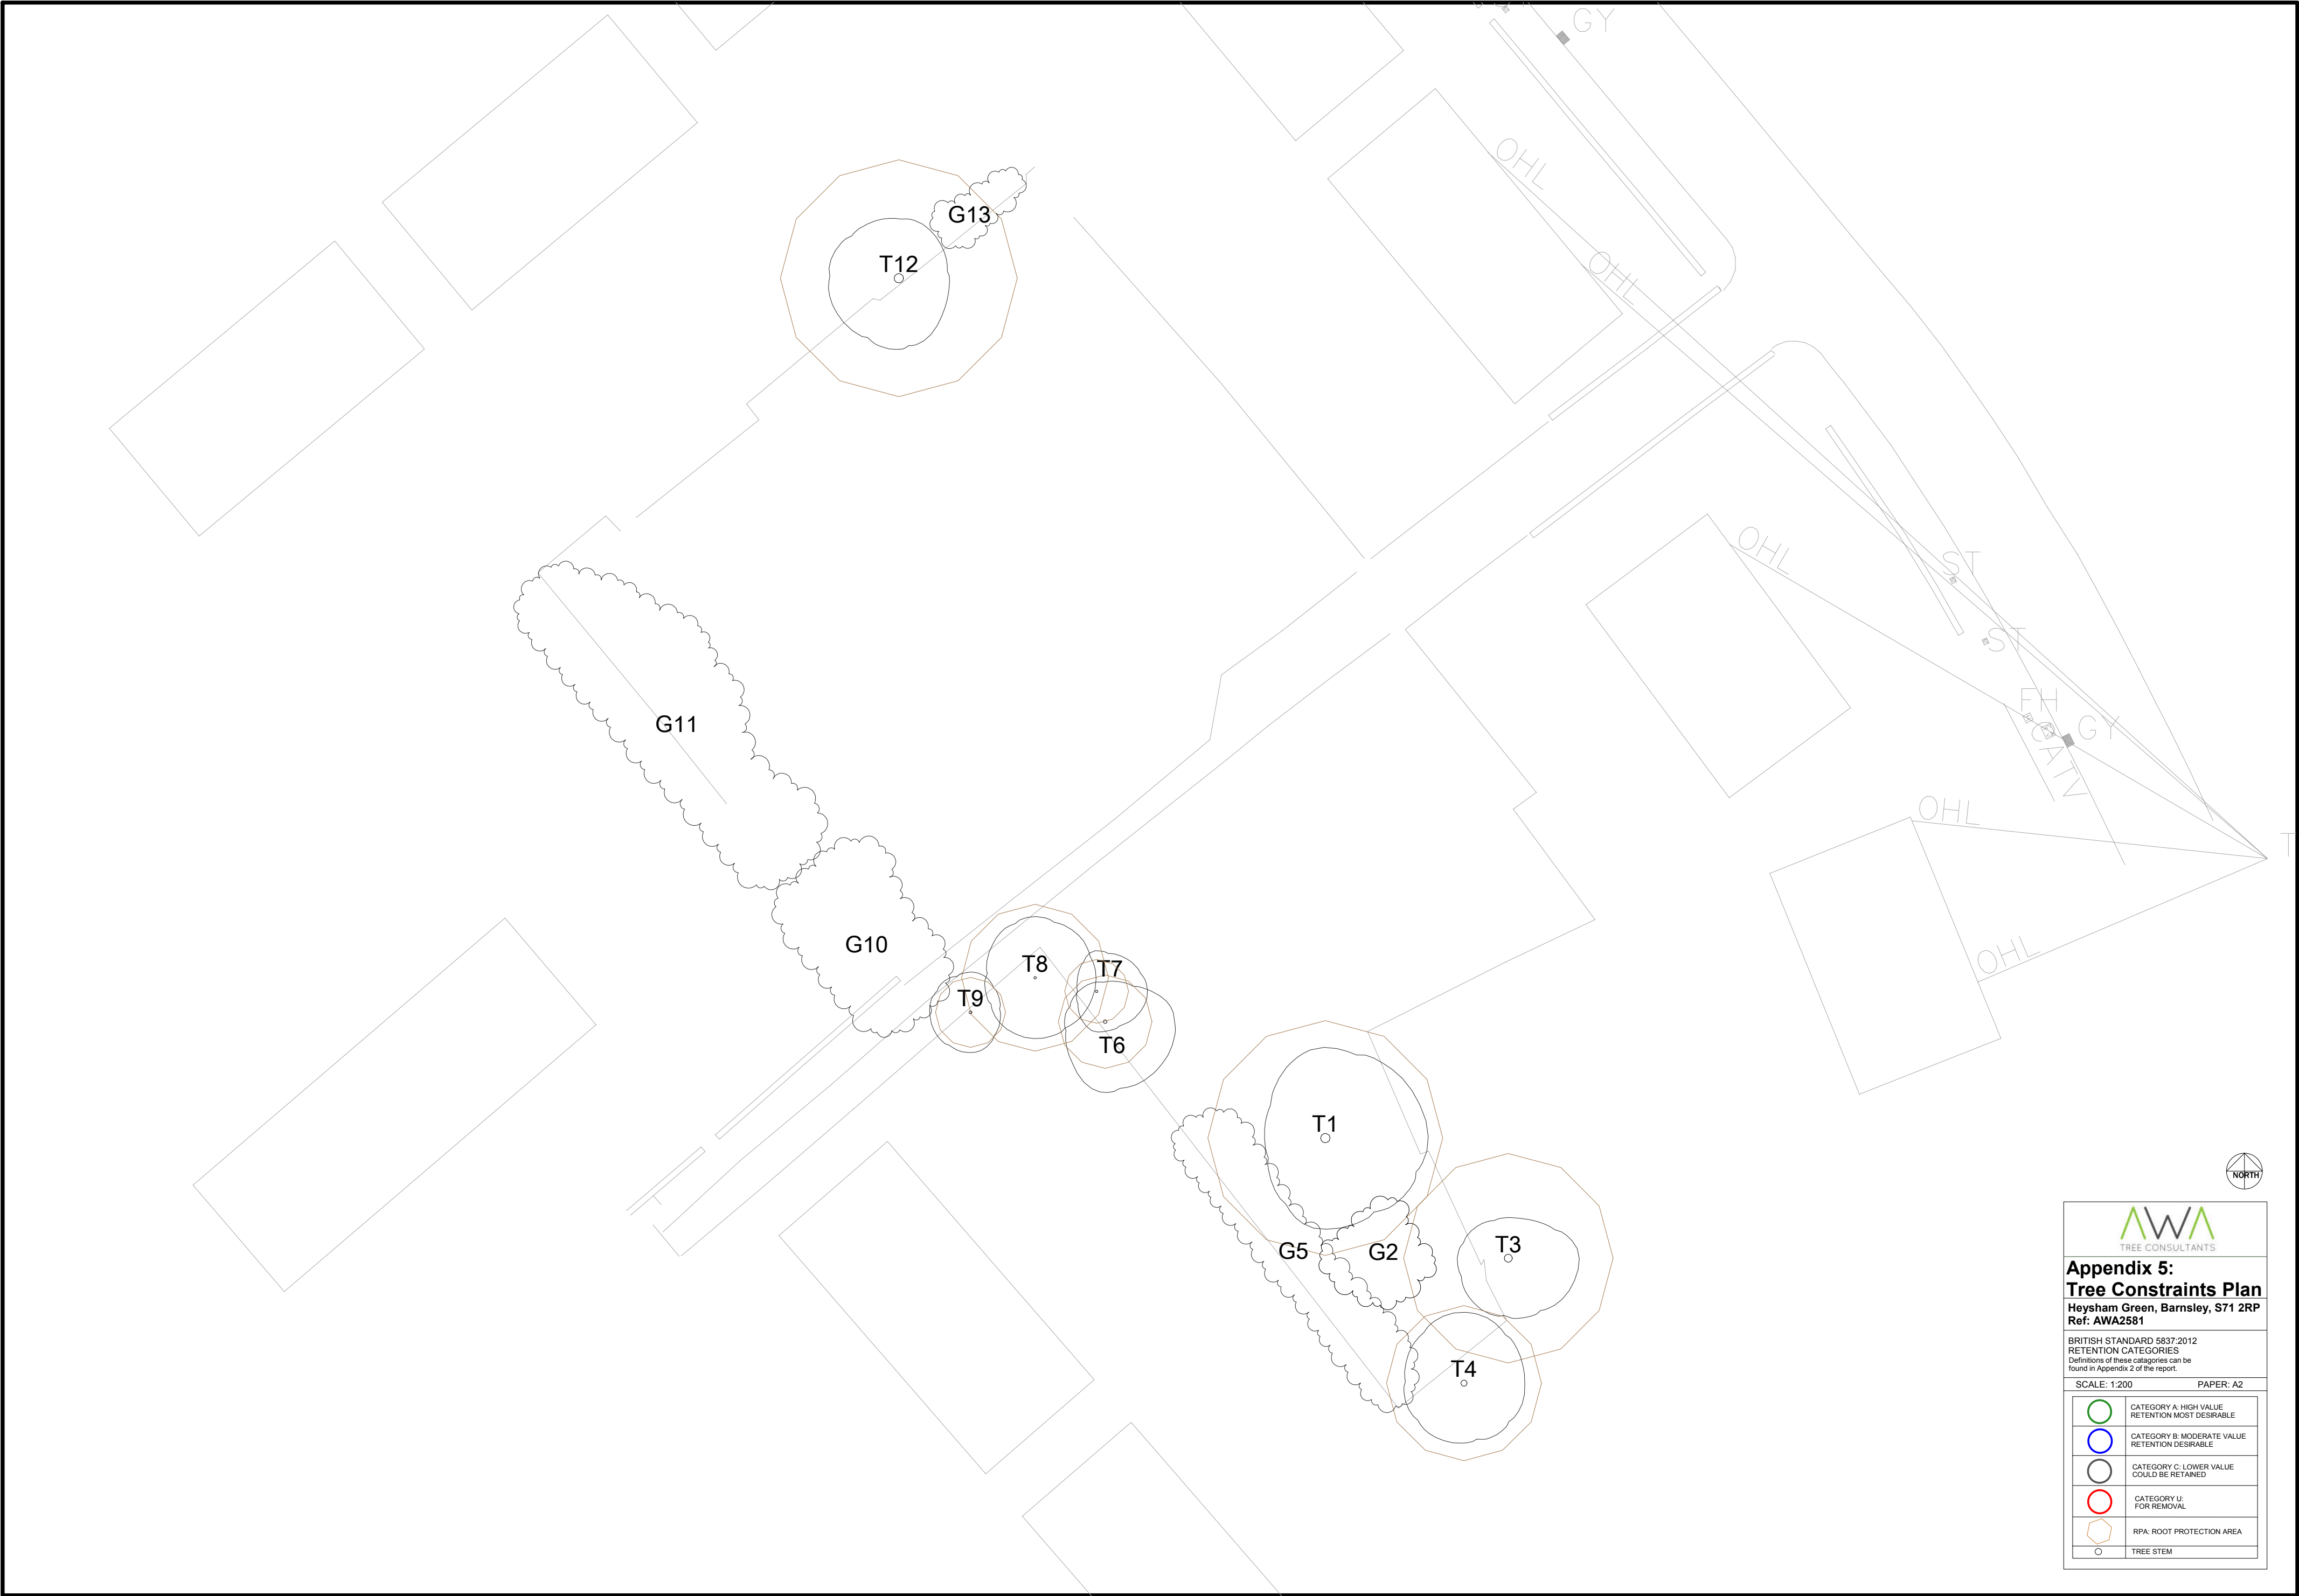
**Appendix 5:**  
**Tree Constraints Plan**  
Heysham Green, Barnsley, S71 2RP  
Ref: AWA2581

- 3.2.12 The tree Root Protection Area (RPA) detailed on the Tree Constraints Plan at Appendix 5, has been used as a layout design tool, to inform on the area around a tree where the protection of the roots and soil structure is treated as a priority.

- 3.2.13 The lower value tree and hedge groups do not have RPAs detailed on tree plans. The detailed extent and spread of the low value groups, in conjunction with the tree schedule, is sufficient to assess the associated potential constraints.

- 3.2.14 The RPA for each tree has been plotted as a polygon centred on the base of the stem. Due to the presence of roads, structures, topography (and past tree management) the RPA is likely to be a simplified representation of the tree roots actual morphology and disposition. However, detailed modifications to the shape of the RPA would largely be based on conjecture and so have been avoided.

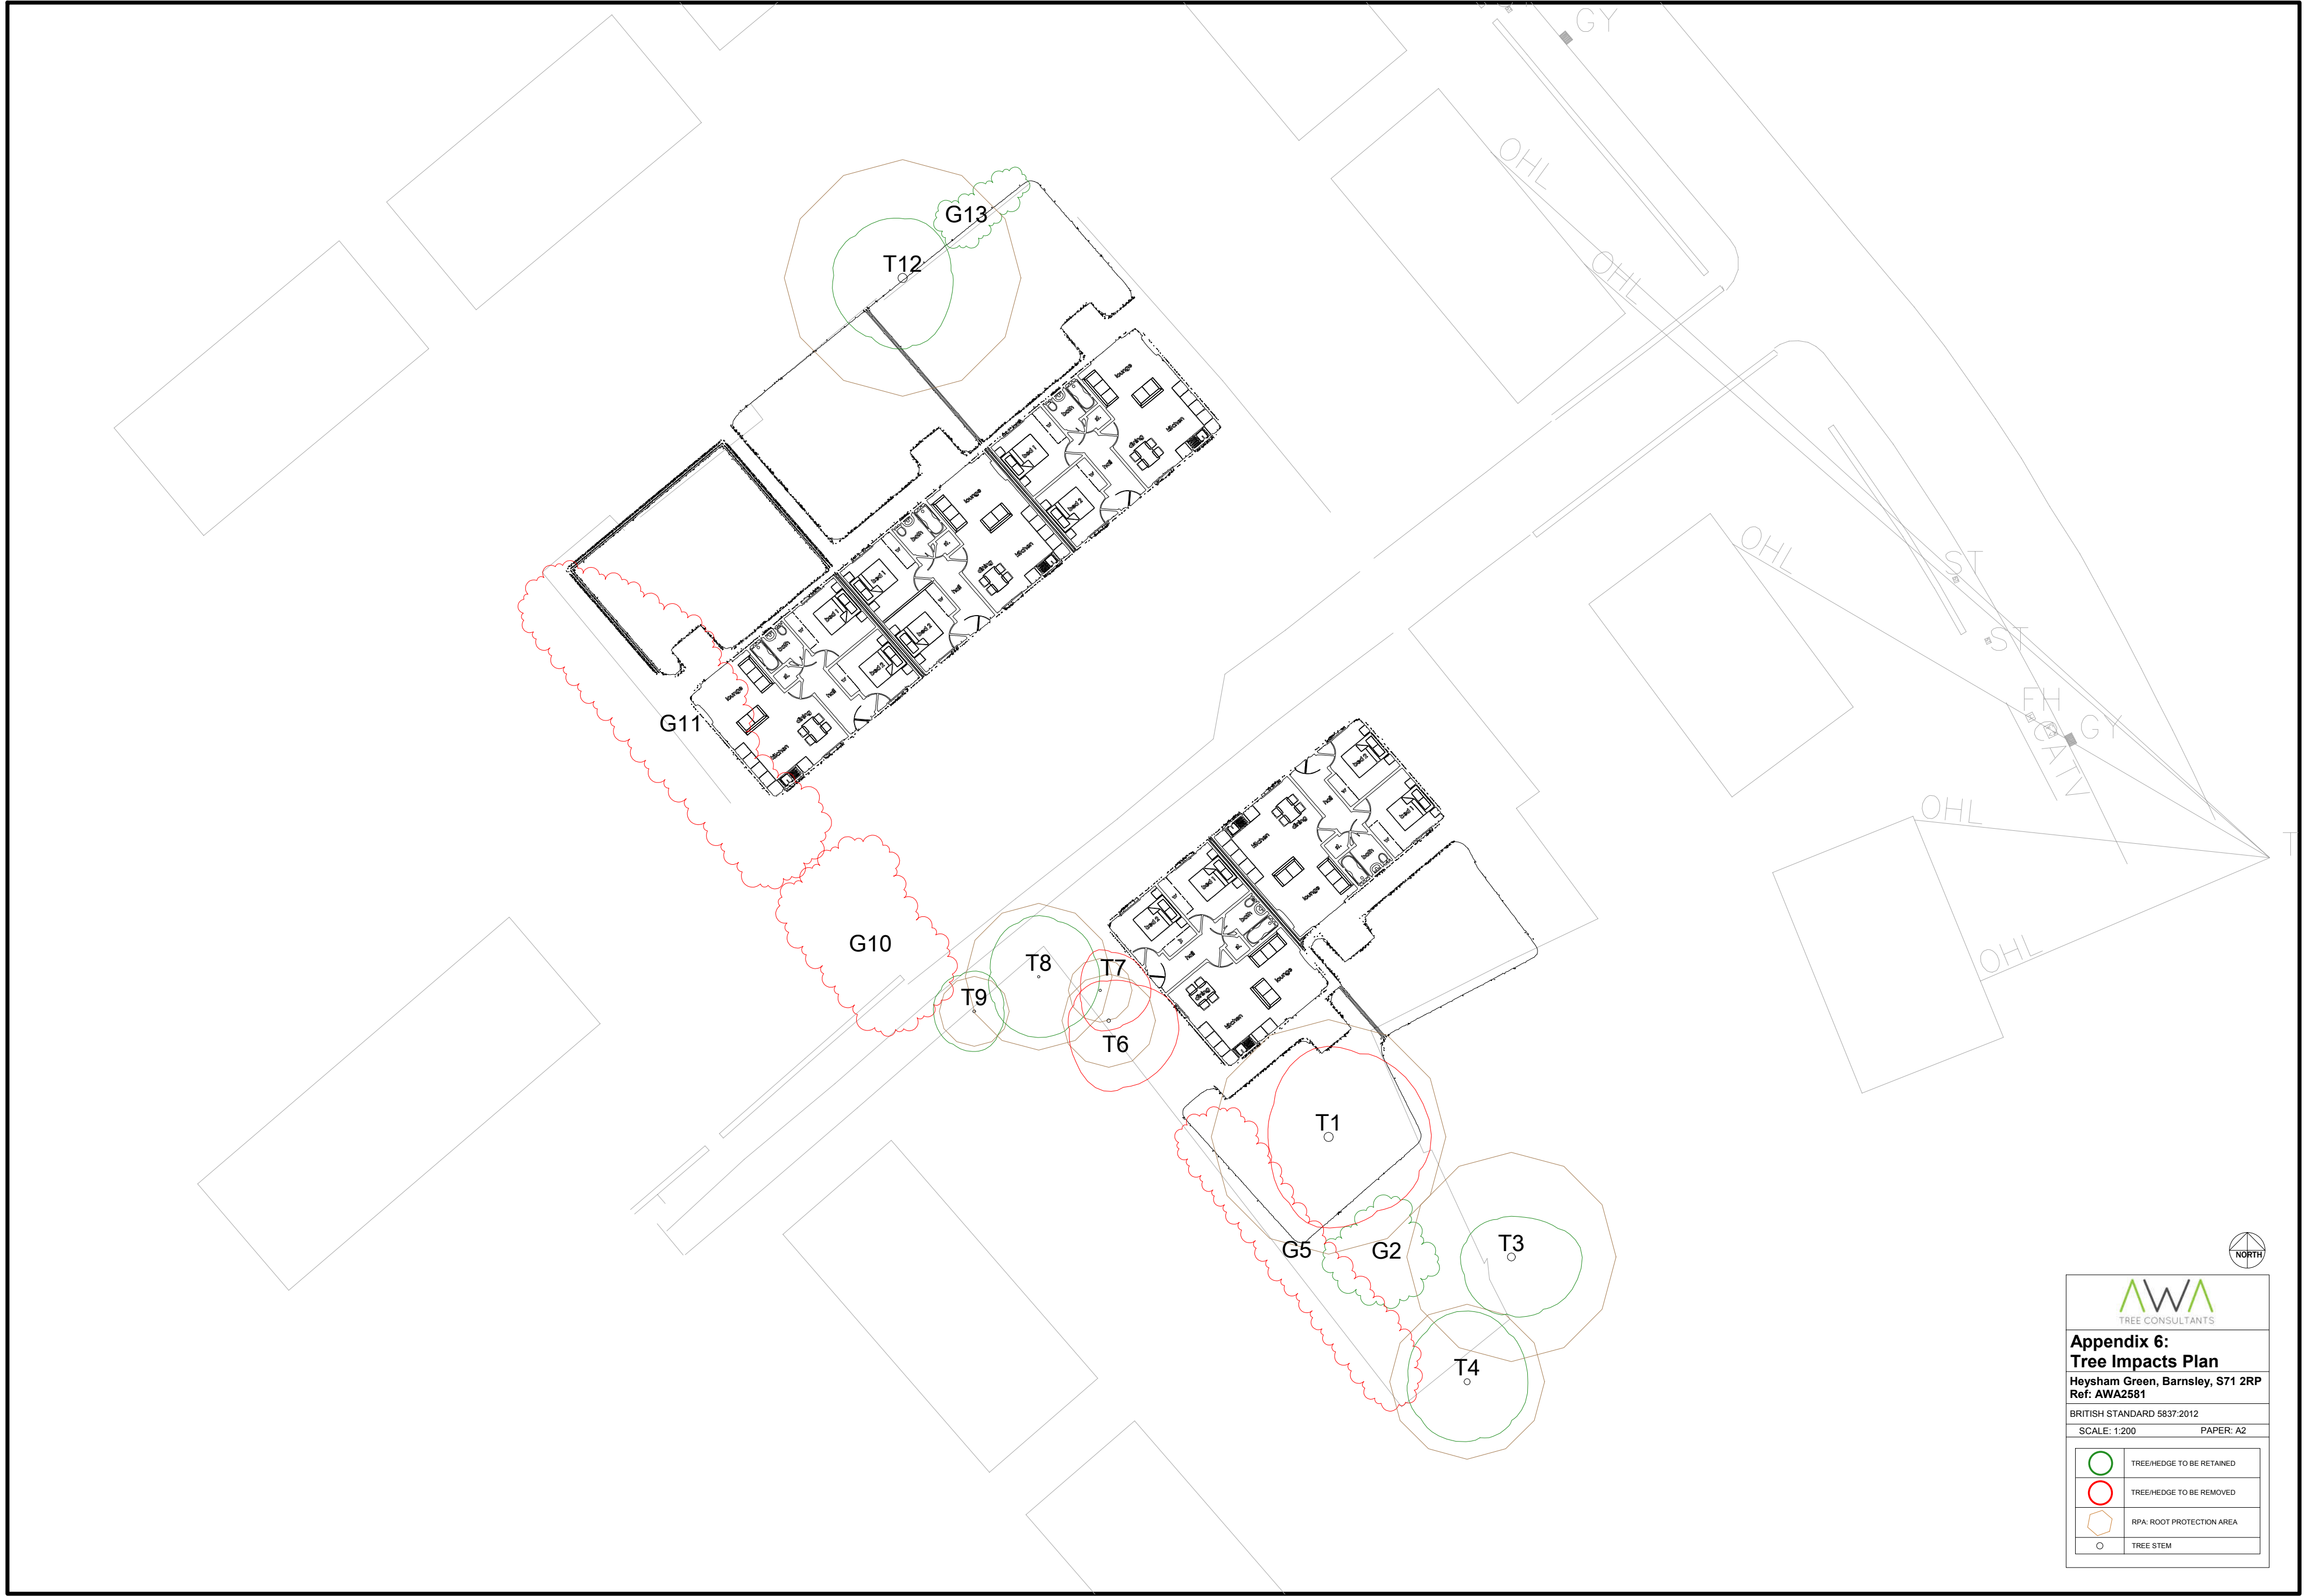
**Appendix 6:**  
**Tree Impacts Plan**  
Heysham Green, Barnsley, S71 2RP  
Ref: AWA2581

- 4.2.1 From assessing the new development proposals, 3 trees and 3 hedge groups will require removal as they are situated in the footprint of the structure or their retention and protection throughout the development is not suitable.
- 4.2.2 The trees and hedges that require removal are T1, G5, T6, T7, G10 and G11.
- 4.2.3 The trees that require removal are all lower value, retention category 'C'. T1 is a larger Sycamore tree with significant defects and possible fire damage, G5, G10 and G11 are low value overgrown hedgerows that would require significant management works to maintain their suitability, and T6 and T7 are a group of recently established self-set Cherry trees with little value.
- 4.2.4 Due to the low value of the trees to be removed the removals will have only a negligible negative arboricultural impact.

- 4.5.1 The retained trees may require protection by fencing in accordance with BS 5837: 2012, during the development phase. The protective fencing for this site should be located to protect the RPAs of the retained trees as detailed on the attached Tree Impacts Plan at Appendix 6.

- 4.5.2 The final fencing position should be agreed on by the LPA before the commencement of any site works. The protective fencing will be appropriate to the degree and proximity of likely construction works. In this instance, it is suggested (if acceptable by the LPA) an adequate level of protection for the trees could be provided by 'Heras' type fencing, of welded mesh panels on rubber or concrete feet.

- 4.5.3 The area enclosed by the fencing is referred to as the Construction Exclusion Zone (CEZ); this area should be considered a restricted area. No pedestrians, vehicles, storage of materials, equipment or machinery should be allowed within the CEZ. The site manager must ensure that all personnel are aware of the restrictions that apply to the fenced-off area.
