**Preliminary Tree Survey  
and  
Arboricultural Impact Assessment**

**Land off New Smithy Avenue  
Thurlstone**

Report reference: R-2736-02  
January 2017

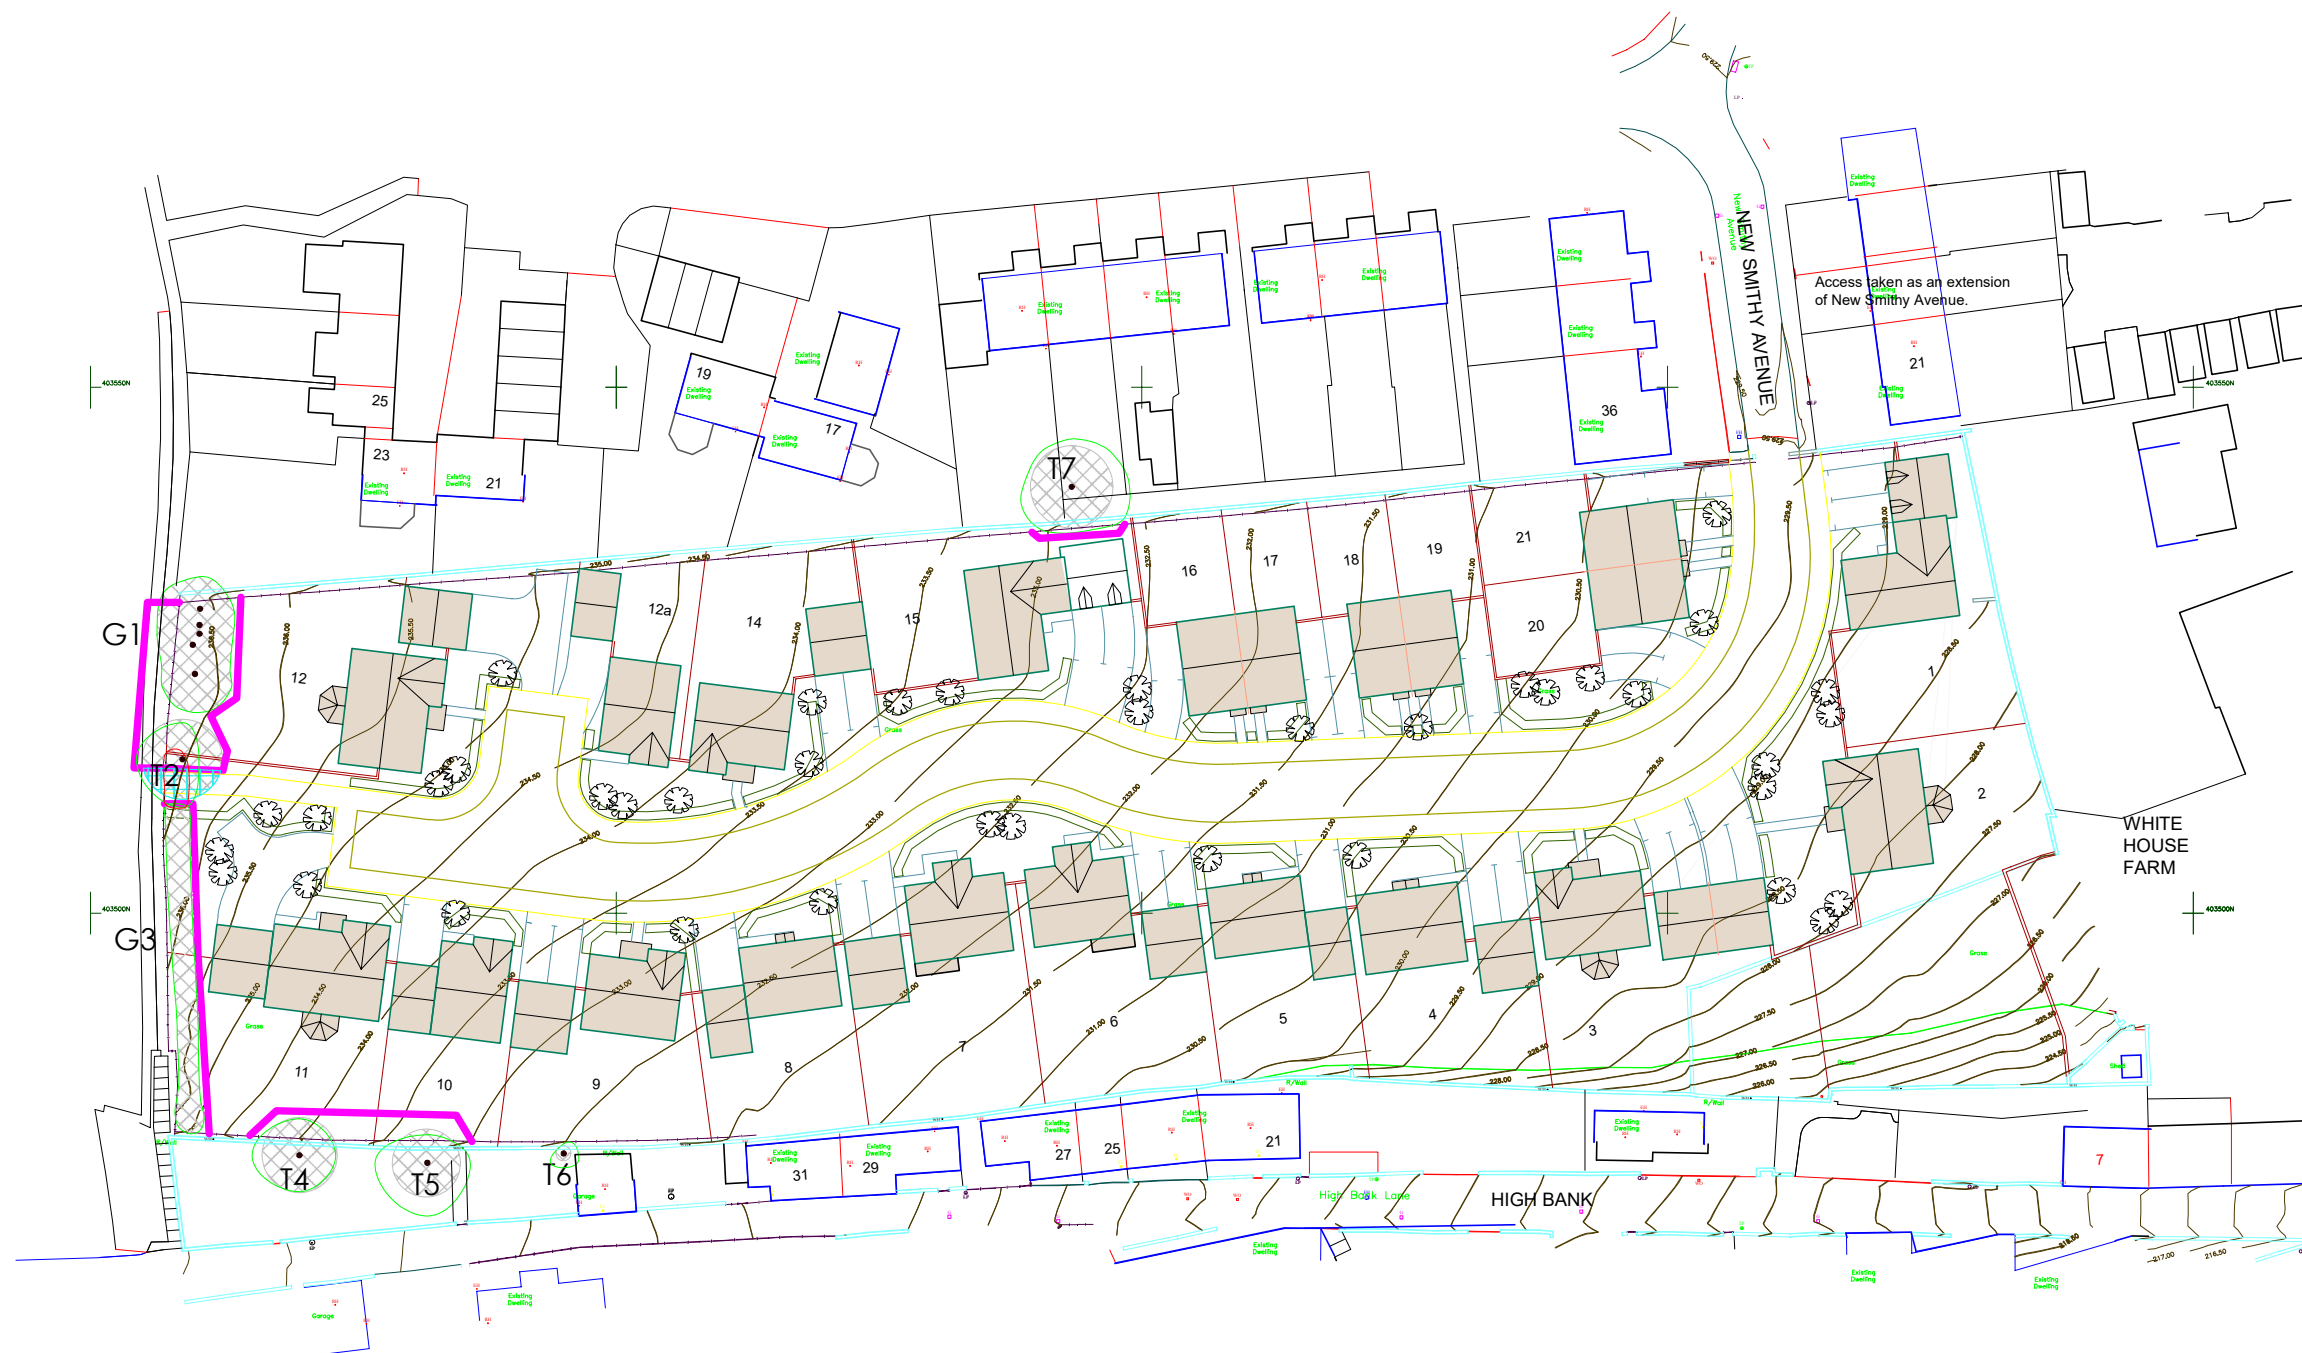
#### APPENDIX 5 - TREE PROTECTION PLAN

29. On this site, it has not been possible to protect the entire root protection area of T2 with the use of protective barriers alone. As such, robust additional ground protection will be required within this area.

30. A proposed footpath will encroach slightly into the RPA of retained tree - T2. This encroachment is deemed substantial, and the construction of a hard surface required within the root protection area requires a "no dig" construction method. The various requirements for a hard surface within the RPA are often achieved using a load suspension layer incorporating a three dimensional cellular confinement system (other systems are also occasionally used). Traditional edge supports are not recommended due to their deep foundations, the use of alternative methods of edge supports, e.g. sleepers pinned in place. The finished surface must be porous in order to allow air and water to reach the tree roots, whilst at the same time being able to withstand the load applied.
