ARBORICULTURAL REPORT & Impact Assessment to BS 5837:2012 at:

***Woodlands Lodge,
106 Hawshaw Lane,
Hoyland,
Barnsley,
S74 0HH***

Prepared for: *White Agus*

Reference: *AWA7446*

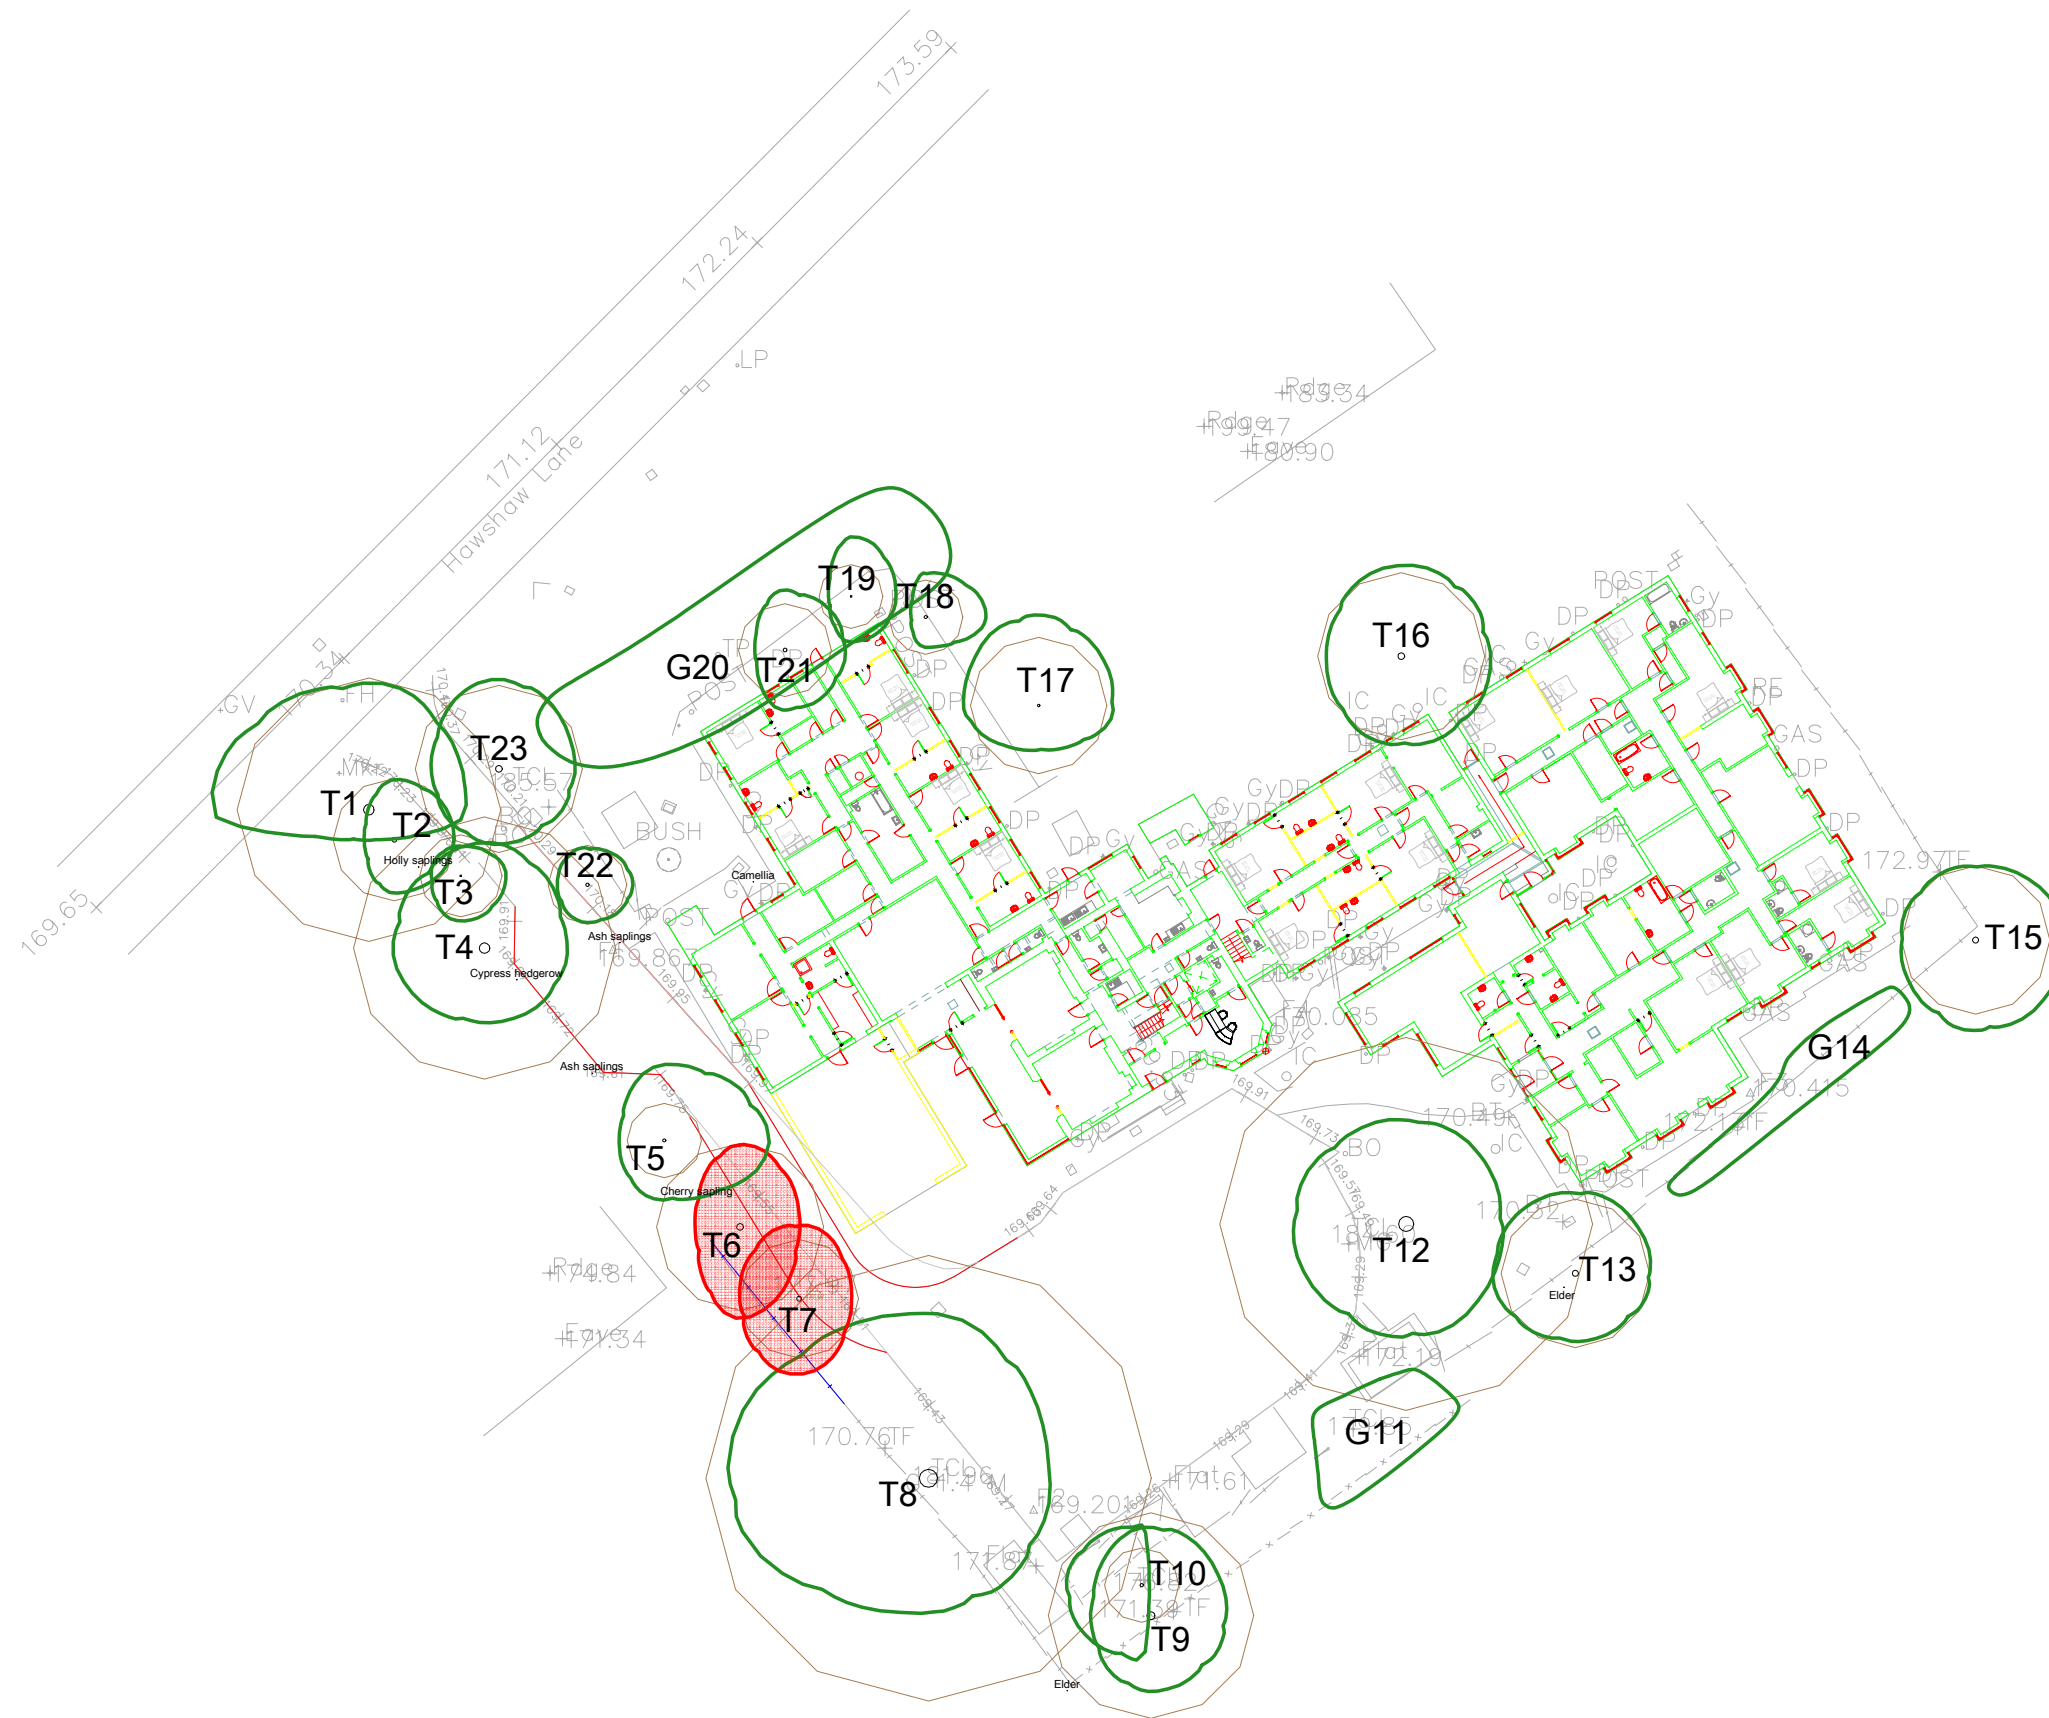
**Appendix 6:
Tree Impacts Plan**

4.2.1 From assessing the new development proposals, 1 moderate value tree and 1 low value tree will require removal to facilitate the development as it is situated in the footprint of the development. No trees will require pruning works.

4.2.2 The trees that require removal to facilitate the development are T6 and T7.

4.2.3 T6 and T7 require removal to facilitate the alterations to the existing access drive. T6 is a retention category 'B' Norway Maple, and T7 is a retention category 'C' Cherry.

4.3.2 Potentially damaging activities are proposed in the vicinity of retained trees. The new hard standing and development encroaches close to and into the edge of the RPA of T5, T8, T12, T16 and T21. Construction within the RPA, can have negative impacts on tree roots. However, the encroachment is minor, and the development is generally limited to the footprint of the existing hardstanding and the existing care home. As such, it is unlikely that significant roots will be within these areas and the retained tree should remain largely unaffected by the works, provided care is taken during construction.

4.2.4 T6 could be retained if specialist 'no-dig' construction methodology was used to construct the driveway.

- 4.5.2 The primary method of protection will be the installation of tree protection fencing, constructed in line with the specification shown in BS 5837:2012.
