ARBORICULTURAL REPORT & Impact Assessment to BS 5837:2012 at:

***Stairfoot Roundabout - Area A,
Stairfoot,
Barnsley,
S71 5DS***

Prepared for: ***Barnsley Metropolitan Borough Council***

Reference: *AWA7181*

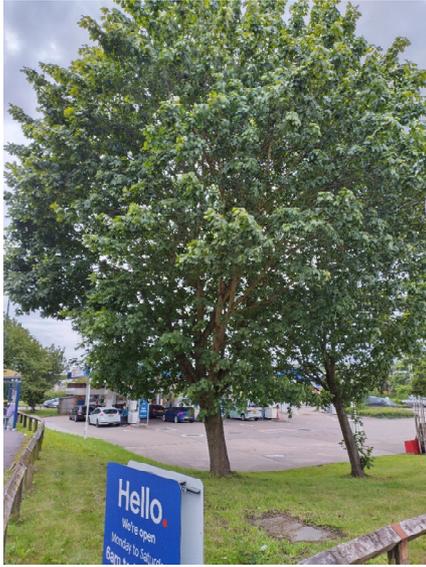
Photo 1: T6 from north.

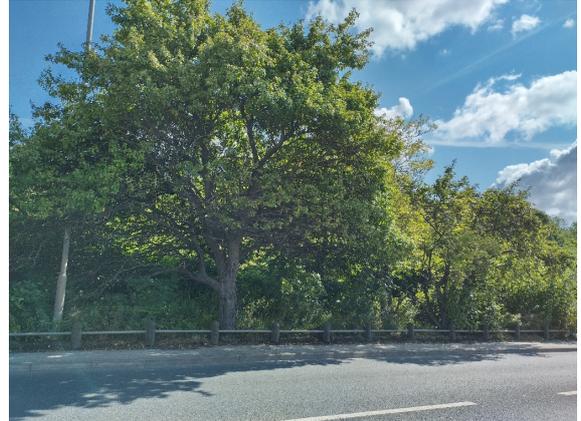
Photo 2: T21 from west.

T21	Apple	<i>Malus domestica</i>	Mature	7	1	480	No	1.5	4.5	4.5	4	4	No visual defects	Single stemmed. Epicormic growths. Old pruning wounds. Stubs. Tight union. Partially included bark. Minor cavities. Minor decay	Minor dieback. Moderate deadwood	Road and pavement to southwest. Crown raised over road. Lower crown over pavement mostly dead.	Fair	Fair	20 to 40 yrs	Moderate	C	No works required
G22	Elder, Apple	<i>Sambucus nigra, Malus domestica</i>	Semi-mature	5	6	150 avg	Yes	0.5	See plan				Group of Elder and Apple. Pavement 1m to southwest.				Fair	Fair	10 to 20 yrs	Low	C	No works required

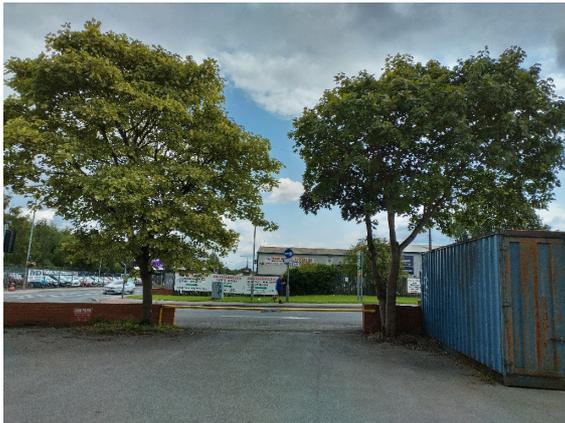
Photo 3: T41 and T42 from northwest.

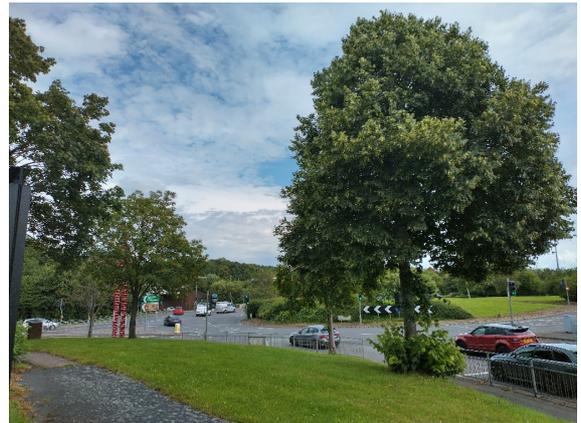
Photo 4: T45, T46 and T47 from southwest.

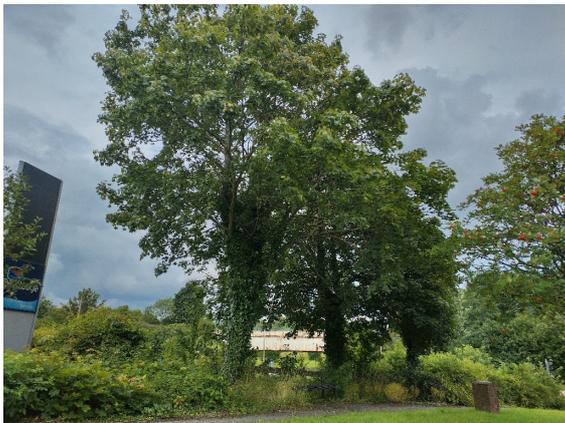
Photo 5: T49 and T50 from south.

T50	Norway Maple	<i>Acer platanoides</i>	Semi-mature	9	1	470	No	2	5	4.5	4.5	4	No visual defects	Single stemmed. Vertical. Ivy covered	Ivy covered. Minor deadwood	Overhanging pavement to south. Carpark 0.5m to north.	Good	Good	>40 yrs	Moderate	B	No works required
T51	Whitebeam	<i>Sorbus aria</i>	Early-mature	6	1	280	No	2	3	3	2.5	0.5	Limited access around base	Single stemmed. Slight lean. Ivy covered	Ivy covered	Ivy prevented detailed inspection. Slight lean to east.	Good	Fair	10 to 20 yrs	Low	C	No works required

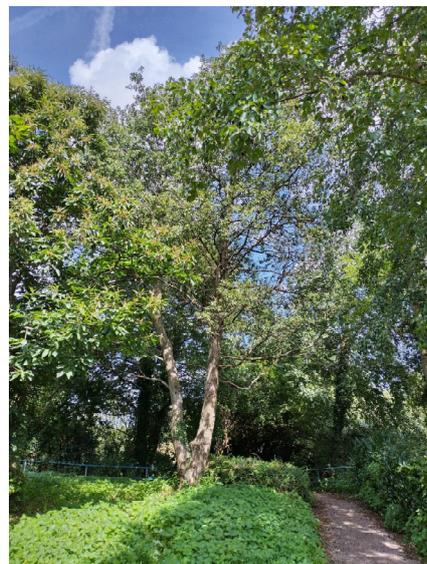
Photo 6: T71 from south.

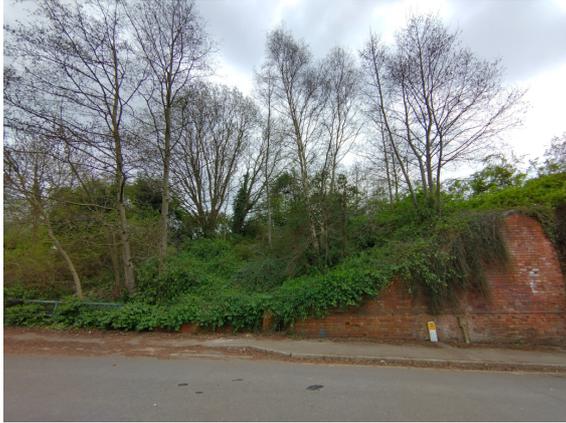
Photo 1: Northern edge of G78 from north.

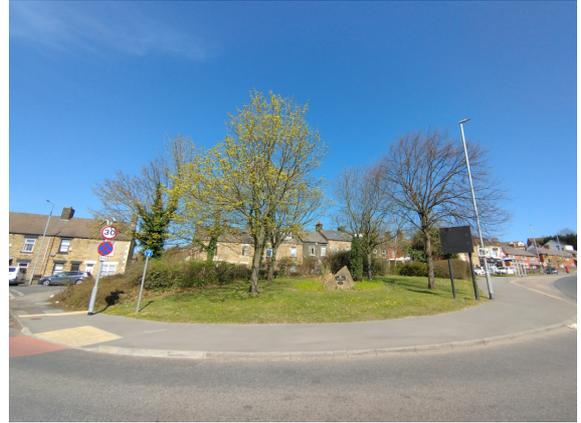
Photo 2: T153 to T156 from west.

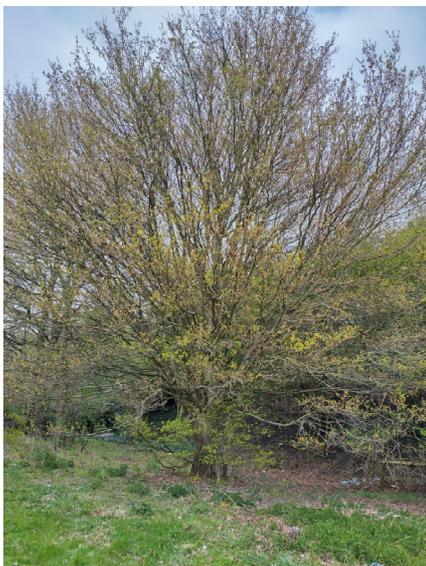
Photo 3: T226 from south

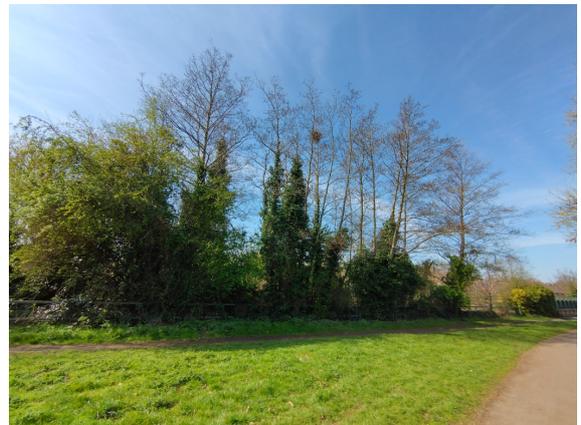
Photo 4: G77 from southeast.

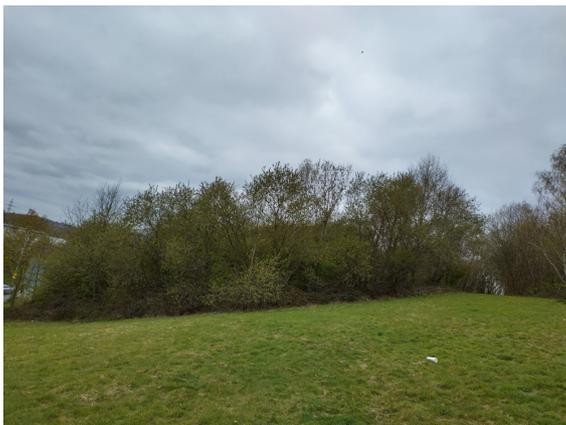
Photo 5: G247 from south.

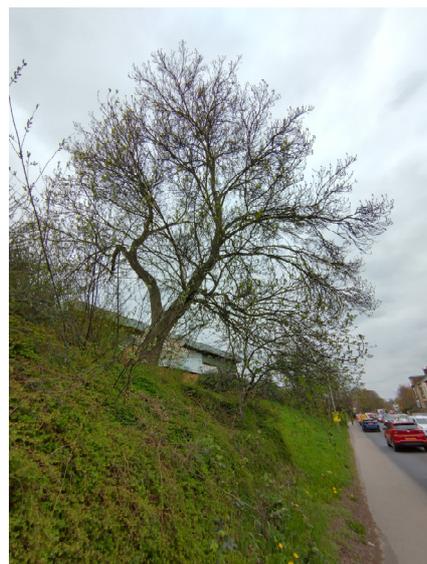
Photo 6: T242 from south.
