## **DESIGN & ACCESS STATEMENT**

**OAKS FARM, OAKS WOOD DRIVE  
DARTON, BARNSELY**

Chris Carr Associates  
6a Eastgate  
BARNSELY  
S70 2EP

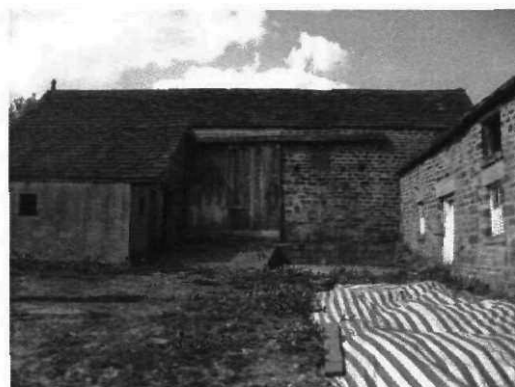
Barn A to the north is seventeenth century Grade II Listed with a later nineteenth century engine house addition to the rear. It includes relatively recent flat roof brick and block additions which detract from its appearance. There is a small, single storey building attached at the south western corner which is worthy of retention historically but is in poor structural condition.

Fig 3 South elevation – Barn A

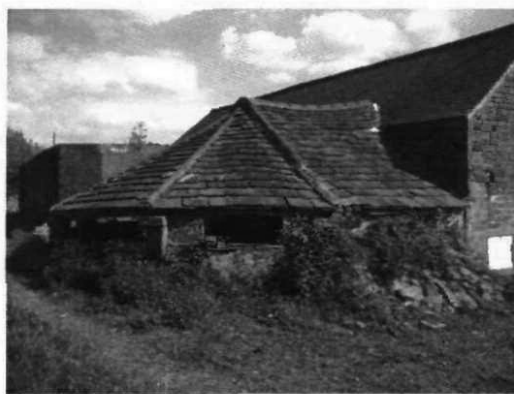
Fig 5 Engine House

To the rear (north) is a single storey later extension referred to as "the engine house". Constructed originally of monolithic stone piers, it forms a four sided, semi-octagonal structure supporting a timber roof structure with a single queen post truss and radiating hip rafters with purlins. The roof is of stone slates. The principal truss is of large span and shows signs of deflection.

Some attempt to reduce the span and overcome the rot at the bearing ends has been made by the addition of brick piers at both bearing ends of the truss. Rot has occurred within the ends of the timber purlins and to the wall plate. The roof structure will require significant repair/replacement of structural members and it would be advisable to consider introducing mid-point support to the principal truss. The monolithic capped stone columns will need to be re-set. Some have been damaged or badly weathered and need to be replaced. It is anticipated that the later addition of infill brickwork between the piers has helped to stabilise the building and a greater degree of reconstruction may be necessary following removal of the brickwork. This could involve re-setting the stone piers onto new foundations to ensure that the structure is stable.

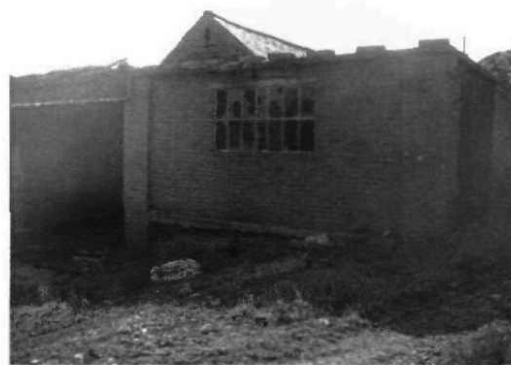
Fig 6 Brick extension to NE corner  
- Barn A

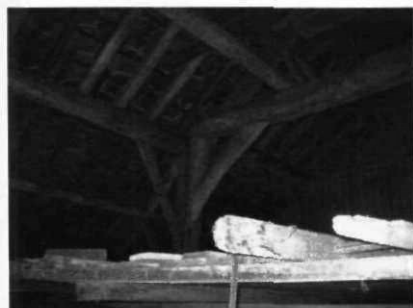
A two storey barn of regularly coursed rubble stone walling with quoins to corners, with a mix of blue slate (north) and stone slate (south) roof having "cat slide" to south elevation, and later rear engine house extension to rear. The principal barn has five equal bays sub-divided by trusses and the two bays at the west extend to form an aisle with a timber post and half truss supporting the lower roof. The ground floors are generally level and partly covered by stone flags. The roof structure is generally of oak trusses and purlins with oak wall plates supporting oak rafters as shown in Figs 13 and 14.

Fig 13 Barn A roof structure

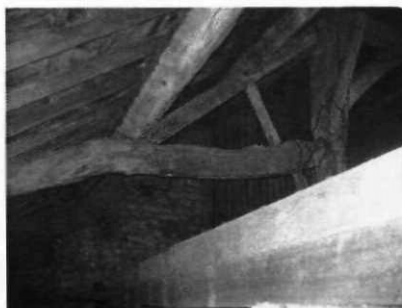
Fig 14 Half truss from timber post

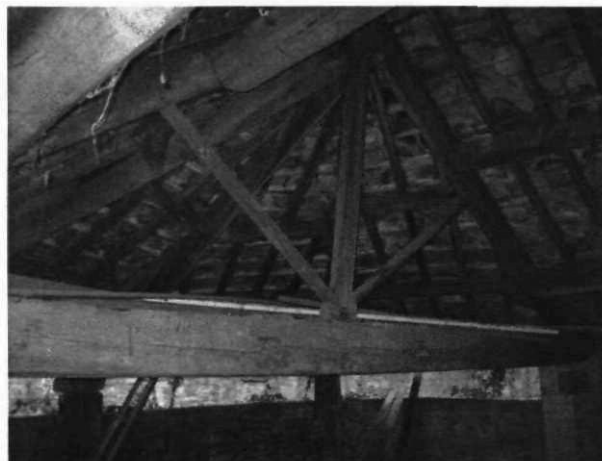
Fig 16 Internal view of roof structure to engine house

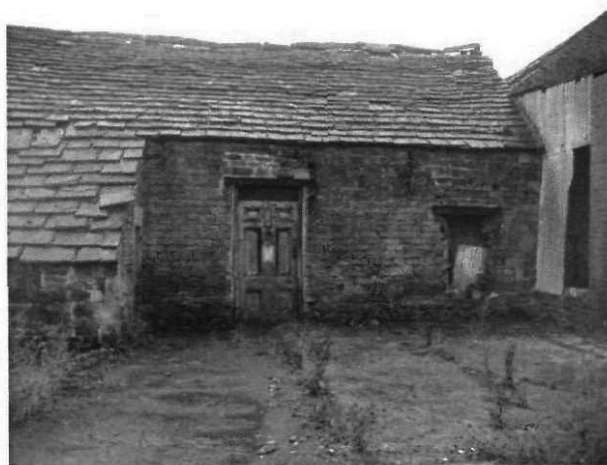
The northern end is sub-divided into three bays by two oak trusses. Some of the ridge and slates over this section of roof have slipped allowing water ingress. The most southerly of the two trusses at the north end has failed and temporary support has been provided to prop the tie beam. The most northerly truss appears to be in good condition, although some rot at the bearing ends cannot be discounted. Large sections of this truss would need to be replaced if it is to be retained or, alternatively, the timber roof purlin could be supported by a new structural wall to replace the truss. There is a first floor structure which is of sub-standard timber beams spanning east to west supporting timber joists throughout the two storey barn. There is a stone staircase supported by a half brick wall giving access to the first floor. This is in poor condition and should be removed or replaced.

Fig 17 East elevation – Barn B – north end

The external walls of Barn B are generally in good condition. There is a minor amount of partial collapse and loosening of stonework on the east elevation where an opening in the external wall has been poorly formed; see Fig 17. In addition, there is a crack and some displacement of a section of stone walling above first floor level at the north end of the west elevation. It is likely that this has been caused by the failure of the roof truss previously mentioned.

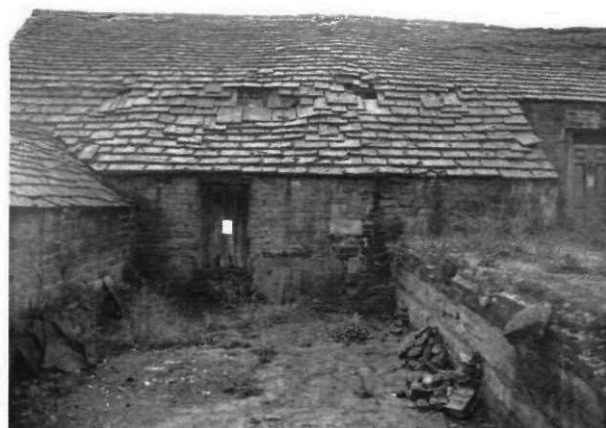
At the southern end, the two storey barn is divided into two bays by a single truss, which is in good condition. The eastern bearing end of the truss is supported onto a timber post, at which point the roof sweeps down to form the cat slide. A half truss supports the lower roof of similar design to Barn A.

Fig 18 Cat slide roof to the rear of Barn B

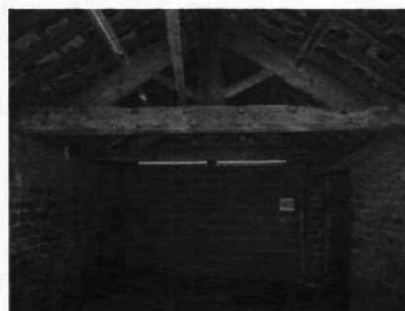
Fig 20 End truss looking east

The gable wall (east) was re-built in cavity construction (see Fig 20) when the land was released for residential development and is constructed at an oblique angle. The south elevation, as shown in Fig 21, has two large openings with sliding doors.

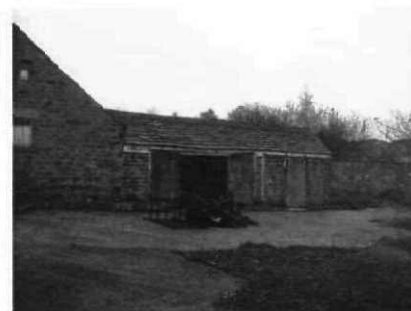
Fig 21 South elevation
