## **DESIGN & ACCESS STATEMENT**

**OAKS FARM, OAKS WOOD DRIVE  
DARTON, BARNSELEY**

Chris Carr Associates  
6a Eastgate  
BARNSELEY  
S70 2EP

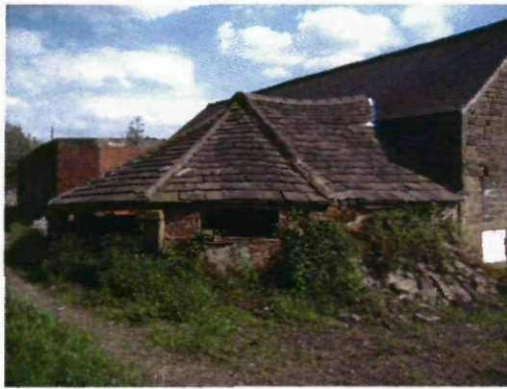
Fig 5 Engine House

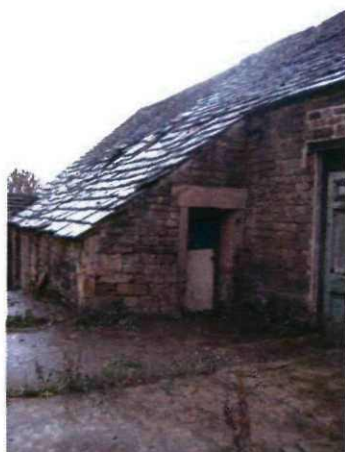
Fig 11 Rear catslide – Barn B

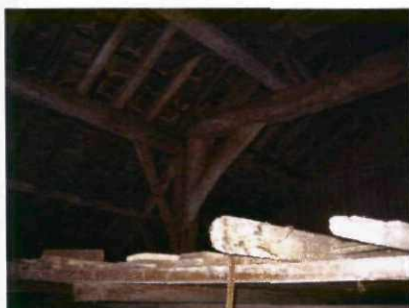
A two storey barn of regularly coursed rubble stone walling with quoins to corners, with a mix of blue slate (north) and stone slate (south) roof having "cat slide" to south elevation, and later rear engine house extension to rear. The principal barn has five equal bays sub-divided by trusses and the two bays at the west extend to form an aisle with a timber post and half truss supporting the lower roof. The ground floors are generally level and partly covered by stone flags. The roof structure is generally of oak trusses and purlins with oak wall plates supporting oak rafters as shown in Figs 13 and 14.

Fig 13 Barn A roof structure

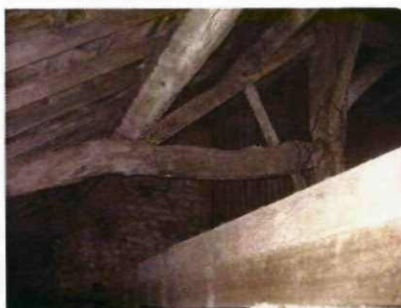
Fig 14 Half truss from timber post

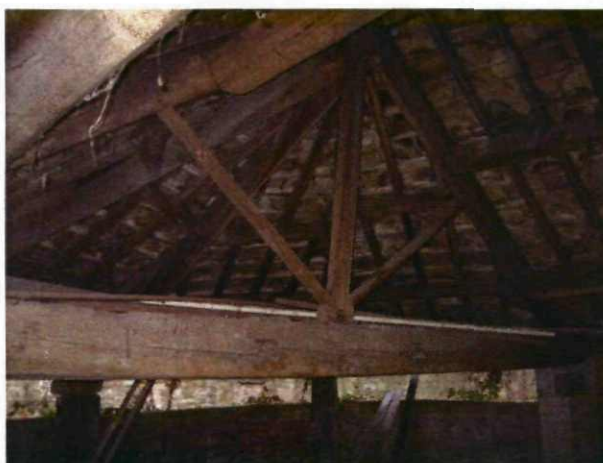
To the rear (north) is a single storey later extension referred to as "the engine house". Constructed originally of monolithic stone piers, it forms a four sided, semi-octagonal structure supporting a timber roof structure with a single queen post truss and radiating hip rafters with purlins. The roof is of stone slates. The principal truss is of large span and shows signs of deflection.

Fig 16 Internal view of roof structure to engine house

Some attempt to reduce the span and overcome the rot at the bearing ends has been made by the addition of brick piers at both bearing ends of the truss. Rot has occurred within the ends of the timber purlins and to the wall plate. The roof structure will require significant repair/replacement of structural members and it would be advisable to consider introducing mid-point support to the principal truss. The monolithic capped stone columns will need to be re-set. Some have been damaged or badly weathered and need to be replaced. It is anticipated that the later addition of infill brickwork between the piers has helped to stabilise the building and a greater degree of reconstruction may be necessary following removal of the brickwork. This could involve re-setting the stone piers onto new foundations to ensure that the structure is stable.

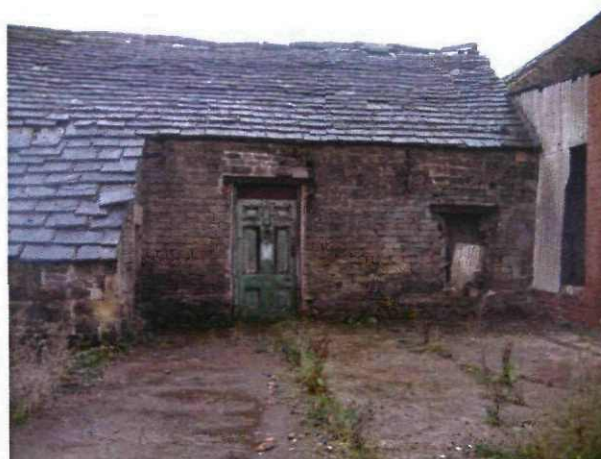
The northern end is sub-divided into three bays by two oak trusses. Some of the ridge and slates over this section of roof have slipped allowing water ingress. The most southerly of the two trusses at the north end has failed and temporary support has been provided to prop the tie beam. The most northerly truss appears to be in good condition, although some rot at the bearing ends cannot be discounted. Large sections of this truss would need to be replaced if it is to be retained or, alternatively, the timber roof purlin could be supported by a new structural wall to replace the truss. There is a first floor structure which is of sub-standard timber beams spanning east to west supporting timber joists throughout the two storey barn. There is a stone staircase supported by a half brick wall giving access to the first floor. This is in poor condition and should be removed or replaced.

Fig 17 East elevation – Barn B – north end

The external walls of Barn B are generally in good condition. There is a minor amount of partial collapse and loosening of stonework on the east elevation where an opening in the external wall has been poorly formed; see Fig 17. In addition, there is a crack and some displacement of a section of stone walling above first floor level at the north end of the west elevation. It is likely that this has been caused by the failure of the roof truss previously mentioned.

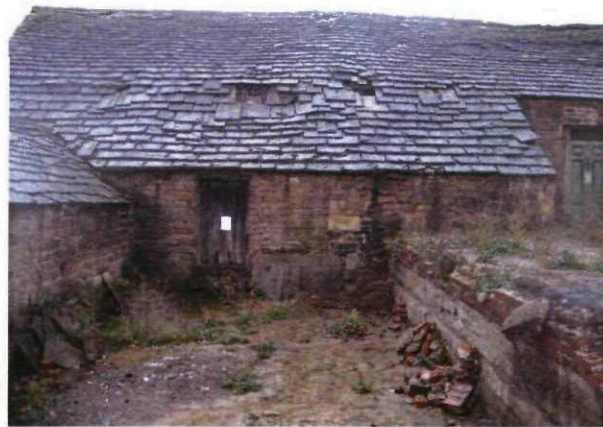
At the southern end, the two storey barn is divided into two bays by a single truss, which is in good condition. The eastern bearing end of the truss is supported onto a timber post, at which point the roof sweeps down to form the cat slide. A half truss supports the lower roof of similar design to Barn A.

Fig 18 Cat slide roof to the rear of Barn B

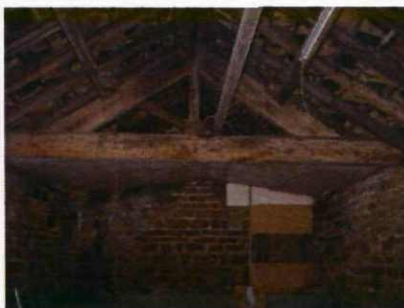
At the south eastern corner of Barn B there is a single storey wing running east with overall measurements of 12m x 5m. It is of similar rubble walling to the main barn but a later addition and sub-divided into four bays by 3 No queen post trusses. The trusses are in squared pine, some with reclaimed oak ties as shown on Figs 19 and 20.

Fig 19 End truss looking west

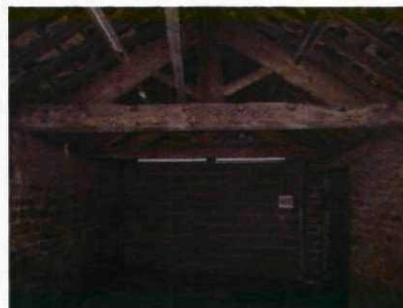
Fig 20 End truss looking east

The gable wall (east) was re-built in cavity construction (see Fig 20) when the land was released for residential development and is constructed at an oblique angle. The south elevation, as shown in Fig 21, has two large openings with sliding doors.

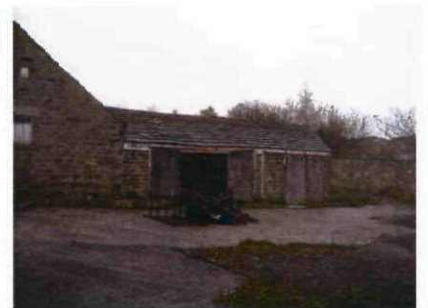
Fig 21 South elevation
