ARBORICULTURAL REPORT & Impact Assessment to BS 5837:2012 at:

***Plumpton Lodge,
Manchester Road,
Thurlstone,
Barnsley,
S36 9QW***

Report Date: *April 2025*

Reference: *AWA6560*

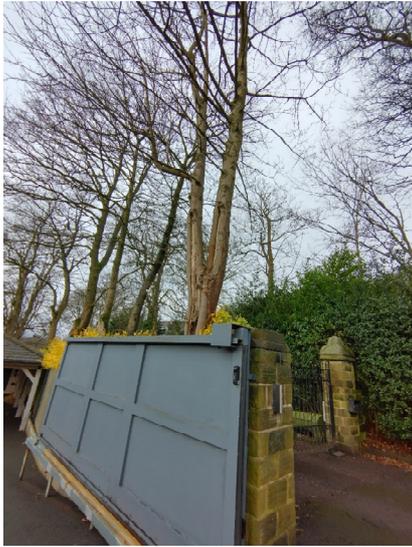
- 3.2.8 T1, G2, T3 and T4 are a row of adjacent Sycamores with moderate amenity to the north of the site boundary. All of these have suffered poor pruning practices in the past resulting in poorly healing pruning wounds with minor

cavities on the stems. T1 has a significant wound on the stem from the base to approximately 4.5m. This is occluding but there is decay within the cavity. It is likely that the long-term prospects of these trees are reduced as a result of these defects and they are retention category C.

Photo 1: T1 to T4 from east

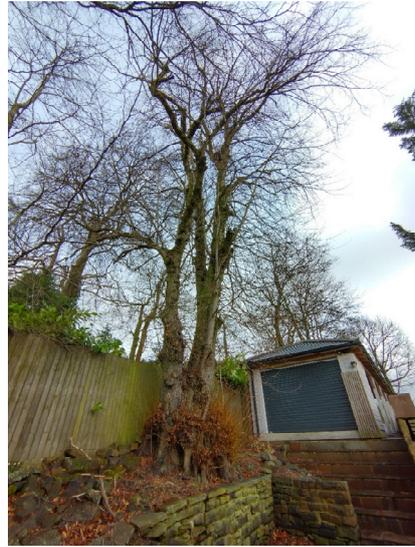
- 3.2.9 T5 is a mature Lime. It is situated on a 1m high retaining wall between the residential property and the car port. It has co-dominant stems at 1.4 m and multiple further tight unions within the crown, likely with included bark which is typical of this species. There is minor and moderate deadwood throughout the crown and on the ground around the base and it is in fair physiological and structural health. This species can grow to a very large size, and it is likely to outgrow its restricted location, limiting its long-term prospects. However, it is a prominent tree within the site, and with appropriate management will likely provide good amenity and arboricultural benefits in the medium term. It is retention category C.

Photo 2: T5 from west

4.2.7 T5 is a mature Lime. This tree has not yet reached its mature size and pruning works are recommended to reduce root growth and canopy spread due to its proximity to the proposed development. Pollarding is an appropriate form of management for this species and whilst visual amenity will be reduced in the short-term, in the long-term T5 will not be significantly impacted in terms of condition.

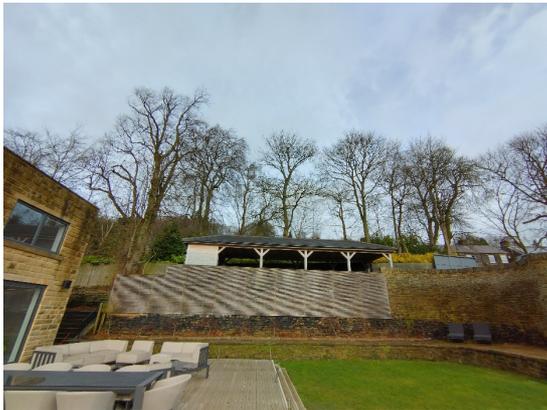
Photo 3: Northern boundary of site

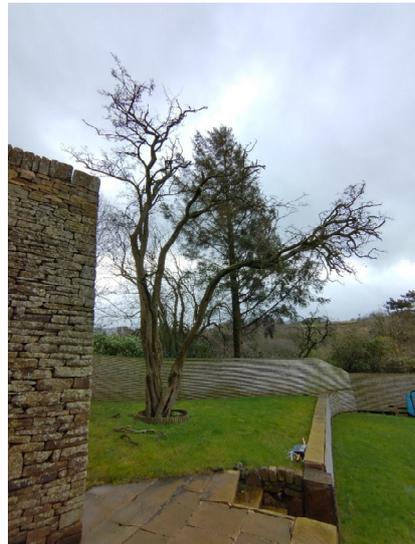
- 3.2.11 Hawthorn T11 is situated on a raised area of lawn to the east of the garden. This has co-dominant stems and the southwestern stem leans heavily over the lawn with some decayed cavities at the base. This is in decline with little live crown remaining, however it can be retained for wildlife habitat and arboricultural interest, but it is recommended that works be carried out regardless of the development in order to extend its safe life.

Photo 4: T11 from northwest

4.2.9 Hawthorn T11 has had pruning works recommended to reduce the weight and leverage on the stems in order to extend the tree's safe life expectancy.

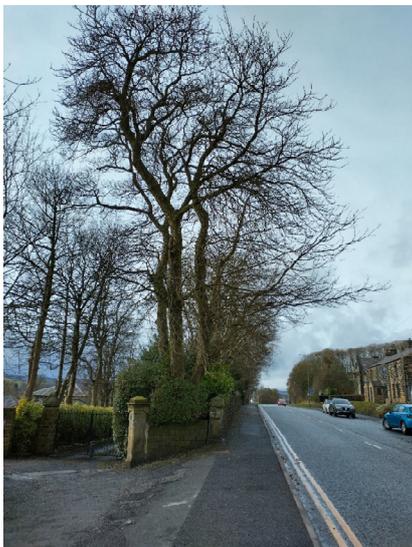
- 3.2.13 Horse Chestnut T22 is a very large adjacent tree overhanging the access drive to the site. This is in good physiological health with some minor structural defects. It is likely to be undermining the structure of the boundary wall. It has moderate amenity value with good long-term prospects and is retention category B.

Photo 5: T22 from east

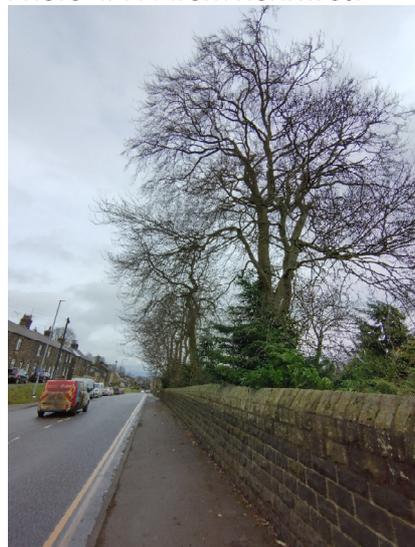
- 3.2.14 Beech T28 is also adjacent beyond the northern boundary of the site. This has high amenity value and is a prominent tree overhanging the road through the village. Access was limited so inspection was only cursory but it appears to be in good physiological and structural health and is retention

category A.

Photo 6: T28 from west
