Date: 4<sup>th</sup> April 2025  
Your ref: (S63 9LQ).  
My Ref: CMRA 00399

**COAL MINING RISK ASSESSMENT (CMRA) - FOR PROPOSED EXTENSION AT 83 HIGH STREET, GOLDTHORPE, ROTHERHAM S63 9LQ**

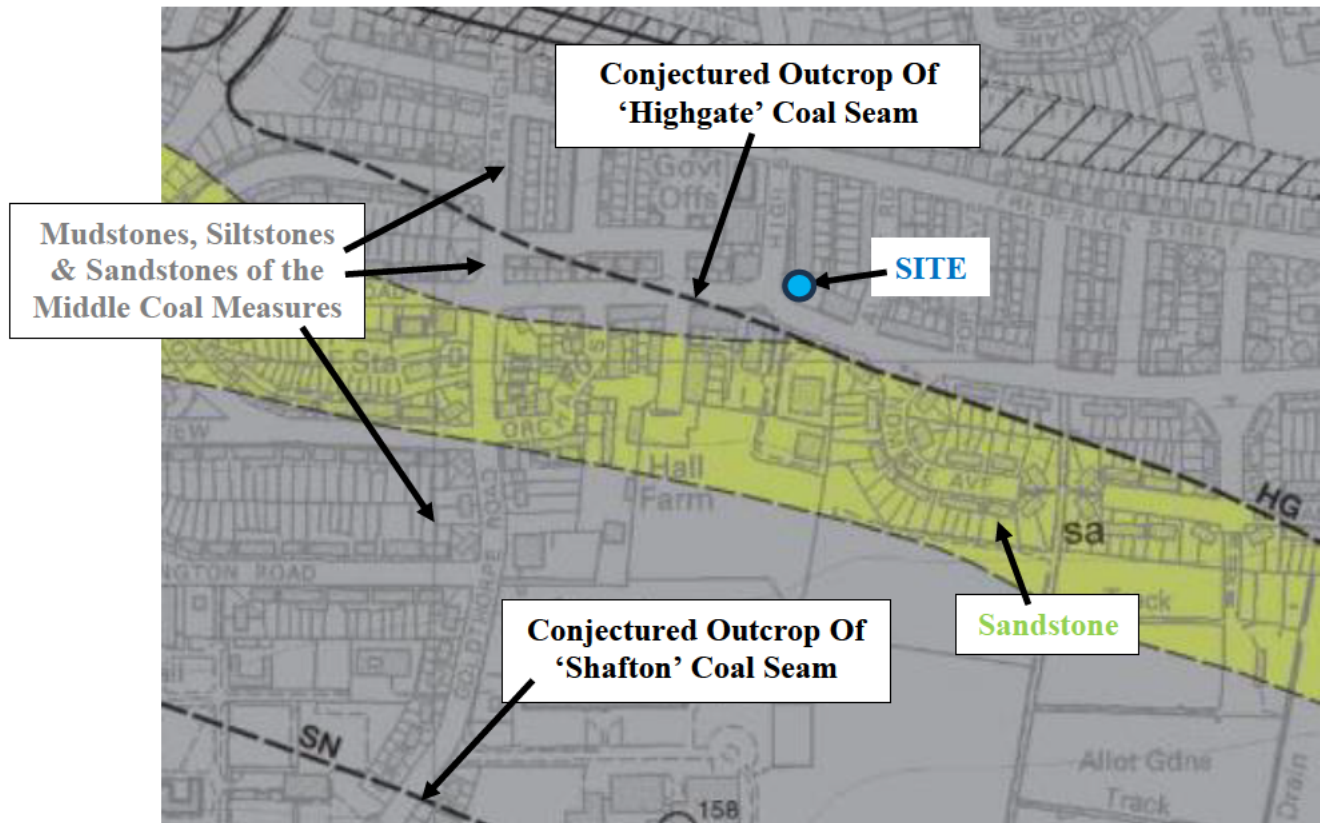
Records indicate the site to be located on mudstones, siltstones and sandstones of the Pennine Middle Coal Measure series from the Carboniferous formation. No superficial deposits are shown in the vicinity of the site. Strata is shown to dip steadily towards the north-east in this vicinity at around 1 in 12 (5°). A summary of the surface geology is illustrated on the image below which is an extract from the BGS SE40SE 2005 Edition:

As shown above, the 'Highgate' coal seam is conjectured to outcrop some 20m away to the south-west and therefore, given the lay of the land and dip of the strata, it should be present beneath the site at around 2m deep, should the conjectured detail be accurate. This coal seam is known to be circa 0.45m thick in this vicinity.

The 'Shafton' coal seam is conjectured to outcrop over 350m away to the south-west, which will dip beneath the site at around 27m deep (some 25m below the Highgate seam given nearby shaft section detail) should the conjectured detail be accurate. Local information suggests a seam thickness of the Shafton coal seam as around 1.5m.

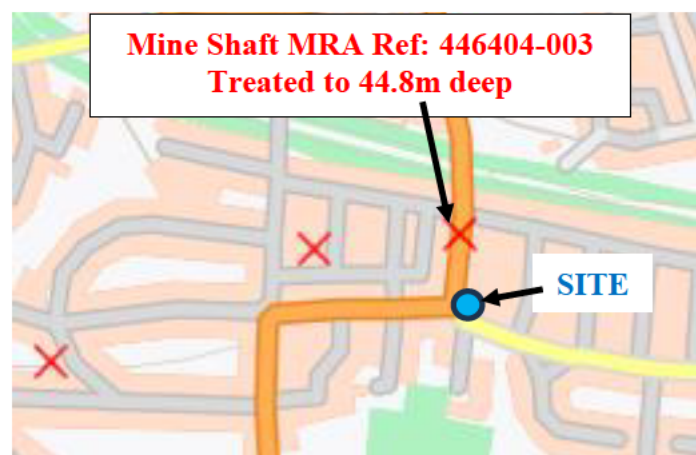
As can be seen on the following image which forms an extract from the Coal Authorities Interactive viewer, no mine entries are known within 20m of the site; the closest is recorded some 65m away to the north, which is known to have been treated to 44.8m deep. This depth is likely to be the Shafton coal seam which corresponds well with the anticipated depth beneath the site given the lay of the land and dip of the strata.

- 6) Although a low risk, watching brief should be employed during any future grounds works for any signs of unrecorded mine entries; circular areas of grey fill within natural ground/bedrock would be an indication. If suspected the Coal Authority (as owners) should be notified immediately for appropriate deliberations.
