Phase 2 Coal Mining Risk Assessment

Tower Street, Barnsley

23095-PWAG-00-XX-RP-G-7000-P01

July 2023

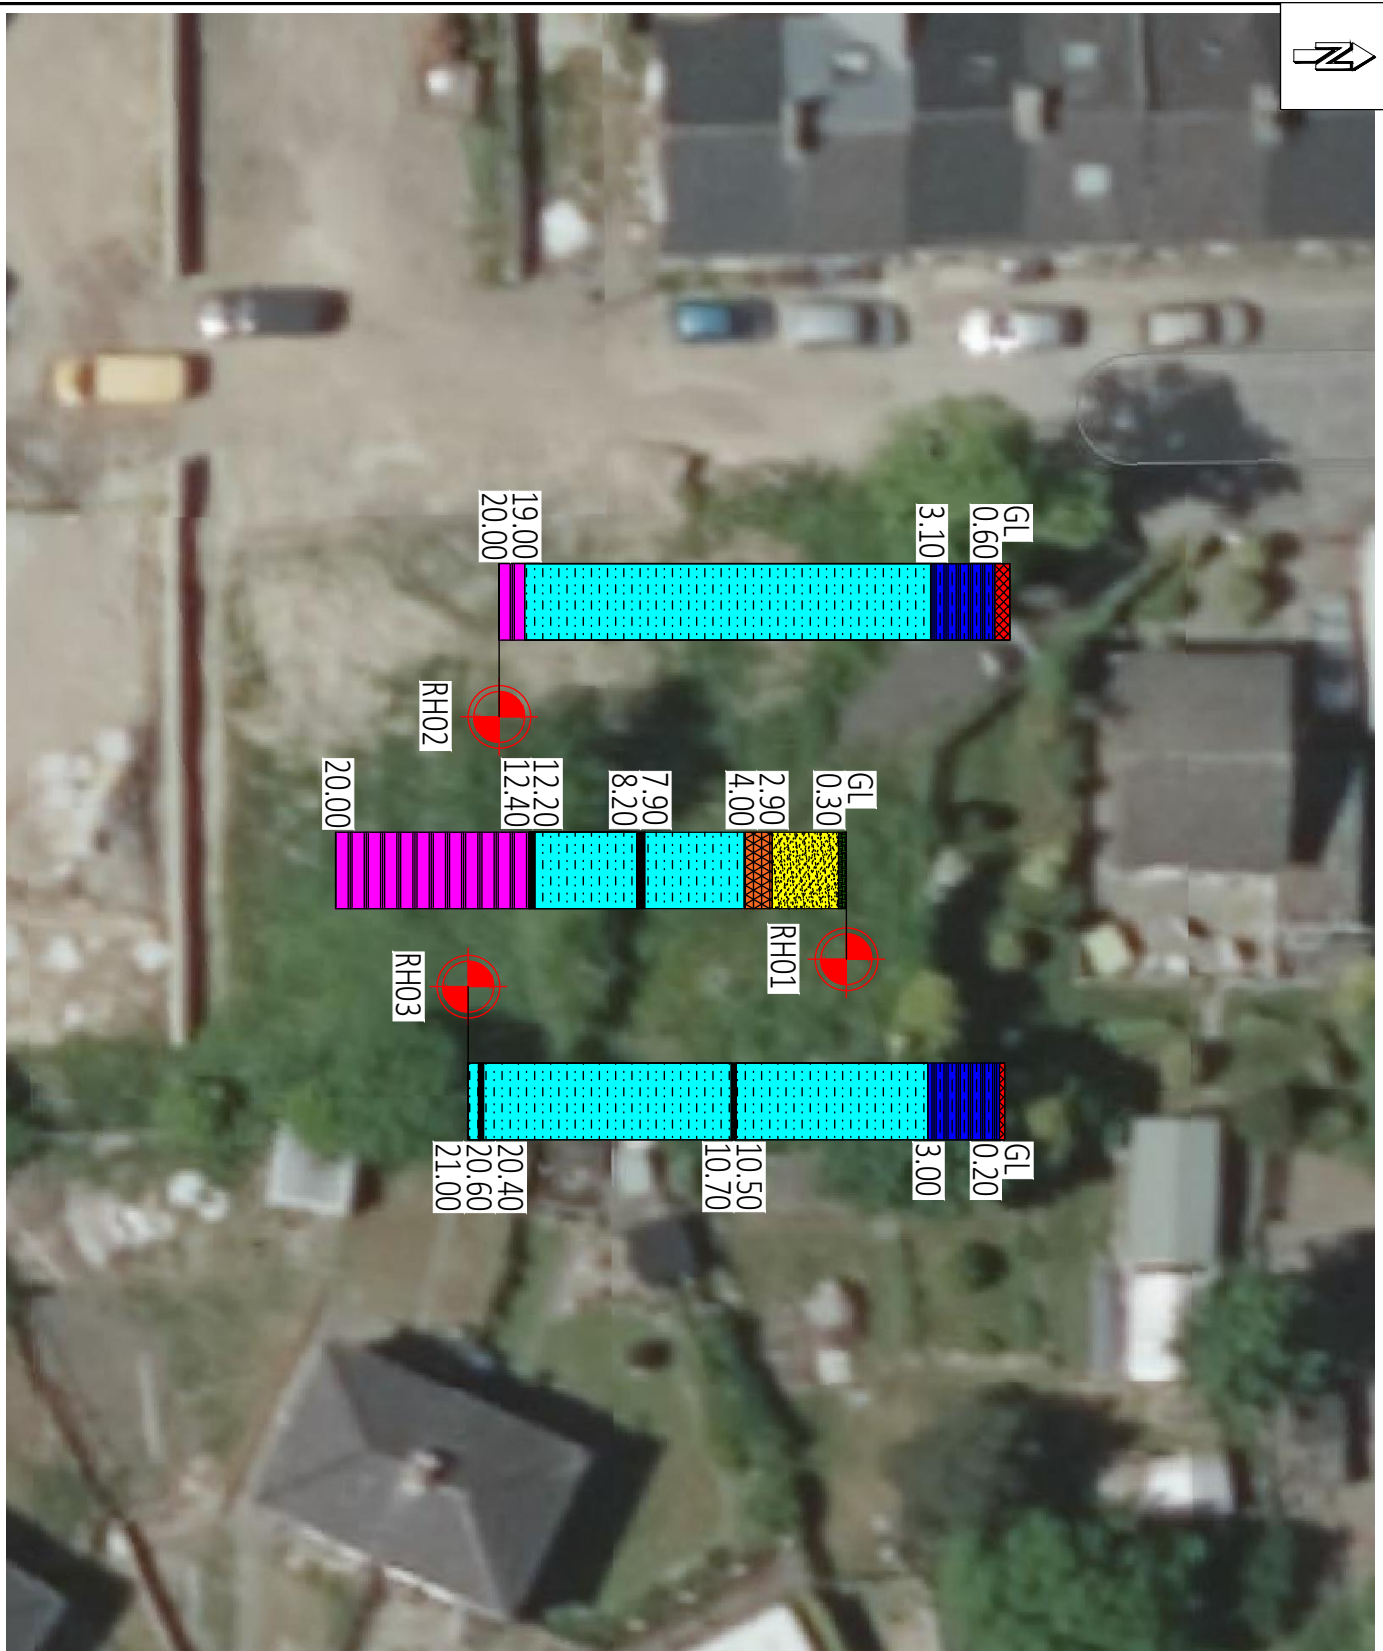
Title: GROUND MODEL
 Drawing Status: PRELIMINARY

A ground model showing coal depth is included as 23095-PWA-00-XX-DR-G-7002 P01 in **Appendix A**.

Two coal seams identified to be dipping southeast have been encountered during the investigation. Across the eastern side of site, two thin seams of coal are present at shallow depth. The first seam is between 7.90 and 10.50 m bgl, with a seam thickness of between 0.20 and 0.30 m. This could be related to the Abdy Coal. The second seam is between 12.20 and 20.4 m bgl, with a seam thickness of 0.20 m. This could be related to be the Top Beamshaw coal. Neither possible seams appear in RH02 on the western side of site. This is illustrated in the Ground Model presented as Drawing No. 23095-PWAG-00-XX-DR-G-7002-P02 in **Appendix A**.
