# Bank End Youth Club, Worsbrough

## Bat Survey Report

29<sup>th</sup> November 2022

| Document ref: MBE/BAT/2022/103/03 | | | | |

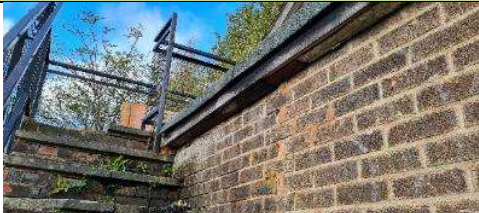
| PRF | Photo | Description |
|---|---|---|
| 1 | | Gap under fascia on single storey section. |

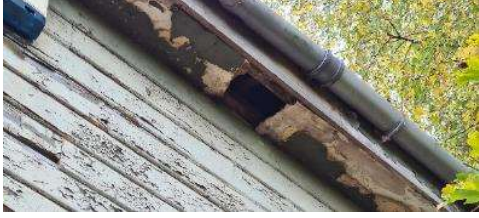
| PRF | Photo | Description |
|---|---|---|
| 2 | | Hole in underside of soffit box - indicative of squirrel damage. |

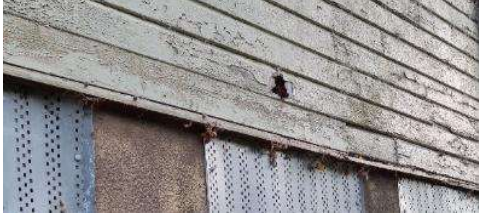
| PRF | Photo | Description |
|---|---|---|
| 3 | | Hole in cladding. |

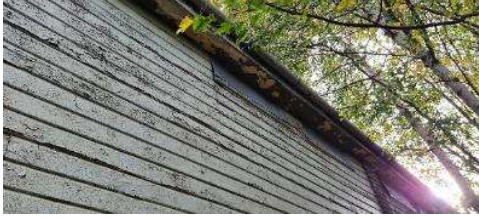
| PRF | Photo | Description |
|---|---|---|
| 4 | | Lifted boarding over window. |

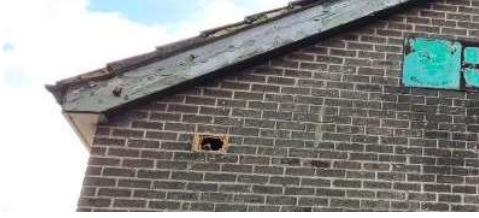
| PRF | Photo | Description |
|---|---|---|
| 5 | | broken air vents. |

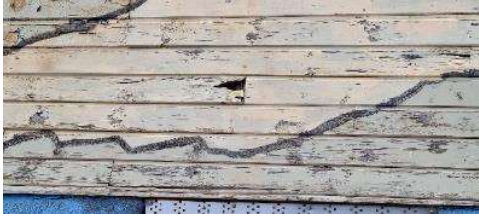
| PRF | Photo | Description |
|---|---|---|
| 6 | | gap in cladding. |

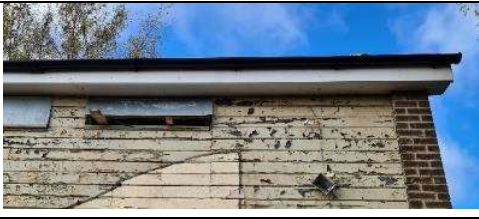
| PRF | Photo | Description |
|---|---|---|
| 8 | | Open window². |

<sup>2</sup> The window was closed and re-boarded by maintenance at the time the survey was undertaken.

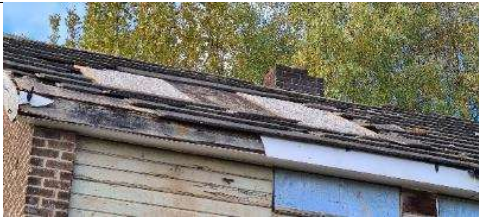
| PRF | Photo | Description |
|---|---|---|
| 11 | | Large hole in roof lots of missing tiles. Hole previously covered with Oriented Strand Board. |

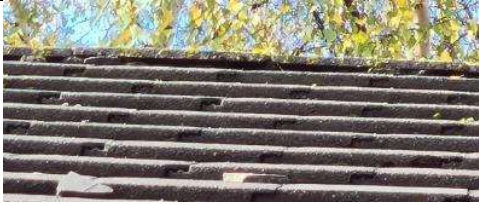
| PRF | Photo | Description |
|---|---|---|
| 12 | | Missing mortar beneath ridge tiles. |

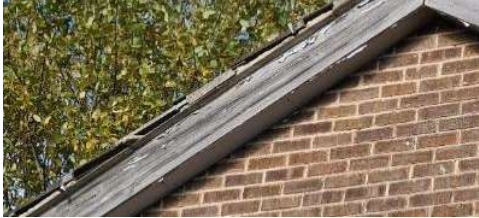
| PRF | Photo | Description |
|---|---|---|
| 13 | | Missing mortar under verge tiles. |

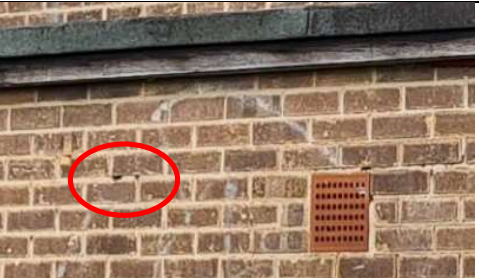
| PRF | Photo | Description |
|---|---|---|
| 14 | | Missing mortar in brickwork |

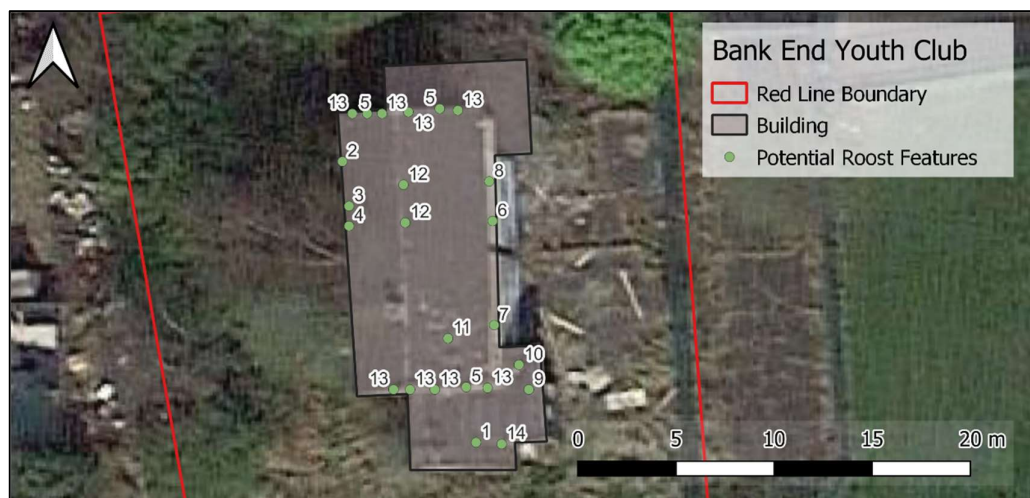
Figure 3. Location of PRFs recorded

- 5.2.3 Gaps with potential to be used by roosting bats were present around the building. They are shown in Table 3 and Figure 3 below.

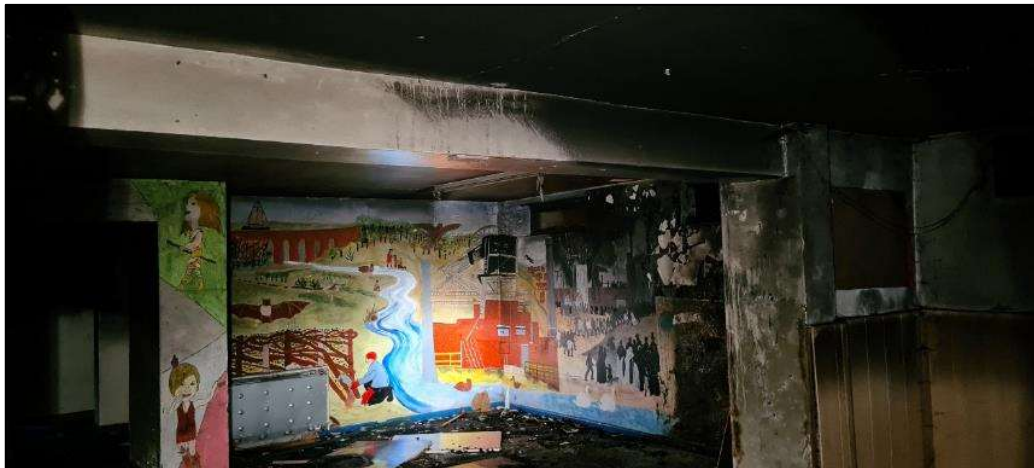
- 5.2.6 The roof void was approximately 2.5 m high. The interlocking concrete tiles were backed by Type 1F bitumen roofing felt.
- 5.2.7 The remainder of the building had been subject to heavy vandalism. Evidence of a fire was present on the ground floor (Plate 6). A burnt odour was present throughout the building and smoke damage was evident throughout – even identifiable on the cobwebs present.

**Plate 6. Fire damage on the ground floor**

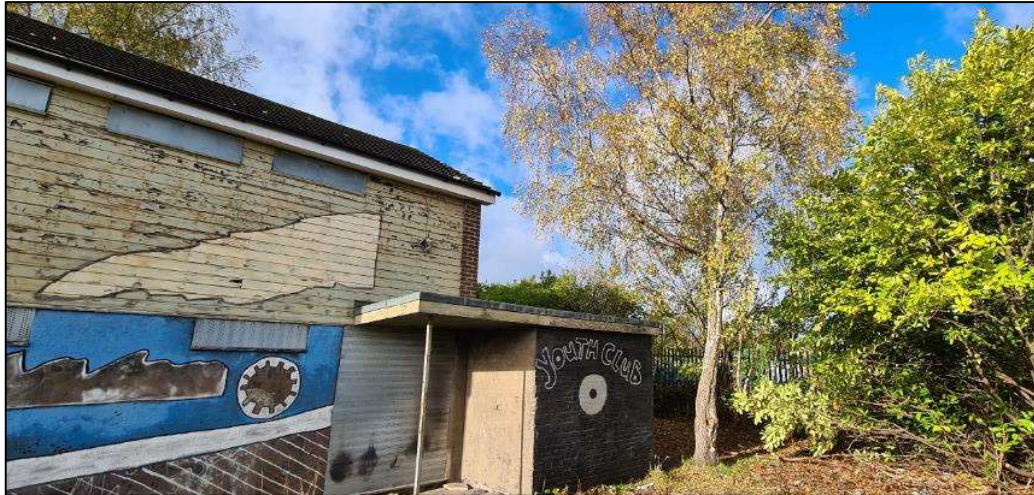
**Plate 7. Silver birch tree suitable for bat box installation**

- 6.3.1 To compensate for the loss of potential roost features it is recommended that three tree-mounted bat boxes are installed on the silver birch *Betula pendula* tree adjacent to the northern end of the site (Plate 7). The boxes should comprise three Greenwoods Ecohabitats boxes (or similar) to provide replacement crevice roosting opportunities similar to those that have been lost (Plate 8). The three boxes should all be installed on the same tree and should be located facing north, southeast and southwest to provide a natural varied range of internal temperatures. One of the boxes will be installed prior to the demolition, with consideration given to the installation of the other two afterwards to reduce the potential for damage during demolition or due to vandalism.

- 6.3.2 Greenwood's Ecohabitats boxes are relatively discrete but should be installed as high as possible (ideally at a height of more than 4.5 m) and secured to the tree at the top and bottom of the box. In order to install the bat boxes at a suitable height it's anticipated that the silver birch tree will require some pruning.
