# ARBORICULTURAL IMPACT ASSESSMENT

Land At Pear Tree Farm Brierley  
S72 9JR

16 July 2025

REF: 0514 Rev. B

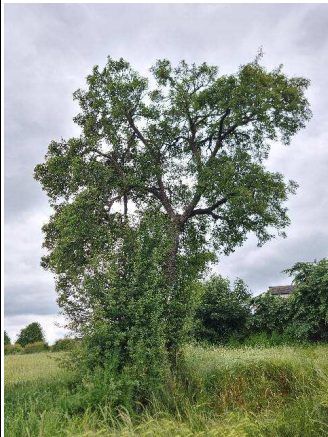
7.5m	5m	5m	3m	4m	1.8m	2m.South West.2m	Mature (M)	A mature tree situated within the field. Various broken stubs present especially on the east side at 2m. Physiological condition is good. 2 x areas of exposed wood present on the main stem on the north at 1.5m. It is likely that decay is present within the main stem in this area. The tree is surrounded by understorey vegetation which limited inspection of the main stem	No preliminary work recommended	550mm (No)	6.60	137	20-40 Years	B1

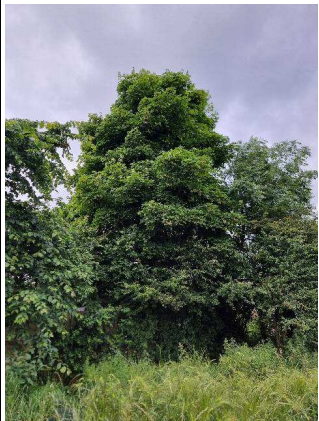
T2	SYCAMORE <i>Acer pseudoplatanus</i>

14m	5m	5m	5m	5m	4m	2.5m.South.5m	Semi-Mature (SM)	Tree is situated offsite and access was restricted to inspect. Physiological condition appears good. Tree is situated on raised ground.	No preliminary work recommended	550mm (Yes)	6.60	137	20-40 Years	B2
T3	SYCAMORE <i>Acer pseudoplatanus</i>

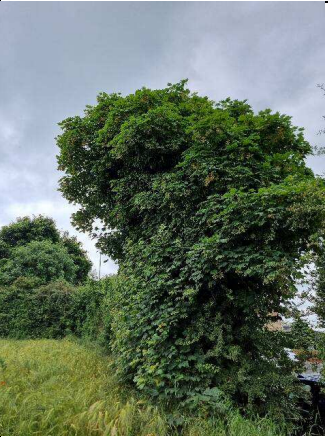
12m	3m	3.5m	4m	3.5m	0.5m	2m.South.2m	Mature (M)	Tree is situated on lower ground level than the site directly adjacent to road. It is multi stemmed below 1.5m and all are significantly ivy clad. Approximately five stems at present. The diameters were estimated. Epicormics are present around the main stem and tree is merging into hedge.	Recommendations: sever ivy and inspect unions	671mm (Yes)	8.10	204	20-40 Years	B2

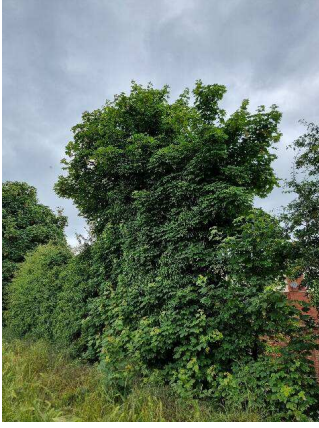
T4	SYCAMORE <i>Acer pseudoplatanus</i>

10m	3m	3m	3m	3m	0.5m	1m.South.1m	Semi-Mature (SM)	Tree is situated directly adjacent to the road within a hedgerow. It has 2 main stems joined at the base but appears to have had a break out or stem removed historically. Tree is heavily ivy clad limiting inspection. All measurements estimated. Physiological condition appears good	Recommendations: sever ivy and inspect unions	390mm (Yes)	4.80	72	10-20 Years	C2
T5	COMMON ASH <i>Fraxinus excelsior</i>

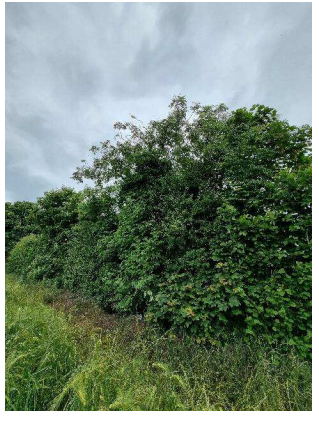
8m	3.5m	4.5m	2.5m	4m	1m	1m.South.1m	Semi-Mature (SM)	Tree is situated adjacent to the road and is situated on the edge of a banking. The tree is heavily ivy clad limiting inspection. Minor dieback is present in the crown and ivy is smothering the tree. Physiological condition is fair. recommendation sever ivy and reinspect unions.	Recommendation: sever ivy and reinspect unions	400mm (Yes)	4.80	72	10-20 Years	C2

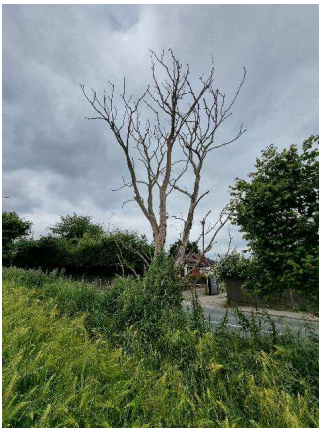
T6	UNKNOWN

10m	3m	3m	3m	3m	2m	1m.South West.2m	Dead (D)	Tree is situated directly adjacent to the road. It is dead and is leaning towards the road. recommendation remove tree	Recommendation: Remove tree	300mm ( )	3.60	41	<10 Years	U

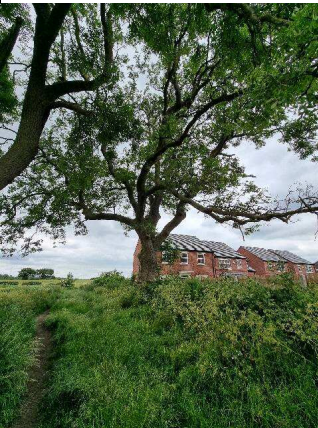
T7	COMMON ASH Fraxinus excelsior

19.2m	11m	8m	11m	11m	3.5m	5m.North.9m	Mature (M)	Tree is situated adjacent to public footpath and adjacent to offsite neighbouring properties. This is a very large mature tree. Tree has multiple pruning wounds on the east side and has been pruned away from neighbouring dwellings. Moderate deadwood is present throughout and some dieback present at the tips. This could be indicative of early Ash dieback disease. Some significant burrs are present on the main stem on all sides. Numerous cavities are present within the crown likely from old pruning wounds. Tree has high ecological value and arboricultural value due to its size and ages	No preliminary work recommended	1130mm (No)	13.50	573	40+ Years	<b>A1</b>
T8	COMMON ASH Fraxinus excelsior

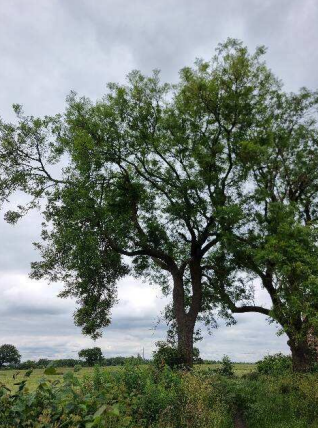
18m	6m	10m	8m	4.5m	2m	7m.North West.7m	Mature (M)	A large spreading tree situated adjacent to public footpath. A large area of exposed wood is present on the main stem on southeast side at approx 1.1m. The tree has multiple broken stubs and Inonotus hispidus fungi is present on one of the stubs on the southwest side at 6m. Physiological condition overall appears quite good. Minor deadwood and dieback is present on the north side but overall not significant. Ash dieback disease could be present however. A hanging branch is present on the west side at 6m. Inspection was limited due to understory Hawthorn surrounding the stem. Tree has high ecological value and arboricultural value due to its size and ages	No preliminary work recommended	670mm (Yes)	8.10	206	40+ Years	<b>A1</b>

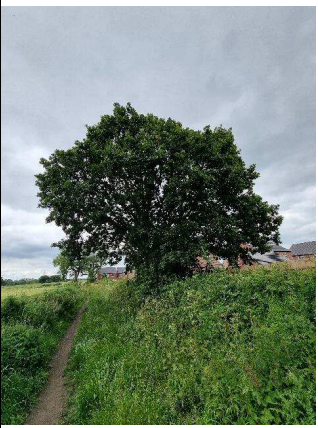
T9	PENDUNCULATE OAK Quercus robur l.

13m	7m		6m	5m	3m	2m.North East.5m	Semi-Mature (SM)	Tree is situated adjacent to the public footpath. It is surrounded by Holly and other vegetation therefore diameter was estimated. Physiological condition is good. Significant future growth can be expected of this tree. Tree has high future contribution potential.	No preliminary work recommended	500mm (Yes)	6.00	113	40+ Years	<b>A2</b>

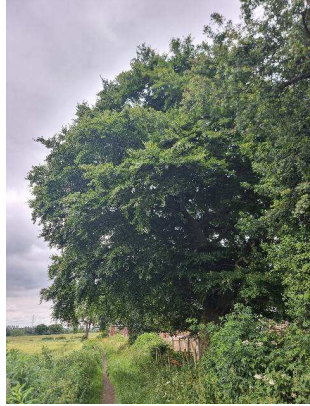
16m	11m	10m	9m	11m	2.5m	3m.North East.5m	Mature (M)	A large mature tree situated adjacent to public footpath. Numerous broken stubs are present with cavities within the crown. Physiological condition good. Tree is very prominent within the skyline of the local area and has high arboricultural value	0	1150mm (No)	13.80	598	40+ Years	A1
T11	SYCAMORE <i>Acer pseudoplatanus</i>

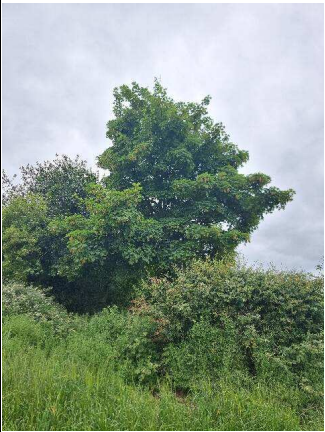
11m	3.5m	4.5m	5m	3.5m	2m	2.5m.South.4m	Semi-Mature (SM)	Tree is growing on an edge of a group of trees which are situated in the offsite church grounds. The tree is onsite. Future growth can be expected of this tree. Physiological condition is good.	No preliminary work recommended	400mm (Yes)	4.80	72	20-40 years Years	B2
T12	SYCAMORE <i>Acer pseudoplatanus</i>

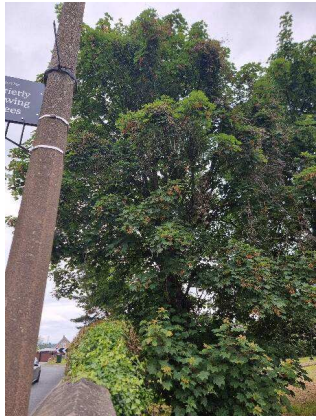
12m	5m	3m	3m	3m	3m	2.5m.North.3m	Semi-Mature (SM)	Tree is situated towards frontage of site and branches overhang main road. Physiological condition is good. Epicormics are present around base hindering inspection.Future growth can be expected of this tree.	No preliminary work recommended	450mm (Yes)	5.40	92	20-40 Years	B2

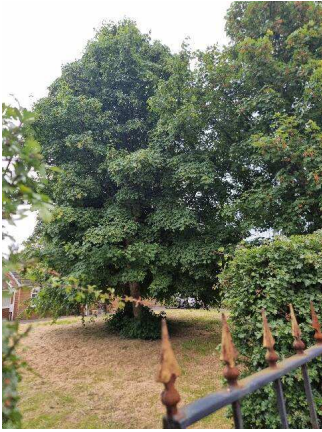
T13	SYCAMORE <i>Acer pseudoplatanus</i>

14m	5m	4m	6m	5m	2m	2.5m.West.3m	Semi-Mature (SM)	Tree is growing as part of a group of trees and is affected by group pressure. Physiological condition is good. Epicormics are present around base limiting inspection and measurement. Access was restricted to inspect tree and all measurements were estimated	No preliminary work recommended	550mm (Yes)	6.60	137	20-40 Years	B2
T14	COMMON LIME <i>Tilia x europaea</i>

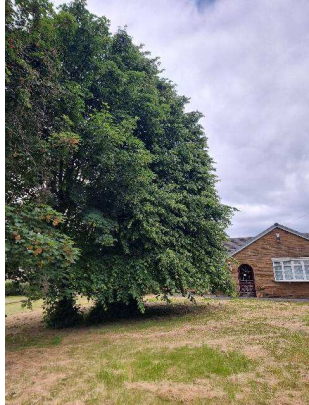
15m	5m	5m	3m	5m	0.3m	2m.North.5m	Semi-Mature (SM)	Tree is growing as part of a group of trees and is the end tree of the group. Access was restricted to inspect. Tree appears to be in good physiological condition and has good positive amenity value as part of a group	No preliminary work recommended	550mm (Yes)	6.60	137	40+ Years	A2
										End of Tree data

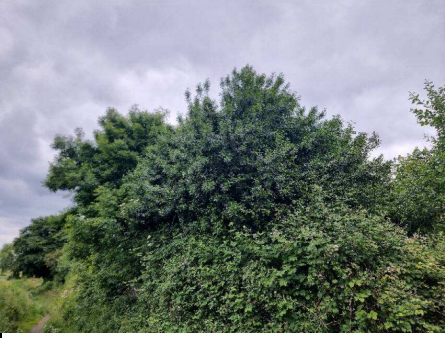
4m	11m	Semi-mature	A mixed group of offsite trees consisting of sycamore ash hawthorn. Maximum diameter 200mm. Branches overhang the public footpath and boundary by around 5m. Physiological condition appears good. Ivy appears prevalent throughout. Inspection was limited to inspect	No preliminary work recommended	200mm	1m	20-40 Years	B2
G2	A Group of offsite trees situated in neighbouring church grounds. Species consist of Cherry ( <i>Prunus avium</i> ), Ash ( <i>Fraxinus excelsior</i> ) and Sycamore ( <i>Acer pseudoplatanus</i> )

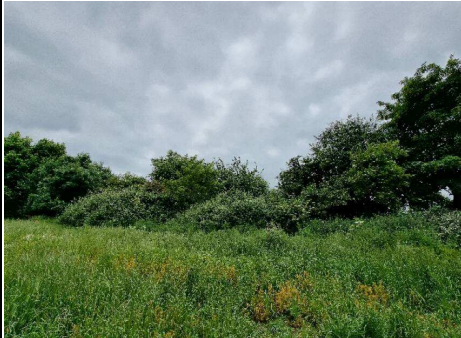
3m	14m	Semi-mature to mature	A Group of offsite trees situated in neighbouring church grounds. Species consist of Cherry ( <i>Prunus avium</i> ), Ash ( <i>Fraxinus excelsior</i> ) and Sycamore ( <i>Acer pseudoplatanus</i> ). The group borders the site and sections overhang the site. Size is variable. The maximum stem diameter was estimated as 400mm. Physiological condition appears good and groups provides good amenity and screening value within the local area.	No preliminary work recommended	400mm	1m	20-40 Years	B2

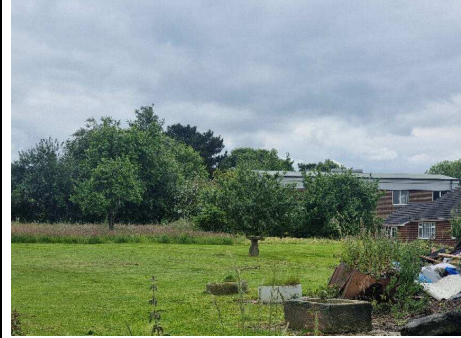
G3	A group of three Apple <i>Malus</i> spp. trees

4m	5m	Mature	A group of three trees. maximum 5. minimum height 4.average diameter 250mm. physiological condition good	No preliminary work recommended	250mm (average)	1.4m	10-20 Years	C2

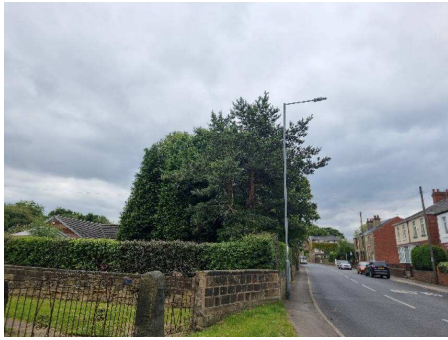
G4	A group of approximately three trees consisting of one pine and two leylandii

6.5m	7.5m	young to semi-mature	A group of approximately three trees consisting of one pine and two leylandii. Minimum height. 6.5m. maximum height 7.5m. All are relatively young. Currently, physiological condition is good. Future growth can be expected of all. diameter of pine estimated as 300mm.	No preliminary work recommended	300mm	0.3m	20-40 Years	B2	
0						End of Group Data						
0

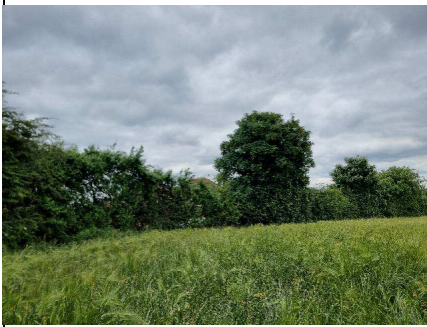
HAWTHORN <i>Crataegus monogyna</i>	70%	3m	8m	2m	Semi-mature	A hedgerow , which runs down the boundary of the field. Larger Sycamore and ash trees are present emedded within the hedge. Physiological condition good. Hedge has screening and wildlife value	No preliminary work recommended.	100mm	20-40 Years	B2
		COMMON ASH <i>Fraxinus excelsior</i>	10%									
		ELM - WYCH ELM <i>Ulmus glabra</i>	10%

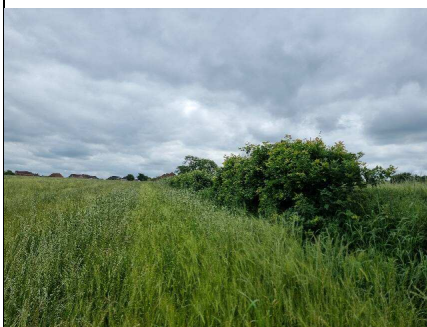
PENDUNCULATE OAK <i>Quercus robur</i> l.	30%	1.5m	2.5m	2m	Semi- mature	A hedgerow which runs through the site which appears to have been maintained historically. The hedge varies in height and consists mostly of these species . The hedgerow is broken and gaps are present in places. Hedge has screening and wildlife value	No preliminary work recommended.	150mm	10-20 Years	C2
		SYCAMORE <i>Acer pseudoplatanus</i>	40%									
		HAWTHORN <i>Crataegus monogyna</i>	30%									
		0	0									
		0	0									
H3

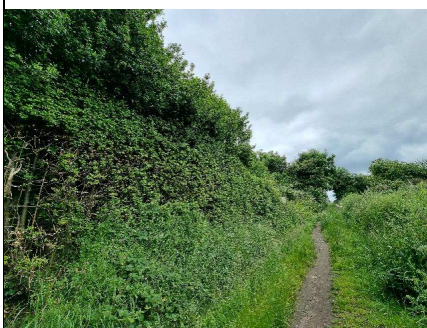
HAWTHORN <i>Crataegus monogyna</i>	50%	2m	7m	4m	Semi-mature	A broken hedgerow extending down the boundary, consisting mostly of Hawthorn Holly. Lower sections have been maintained and cut back from public footpath. Physiological condition appears generally good d	No preliminary work recommended.	90mm	20-40 Years	B2
		HOLLY <i>Ilex aquifolium</i>	50%

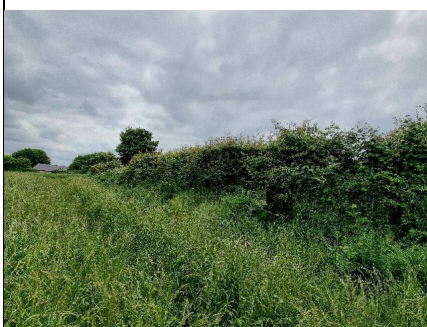
HAWTHORN <i>Crataegus monogyna</i>	0.5	1.6m	2.5m	2m	Semi- Mature	A hedgerow consisting mostly of Hawthorn and Sycamore with brambles present. Other ground vegetation also presnet. Hedge has some screening and wildlife value.	No preliminary work recommended.	90mm	20-40 Years	B2
		SYCAMORE <i>Acer pseudoplatanus</i>	0.5									
		0	0									
		0	0									
		0	0

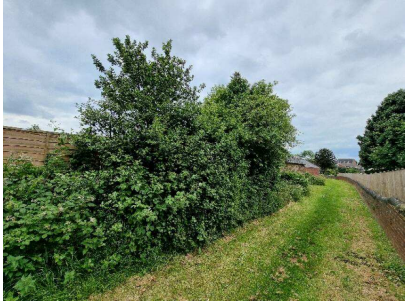
<table border="1"> <tr><td>HOLLY Ilex aquifolium</td><td>70%</td></tr> <tr><td>HAWTHORN Crataegus monogyna</td><td>20%</td></tr> <tr><td>ELDER Sambucus nigra</td><td>10%</td></tr> <tr><td>0</td><td>0</td></tr> <tr><td>0</td><td>0</td></tr> </table>	HOLLY Ilex aquifolium	70%	HAWTHORN Crataegus monogyna	20%	ELDER Sambucus nigra	10%	0	0	0	0	2.5m	5m	4m	Semi mature	A mixed hedgerow consisting mostly of Holly, extending down the boundary. Hawthorn, Elder and Brambles also present. Good physiological condition and hedge has some screening and wildlife value.	No preliminary work recommended at time of survey.	90mm	20-40 Years	B2

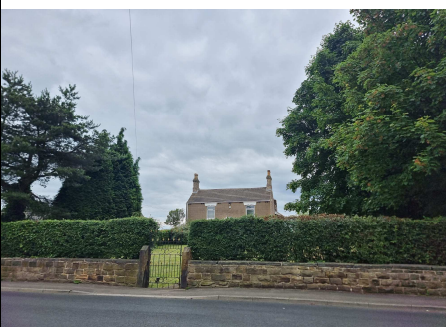
<table border="1"> <tr><td>HAWTHORN Crataegus monogyna</td><td></td></tr> <tr><td>0</td><td>0</td></tr> <tr><td>0</td><td>0</td></tr> <tr><td>0</td><td>0</td></tr> <tr><td>0</td><td>0</td></tr> </table>	HAWTHORN Crataegus monogyna		0	0	0	0	0	0	0	0	2.4m	2.6m	0.6m	Semi-mature to mature	A well maintained Hawthorn hedgerow, with ivy, extending along the frontage of the site. Hedge provides valuable screening and amenity valye between the road and the site	No preliminary work recommended at time of survey.	50mm	20-40 Years	B2
HAWTHORN Crataegus monogyna																					
0	0																				
0	0																				
0	0																				
0	0																				
							End of Hedge Data
