**LYONS CMC**  
**COAL MINING & GEOTECHNICAL**  
**CONSULTANCY**

Date: 6<sup>th</sup> December 2021  
Your ref: (S70 1NQ).  
My Ref: CMRA 00277

**COAL MINING RISK ASSESSMENT (CMRA) - FOR PROPOSED STOARGE BUILDING AT  
LAND AT POND STREET, BARNSELEY S70 1NQ**

**434446 / 405692**

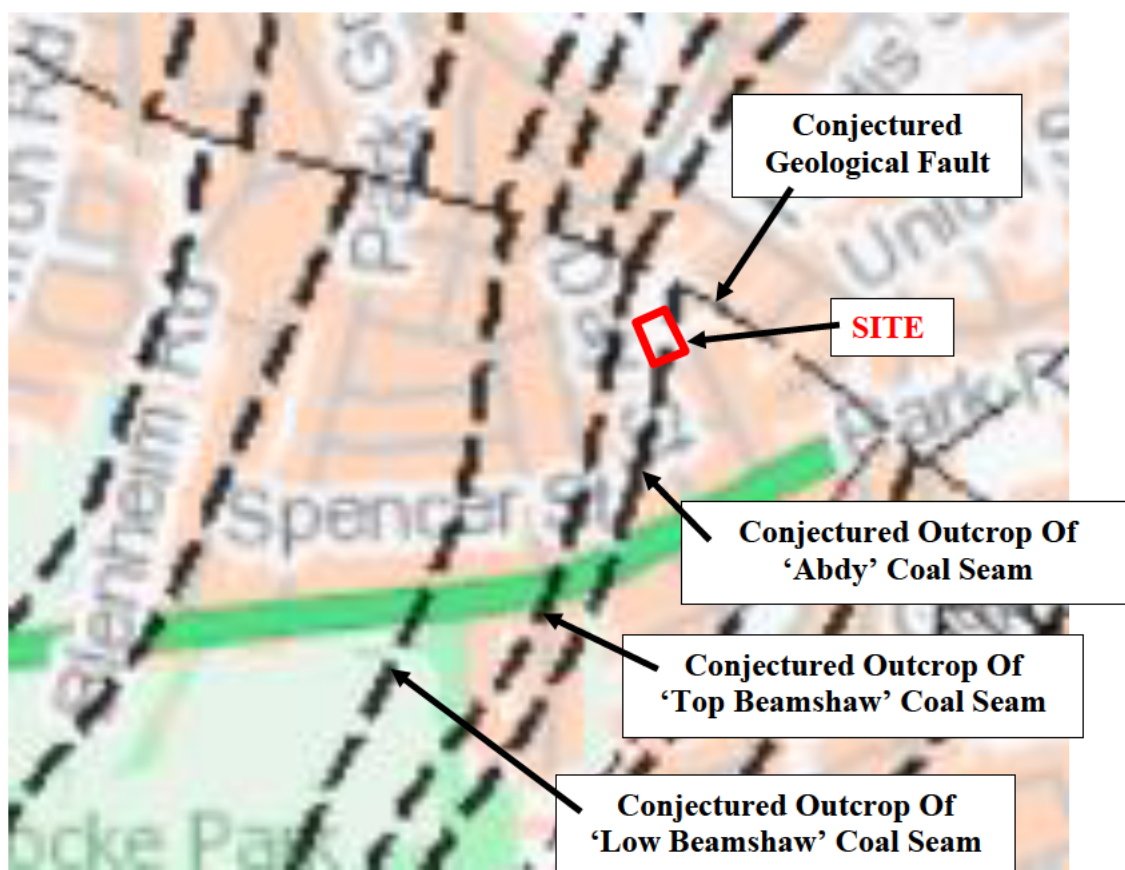
Records indicate the site to be located on sandstones, shales and mudstones of the Middle Coal Measure series from the Carboniferous formation. No superficial deposits are indicated in the vicinity of the site itself. A summary of the surface geology is illustrated on the image below which is an extract from the BGS Onshore Interactive Viewer:

A geological fault is conjectured to pass the site some 30m away to the north-east of the site as shown above. Although no fissuring of bedrock is known in the vicinity, the likelihood of natural fissures within any sandstone bedrock, that could have been opened out by the past deep coal mining in the area, should not be precluded.

As outlined on the extract image above from the BGS Onshore Interactive Viewer, the ‘Abdy’ coal seam (also known as the ‘Winter’ coal seam), of around 1m thickness, is conjectured to outcrop through the site itself. As such, this seam or part of it may be experienced beneath the surface soils and/or any made ground. The ‘Top Beamshaw’ coal seam is conjectured to outcrop some 20m away to the west as indicated, which is known locally to be of around 1.2m thickness – but this includes a dirt band of around 0.3m. Dipping gently eastwards, the Top Beamshaw seam would be anticipated as being beneath the site at a very shallow depth. The ‘Low Beamshaw’ coal seam is conjectured to outcrop some 130m away to the west as indicated. This coal is known to be of around 0.6m thickness, some 9m or so beneath the Top Beamshaw coal seam.

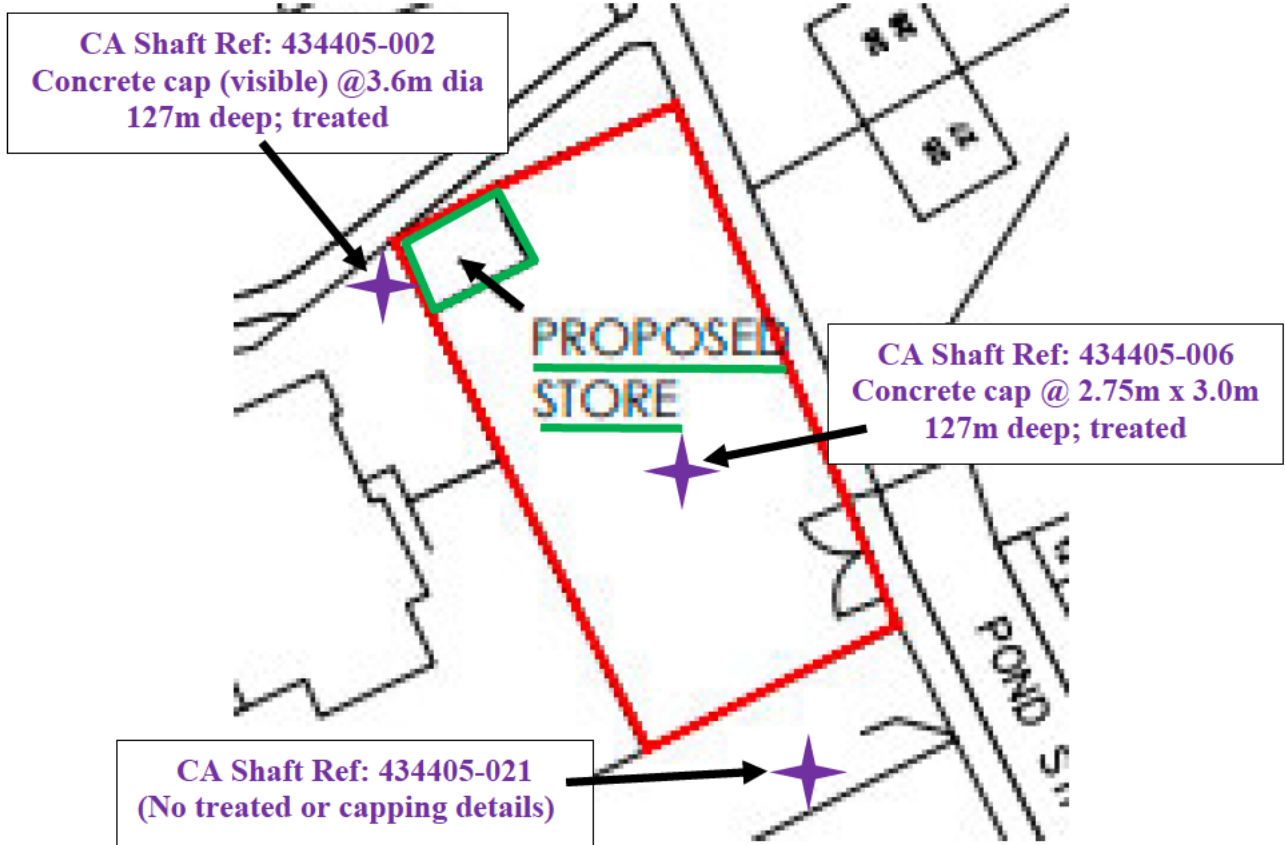
According to Coal Authority details, three old mine shafts are located in the positions as indicated below, associated with the former 'Agnes Colliery' of the mid to late 1800's which worked the Barnsley coal seam at circa 125m deep. The southernmost shaft (ref: 434405-021) will not have any implications on the proposed development provided the building is located in the northern part of the site (i.e. over 20m away).

The shaft within the site itself (ref: 434405-006) is shown to be circa 19m away from the currently proposed building. Provided this clearance remains as such, it is unlikely this shaft will have any stability issues providing the depth to bedrock is not abnormally significant. No visible signs of the associated cap are noted – recorded by the Coal Authority as 2.75m x 3.0m.

- 3) Current guidelines indicate that best practice regarding the mine shafts would be for buildings to be sited at least 45° back from where the shaft side intersects rock head (as detailed in CIRIA C758D). This is very likely to be achieved for mine shaft ref: 434405-006. However, as a degree of uncertainty exists for its precise location an element of trenching works would be recommended on the southern side of the proposed footprint to ensure that it is not present further northwards than expected; unless actual signs of this shaft can be determined which prove it to be well clear

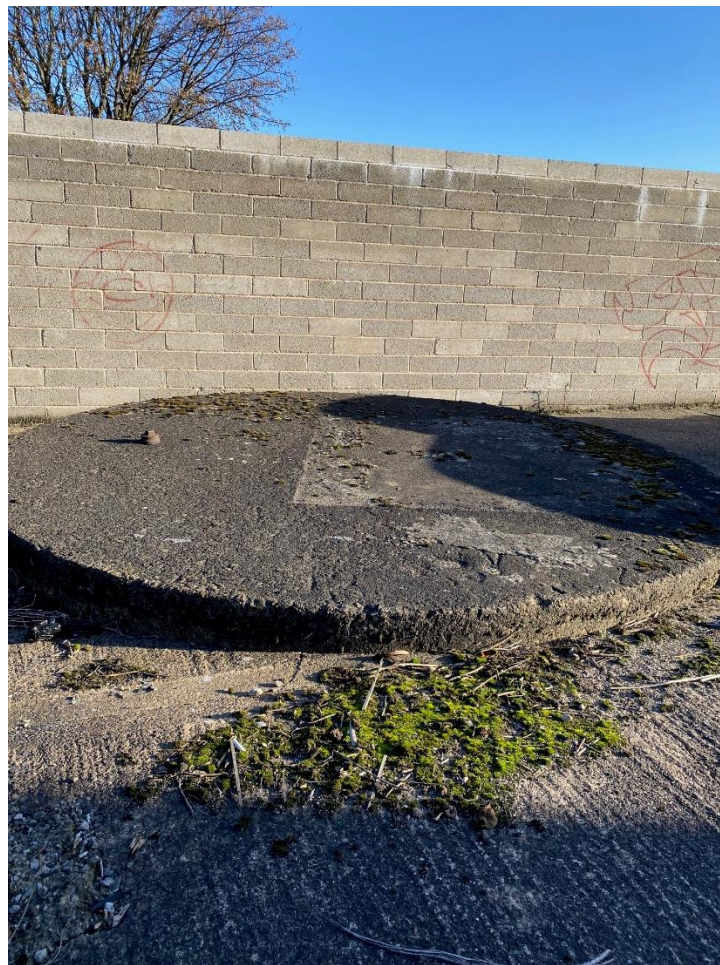
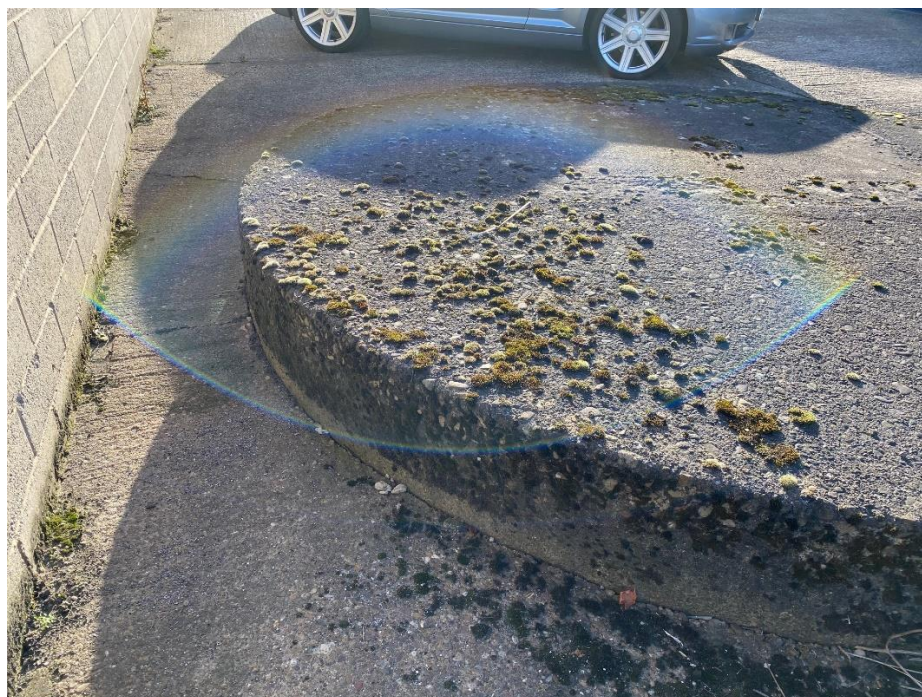
Shaft ref: 434405-002

The concrete cap of shaft ref: 435505-002 is clearly visible at the surface (as indication in the following photographs), situated within the hardstanding of the adjacent property. The boundary blockwork wall can be seen approximately 400mm away from the shaft cap. The applicant is considering the possibility of using this boundary wall as one of the sides of the proposed storage building. From the available Coal Authority details (including their response to BMBC Ms Willows of 4<sup>th</sup> November 2021) it is unclear as to any specific details as to the actual shaft diameter itself; it may be reasonable to assume however that the shaft side would be at a minimum of 300mm (1ft) inside from the edge of the cap; making for at least 700mm distance from the shaft side to the boundary wall.

As regards the mine entry ref: 434405-002, with the circular concrete cap clearly visible some 400mm away to the west of the existing boundary blockwork wall, a trenching exercise would be recommended to determine the depth to bedrock and indeed if the wall itself is located on such. If this is the case and rock head is quite shallow, given the nature of development there may be a possibility (considering that it would be reasonable to assume that the adjacent shaft cap would also be sited on rock head at a similar horizon) that the boundary wall could be classed as being stable and not interfering with the integrity of the shaft/shaft cap. Consultations with the Coal Authority (as owners of the shaft) should take place to determine the feasibility of this subsequent to the investigations and indeed whether the wall can therefore be utilised as the side of the proposed building. If depth to bedrock is more significant then a stand-off to achieve the 45° rule would need to be considered – i.e. a separate wall built inside of the boundary wall.
