Woodwalk, Hoyland– BS 5837: 2012 Arboricultural Report, Impact Assessment and Method Statement

Bellway Homes LTD (Yorkshire)

Ref: 21805

Report Title: Wood Walk Hoyland – BS 5837:2012 Arboricultural Report,
Impact Assessment and Method Statement

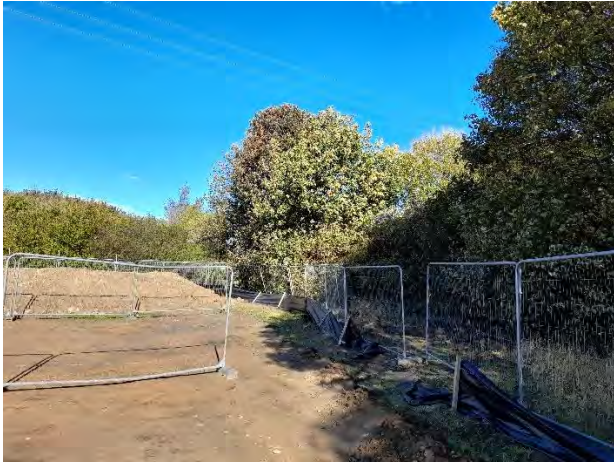
Plate 7: T015 – T026 6th October by LE

T014#	Field maple (<i>Acer campestre</i>)	15#	1	210	3	3	3	3	3	Semi Mature	10+ Years	Fair	Matured plantation. Damage to exposed roots. Crown vitality reduced.	-	C1	0.4	1
T015	Sycamore (<i>Acer pseudoplatanus</i>)	15#	1	310	4#	4#	4#	4#	2	Semi Mature	20+ Years	Good	Linear group at the edge of the plantation outside the stock fencing, which defines the boundary.	Remove to facilitate the proposed retaining wall	B1	3.7	43
T016	Sycamore (<i>Acer pseudoplatanus</i>)	15#	1	270	4#	4#	4#	4#	2	Semi Mature	20+ Years	Good	Linear group at the edge of the plantation outside the stock fencing, which defines the boundary.	Remove to facilitate the proposed retaining wall	B1	3.2	32
T017	Sycamore (<i>Acer pseudoplatanus</i>)	15#	1	330	4#	4#	4#	4#	2	Semi Mature	20+ Years	Good	Linear group at the edge of the plantation outside the stock fencing, which defines the boundary.	Remove to facilitate the proposed retaining wall	B1	3.7	43

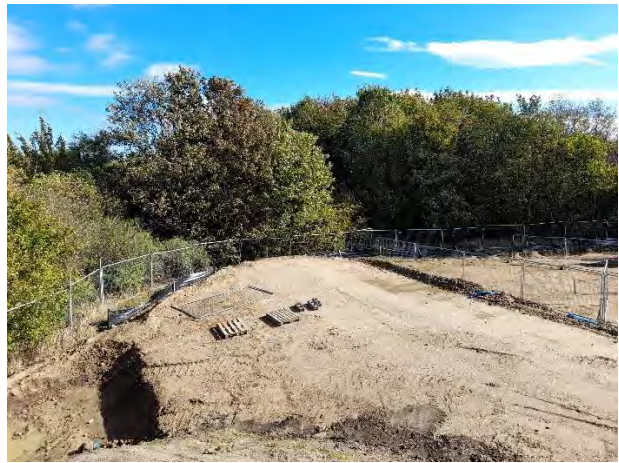
Plate 8: G047 6th of October by LE

Tree No.	Species	Height (m)	No. of Stems	Stem Dia. @ 1.5m (mm)	Crown Spreads (m)				Height of Crown Clearance (m)	Age Class	SLE	Overall Condition	Comments	Management	Category	RPA Radius (m)	RPA Area (m ²)
					N	E	S	W									
G047#	Mixed woodland (Mixed woodland) Hazel (<i>Corylus avellana</i>) Field maple (<i>Acer campestre</i>)	8	1	200	See Plan				0	Semi Mature	10+ Years	Fair	Hazel coppice stools with an average diameter of 80mm. Field maple and hawthorn. Diameter average at 80mm. Spacing at 3m. More established specimens have been plotted	Partial removal to facilitate the proposed retaining wall	C1	–	–
G048#	Blackthorn (<i>Prunus spinosa</i>) Mixed woodland (Mixed woodland) Common hawthorn (<i>Crataegus monogyna</i>)	4#	1	200	See Plan				0	Semi Mature	20+ Years	Fair	Behind secured existing heras fencing. Dense scrub with small diameter stems averages less than 50mm. Planted as a hawthorn edge. Previously topped. Maturing field maple along the boundary	Prune back to the wooden fence to facilitate development	C1	–	–

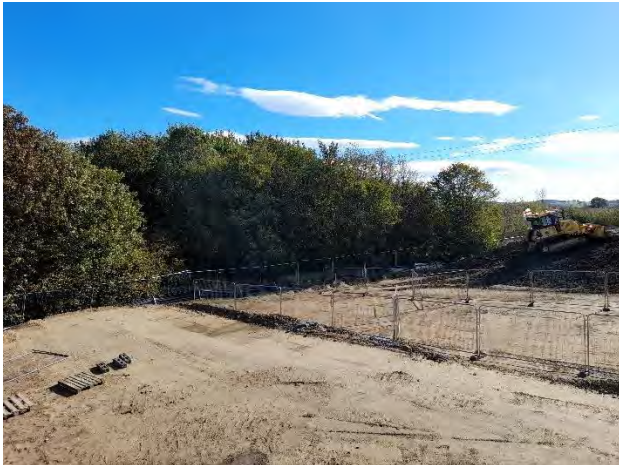
Plate 9: T20 – T40 6th October by LE

- 4.3.3 Trees T015 – T040 are of a medium to low quality and have formed part of a woodland plantation to the east of the site (G047). The trees within this group are comprised of established, semi-mature trees with a woodland understory.
- 4.3.4 The partial removal of sections of the hedgerows H003 and H009 will have a negligible impact.
- 4.3.5 The loss of trees designated for removal can be offset by (tree) planting within the development boundary.
- 4.3.6 The development proposals have allowed space for the planting of replacement trees throughout the site once construction is complete. The planting of diverse tree species that are in-keeping with the surrounding landscape character and tolerant of climate change can mitigate the required removals and, in the longer term, increase the amenity value and ecosystem service benefits that the site's trees provide.

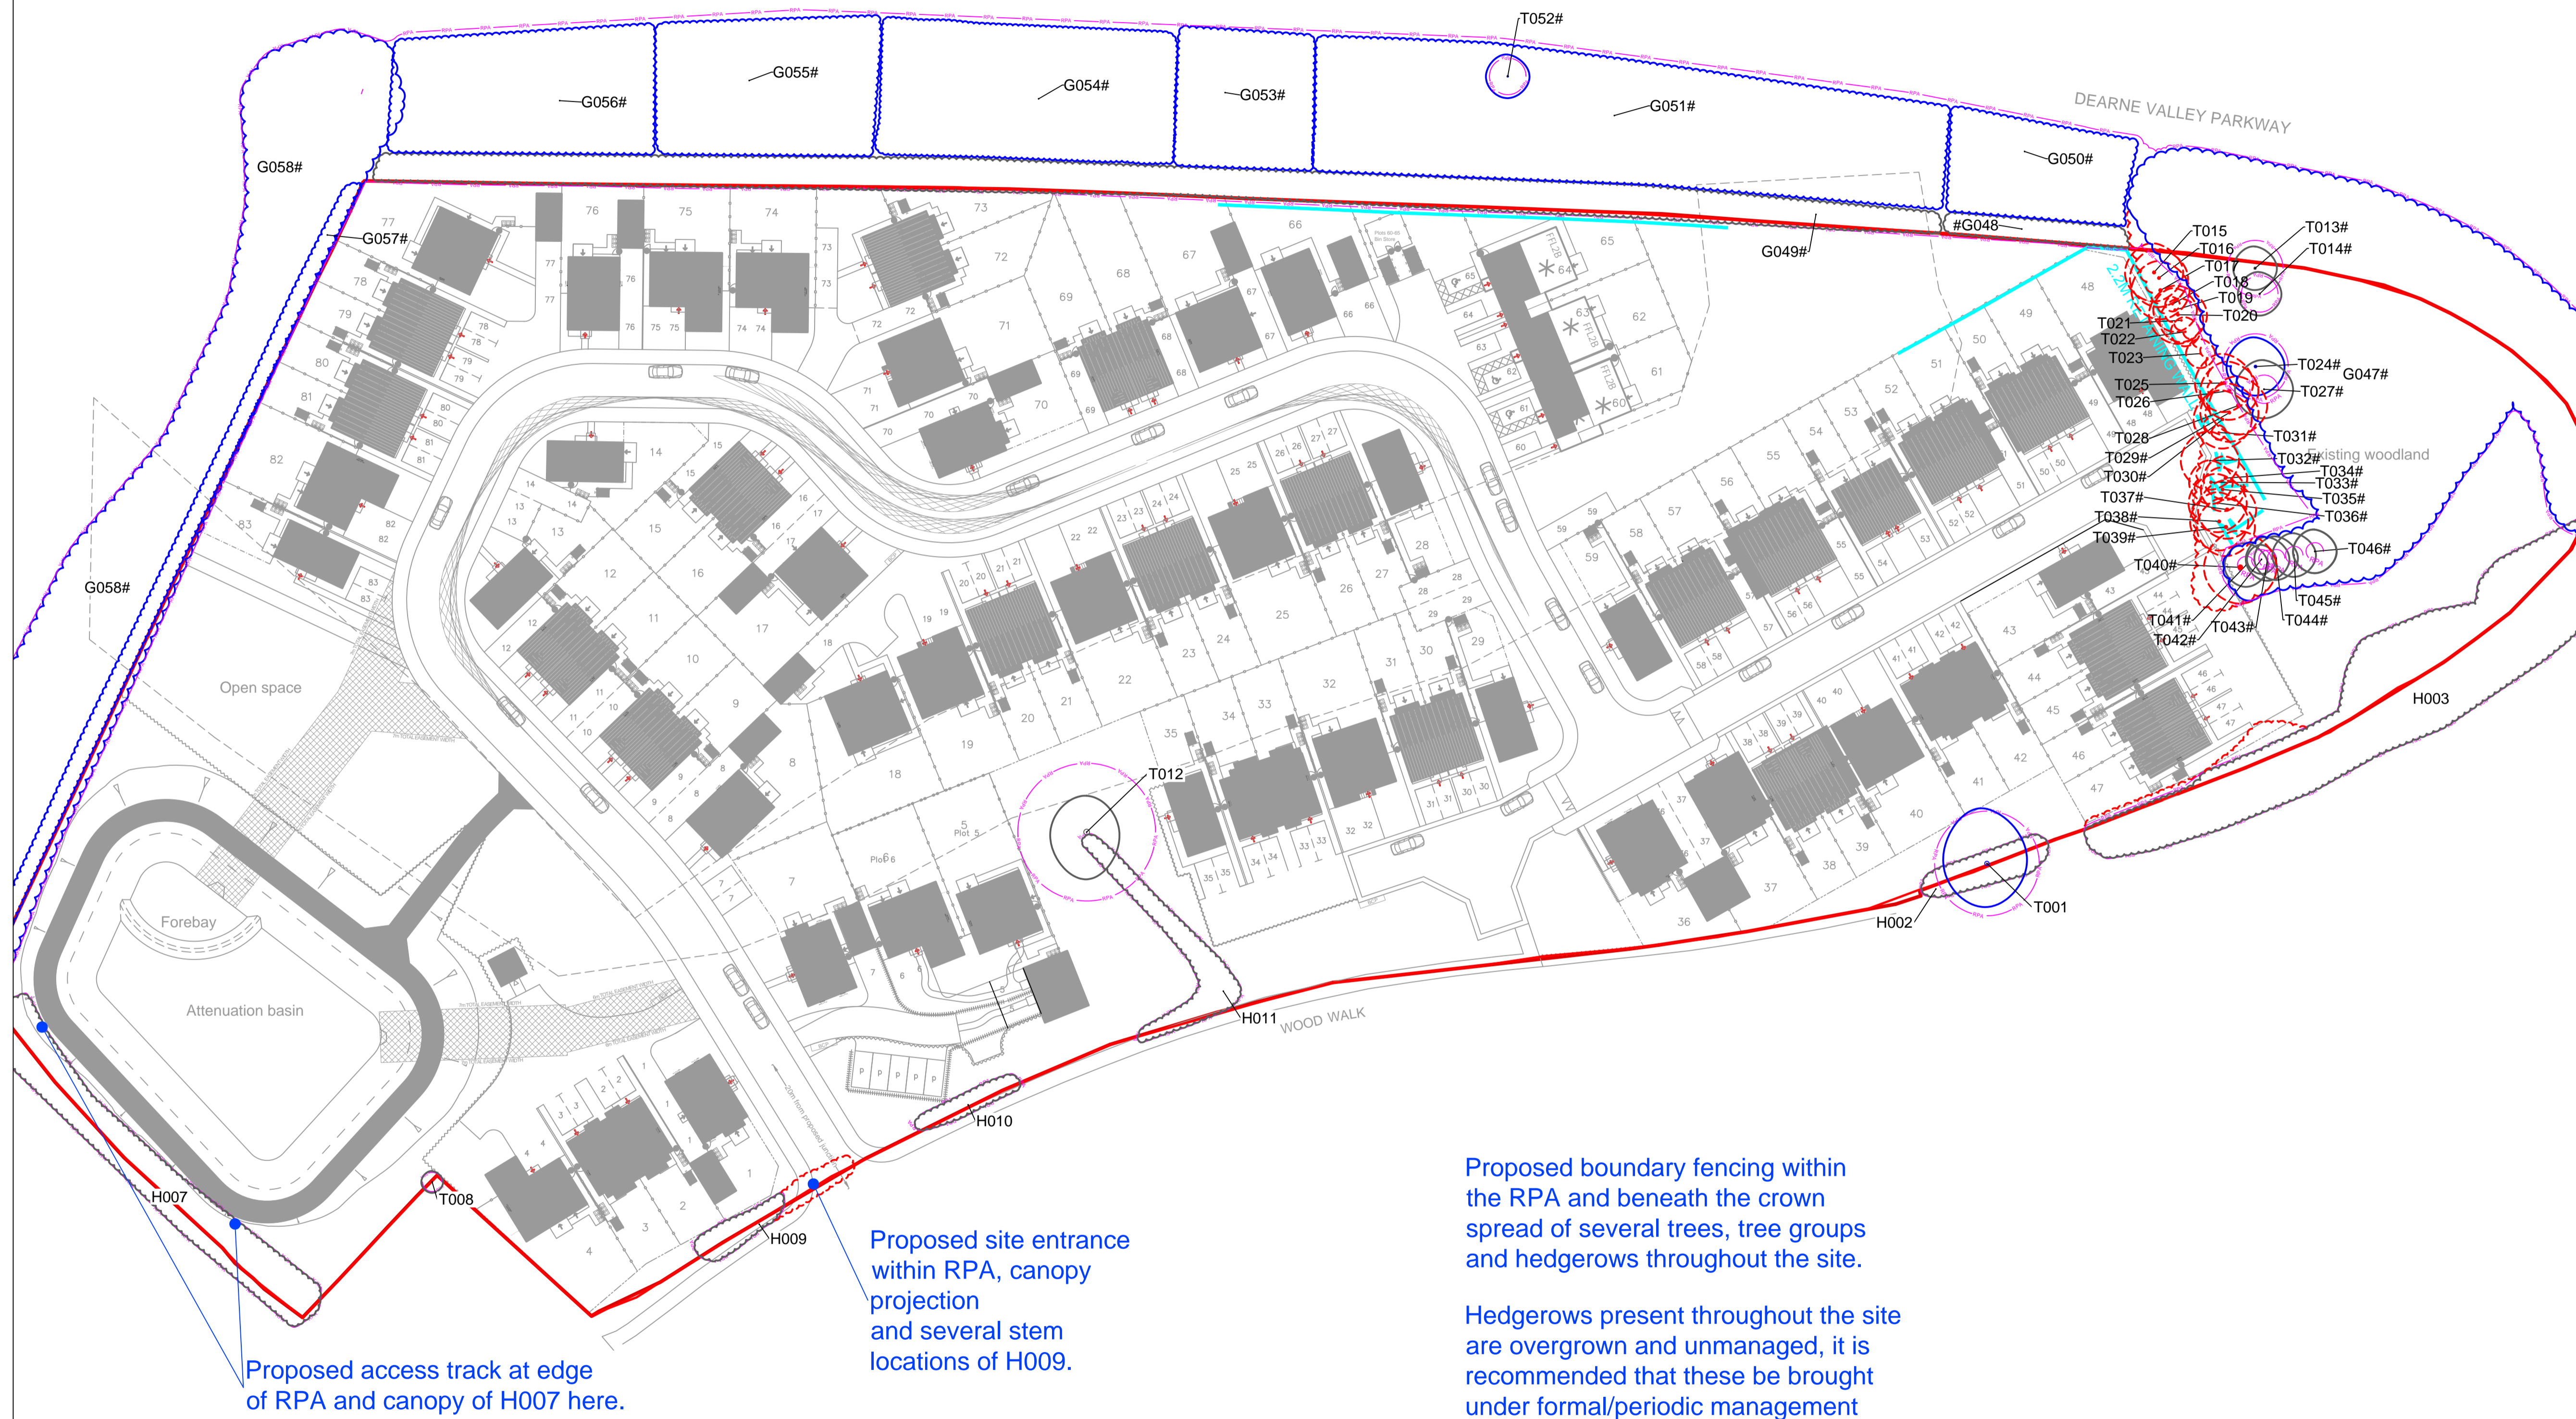
Proposed access track at edge of RPA and canopy of H007 here.

Proposed site entrance within RPA, canopy projection and several stem locations of H009.

Proposed boundary fencing within the RPA and beneath the crown spread of several trees, tree groups and hedgerows throughout the site.

Hedgerows present throughout the site are overgrown and unmanaged, it is recommended that these be brought under formal/periodic management through regular cyclical pruning.
