## Proposed Drainage Strategy

PERSEVERANCE STREET, BARNSELEY

CAIRNWELL DEVELOPMENTS LTD

**48063-ECE-XX-XX-RP-C-0005**

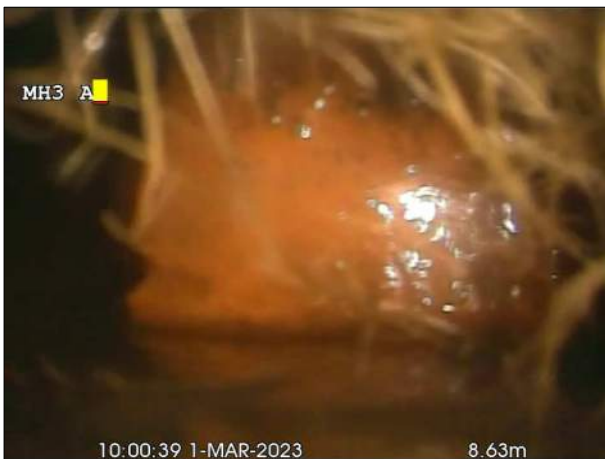
Photo: 3\_6a, 00:00:00  
7.5m, Obstruction, 80 % height/diameter loss

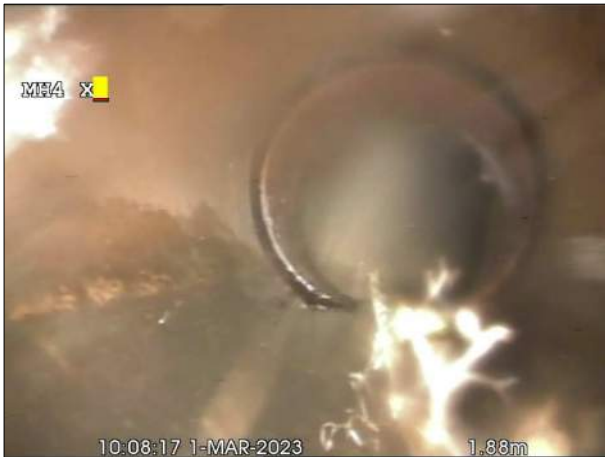
Photo: 42\_4a, 00:00:00  
1.9m, Joint displaced. Medium

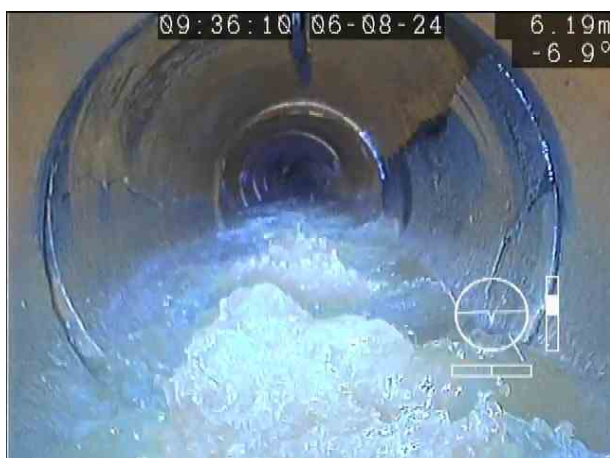
MH1X\_57331753-2901-490a-b26d-40df08841c2e\_20240812\_111305\_771.jpg, 00:00:50, 6.19 m  
 Fractures, multiple from 12 o'clock to 12 o'clock

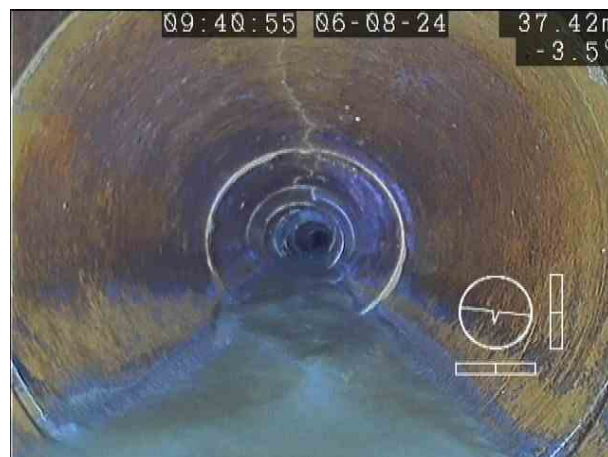
MH1X\_cafab7d0-50e5-4003-9632-e5a048611cf2\_20240812\_111451\_058.jpg, 00:02:44, 37.10 m  
 Crack, longitudinal at 12 o'clock, start

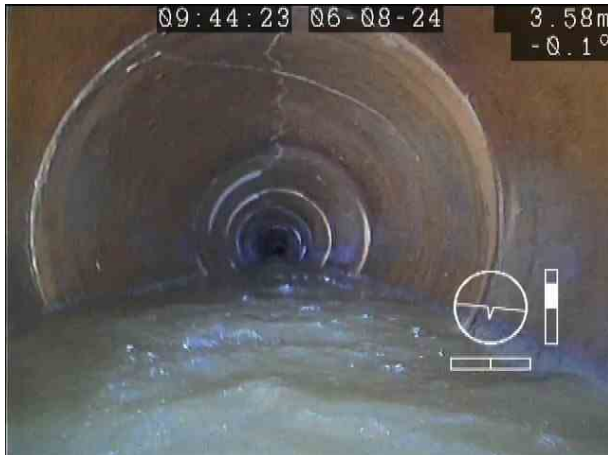
| Scale: 1:441 | Position [m] | Code | Observation | MPEG | Photo | Grade |
|---|---|---|---|---|---|---|
| | 3.58 | CM | Cracks, multiple from 10 o'clock to 03 o'clock | 00:00:30 | MH2X_34<br>3fe477-d1<br>13-4899-a | 3 / 2 |

MH2X\_343fe477-d113-4899-a973-9e4abd930d52\_20240812\_111631\_725.jpg, 00:00:30, 3.58 m  
 Cracks, multiple from 10 o'clock to 03 o'clock

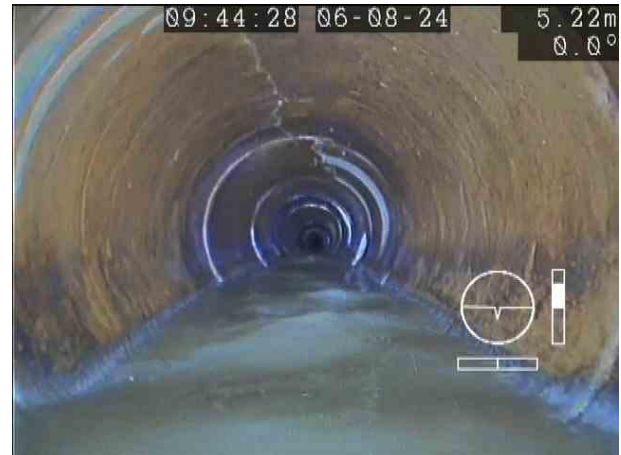
MH2X\_6db244d5-3ff5-431f-bfec-cfd338009be2\_20240812\_111652\_207.jpg, 00:00:35, 5.22 m  
 Crack, longitudinal at 11 o'clock, start

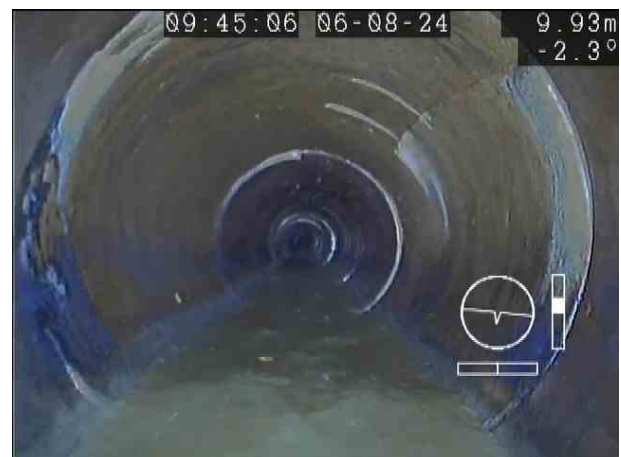
| Scale: 1:441 | Position [m] | Code | Observation | MPEG | Photo | Grade |
|---|---|---|---|---|---|---|
| | 9.93 | CL | Crack, longitudinal at 02 o'clock | 00:01:13 | MH2X_8b<br>485754-31<br>ee-4d55-9 | 2 / 2 |

MH2X\_8b485754-31ee-4d55-9e34-2c7c51316338\_20240812\_111744\_612.jpg, 00:01:13, 9.93 m  
 Crack, longitudinal at 02 o'clock

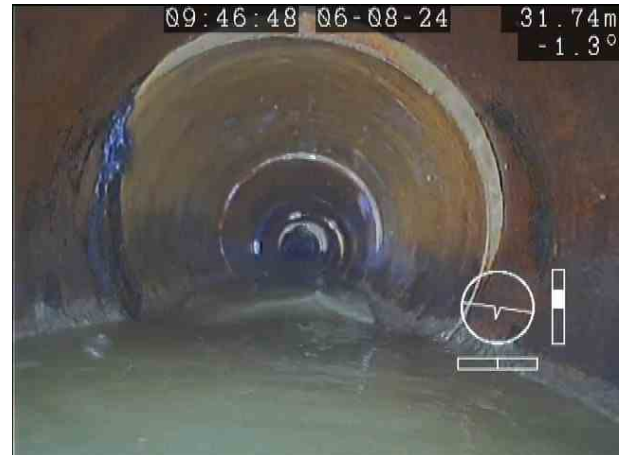
MH2X\_d2c1b144-da18-423f-8fe2-9c940f5444cc\_20240812\_111859\_743.jpg, 00:02:55, 31.74 m  
 Joint displaced, medium

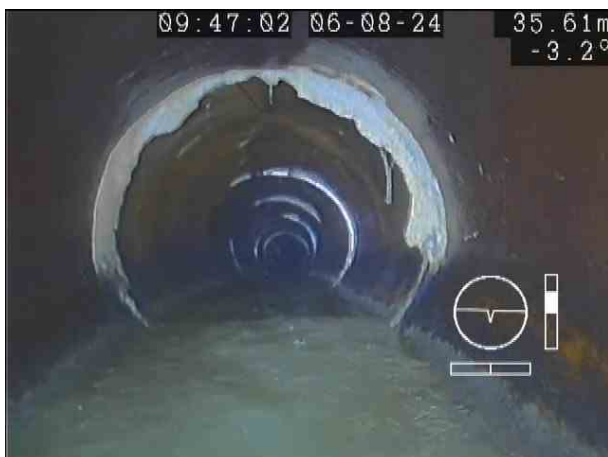
MH2X\_ad42cbe7-0a16-4016-9956-fc94c6be4d1a\_20240812\_111922\_830.jpg, 00:03:09, 35.61 m  
 Attached deposits, encrustation at joint from 07 o'clock to 04 o'clock, 10% cross-sectional area loss

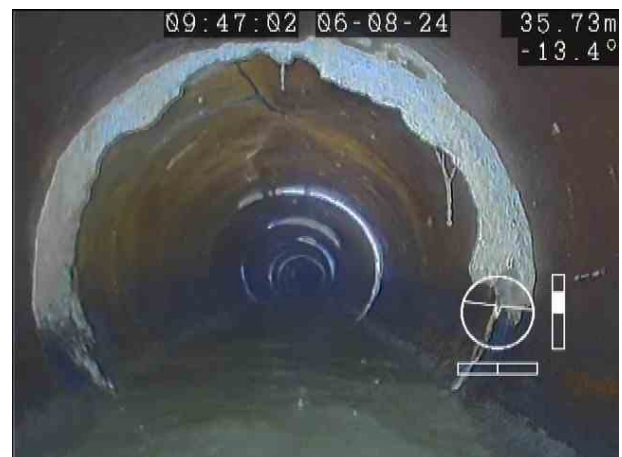
| Scale: 1:441 | Position [m] | Code | Observation | MPEG | Photo | Grade |
|---|---|---|---|---|---|---|
| | 35.73 | CL | Crack, longitudinal at 12 o'clock | 00:03:10 | MH2X_de<br>e560cd-5f<br>12-4c64-9 | 2 / 2 |

MH2X\_dee560cd-5f12-4c64-963a-88c51db298de\_20240812\_111948\_233.jpg, 00:03:10, 35.73 m  
 Crack, longitudinal at 12 o'clock

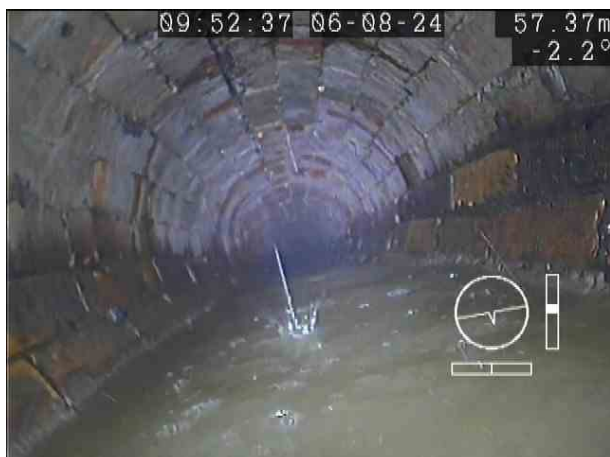
MH2X\_5635edc3-1272-4f0a-9816-837d2ba72dcf\_20240812\_112134\_435.jpg, 00:05:16, 57.37 m  
 Infiltration, dripping from 10 o'clock to 02 o'clock, start

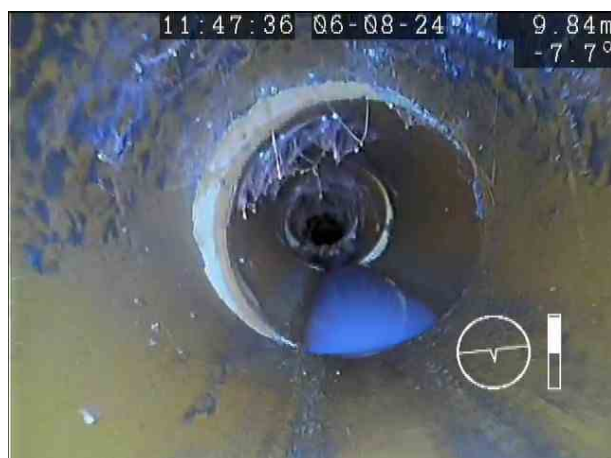
Exc  
 Pipe1X\_041e4a96-962b-4fe0-88a0-0faee3dbe9b0\_20240812\_113726\_191.jpg, 00:01:10, 9.84 m  
 Joint displaced, medium

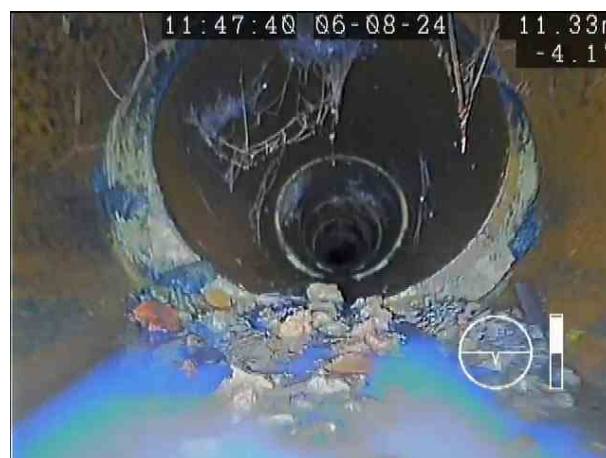
Exc  
 Pipe1X\_105ee651-1135-472e-ba40-8f5d479d03a8\_20240812\_113739\_703.jpg, 00:01:14, 11.33 m  
 Joint displaced, medium

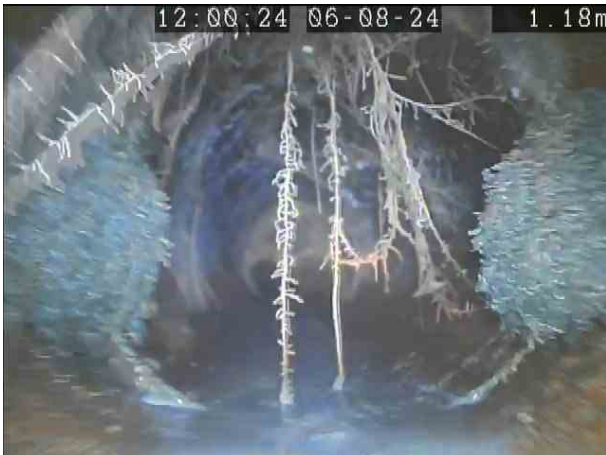
UpstreamX\_b0335336-3924-4b33-a2be-40099bb87b09\_20240812\_114204\_616.jpg, 00:00:15, 1.18 m  
 Roots, mass at joint, 25% cross-sectional area loss

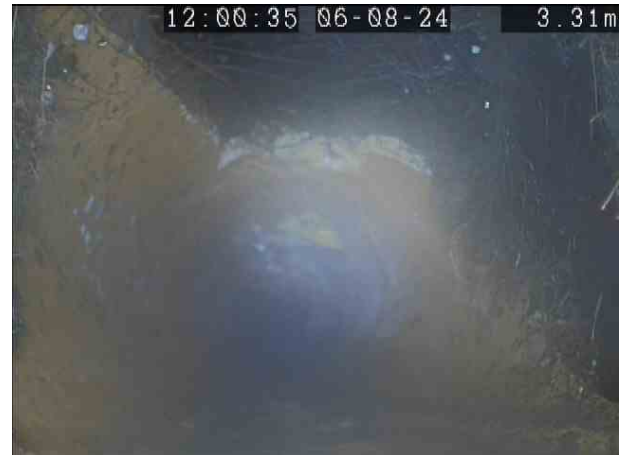
UpstreamX\_0cc2a8b9-c6fe-4dc4-8f75-75a0937ea0fd\_20240812\_114226\_042.jpg, 00:00:26, 3.31 m  
 Hole in drain or sewer from 01 o'clock to 05 o'clock

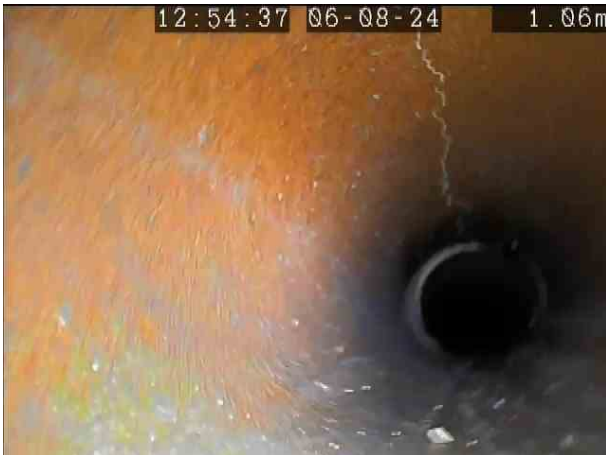
| Scale: 1:128 | Position [m] | Code | Observation | MPEG | Photo | Grade |
|---|---|---|---|---|---|---|
| | 1.06 | CL | Crack, longitudinal at 12 o'clock | 00:00:34 | Upstream<br>X_2073ff9<br>d-1059-4b | 2 / 2 |

UpstreamX\_2073ff9d-1059-4bdf-8054-2b143b36b8bf\_20240812\_114833\_120.jpg, 00:00:34, 1.06 m  
Crack, longitudinal at 12 o'clock

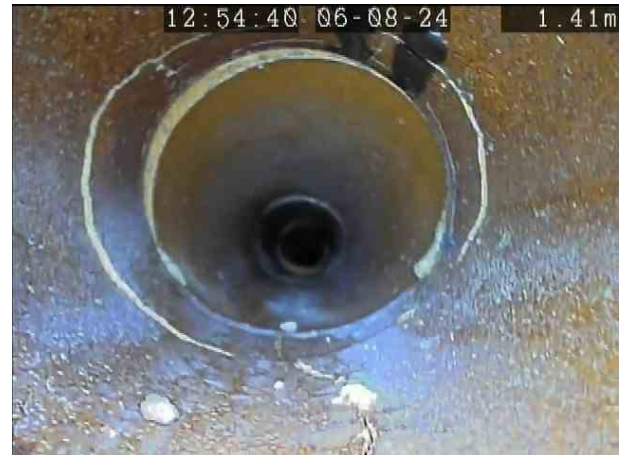
| Scale: 1:128 | Position [m] | Code | Observation | MPEG | Photo | Grade |
|---|---|---|---|---|---|---|
| | 1.41 | FC | Fracture, circumferential from 12 o'clock to 12 o'clock | 00:00:37 | Upstream<br>X_139ac1<br>7c-f647-45 | 3 / 2 |

UpstreamX\_139ac17c-f647-4501-9898-87e944ac7036\_20240812\_114850\_286.jpg, 00:00:37, 1.41 m  
Fracture, circumferential from 12 o'clock to 12 o'clock

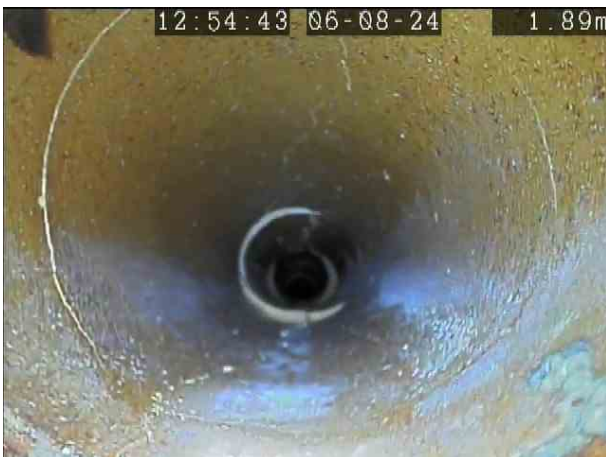
| Scale: 1:128 | Position [m] | Code | Observation | MPEG | Photo | Grade |
|---|---|---|---|---|---|---|
| | 1.89 | CC | Crack, circumferential from 12 o'clock to 12 o'clock | 00:00:40 | Upstream<br>X_56508c<br>19-a7f9-41 | 2 / 2 |

UpstreamX\_56508c19-a7f9-4108-8dab-9e6aa03b9b98\_20240812\_114906\_832.jpg, 00:00:40, 1.89 m  
Crack, circumferential from 12 o'clock to 12 o'clock

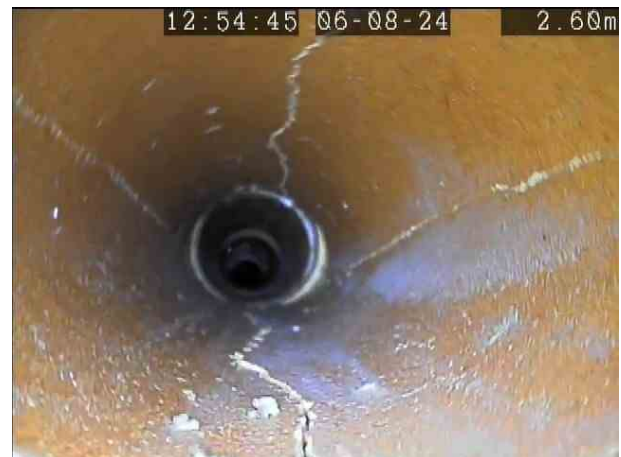
| Scale: 1:128 | Position [m] | Code | Observation | MPEG | Photo | Grade |
|---|---|---|---|---|---|---|
| | 2.60 | CM | Cracks, multiple from 12 o'clock to 12 o'clock | 00:00:42 | Upstream<br>X_342c90<br>7d-01b5-4 | 3 / 2 |

UpstreamX\_342c907d-01b5-48cb-a028-132170947893\_20240812\_114927\_787.jpg, 00:00:42, 2.60 m  
Cracks, multiple from 12 o'clock to 12 o'clock

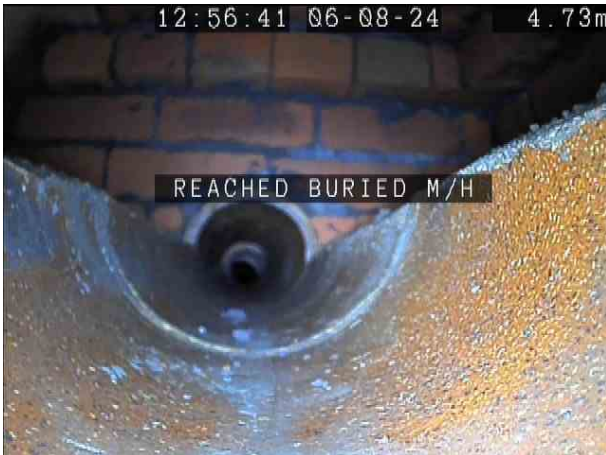
UpstreamX\_305cf42b-dc3d-4801-b555-6358f9682f41\_20240812\_115001\_507.jpg, 00:01:34, 4.73 m  
 General photograph taken at this point, buried manhole

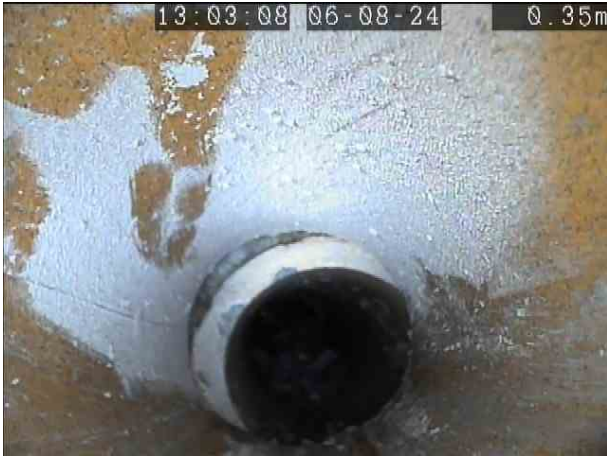
BX\_9bcc79f6-955a-474c-bba5-4111b563cb96\_20240812\_120  
 226\_386.jpg, 00:00:10, 0.35 m  
 Joint displaced, large

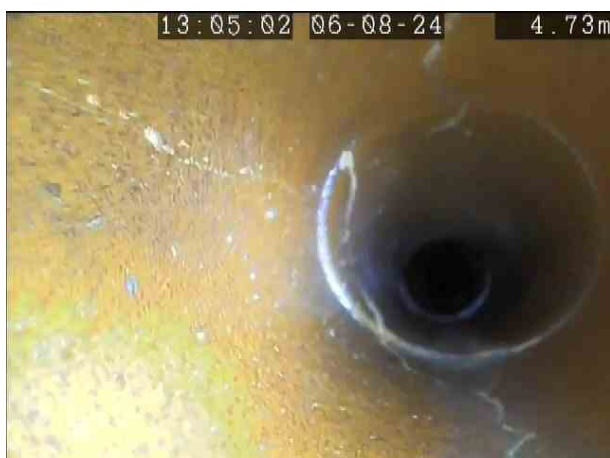
| Scale: 1:111 | Position [m] | Code | Observation | MPEG | Photo | Grade |
|---|---|---|---|---|---|---|
| | 4.73 | CM | Cracks, multiple from 12 o'clock to 12 o'clock | 00:00:28 | MH4X_6b<br>b3e22b-fa<br>39-4978-a | 3 / 2 |

MH4X\_6bb3e22b-fa39-4978-ac21-88070a5b0208\_20240812\_120351\_013.jpg, 00:00:28, 4.73 m  
 Cracks, multiple from 12 o'clock to 12 o'clock

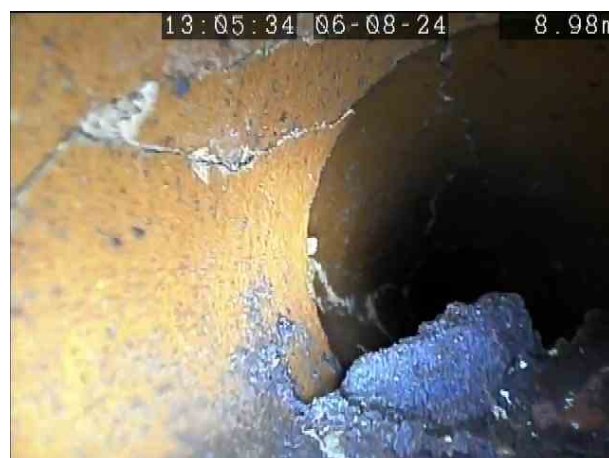
MH4X\_7d501f97-82de-4354-9a49-4944b60663d8\_20240812\_120423\_882.jpg, 00:00:51, 8.98 m  
 Settled deposits, fine, 30% cross-sectional area loss

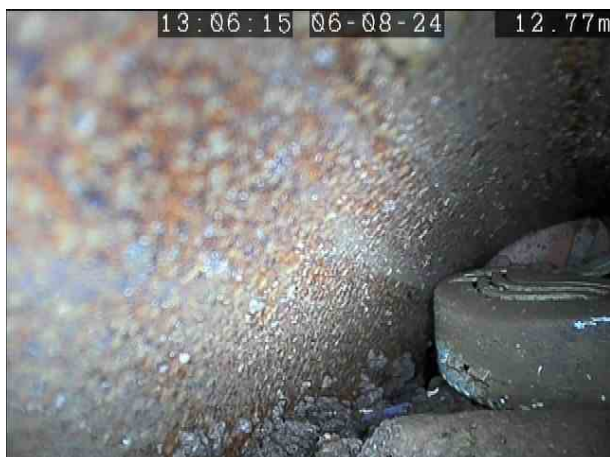
MH4X\_dce3b7e3-68ce-42c4-944b-711f0315f6dd\_20240812\_120454\_527.jpg, 00:01:10, 12.65 m  
 Settled deposits, coarse, 95% cross-sectional area loss

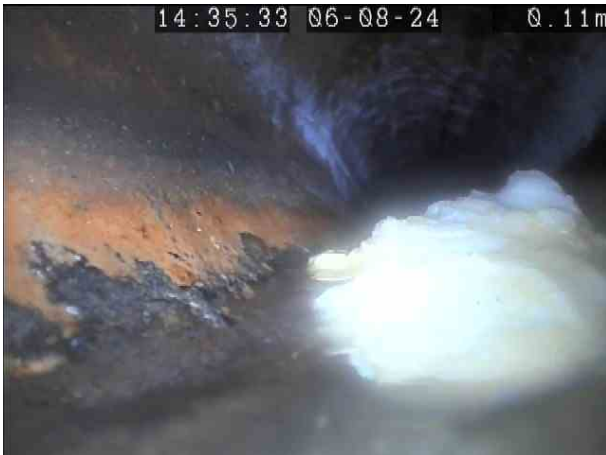
MH9X\_b61292d1-0c30-4b2b-b659-c26eacf2a2cb\_20240812\_121118\_358.jpg, 00:00:10, 0.11 m  
 Attached deposits, fouling from 04 o'clock to 08 o'clock, 30% cross-sectional area loss

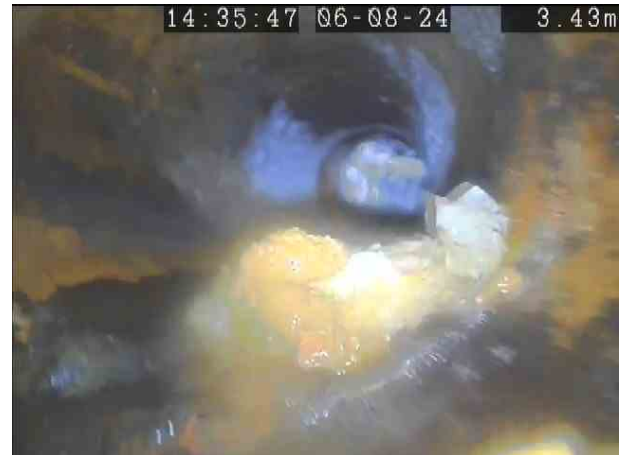
MH9X\_549ea207-83ad-44cc-b032-0152d315ed48\_20240812\_121140\_525.jpg, 00:00:24, 3.43 m  
 Attached deposits, fouling from 04 o'clock to 07 o'clock, 15% cross-sectional area loss

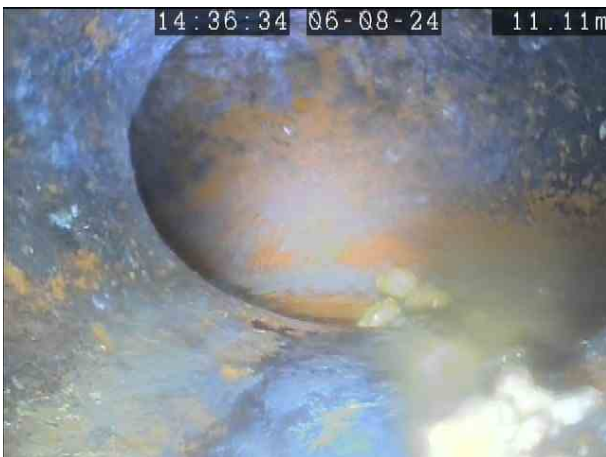
MH9X\_b4188a44-f55b-49ee-b505-0b5ae8c3b84a\_20240812\_121212\_354.jpg, 00:01:04, 11.11 m  
 Line deviates left, INTO JUNCTION
