# ARBORICULTURAL REPORT

to BS 5837:2012 at:

***Stairfoot Roundabout,  
Stairfoot,  
Barnsley,  
S71 5DS***

Reference: *AWA6520*

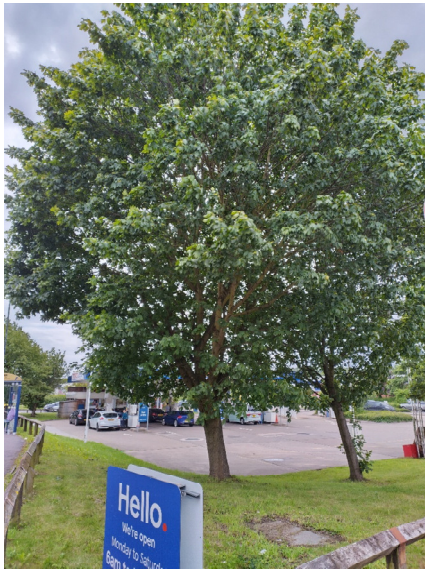
Photo 1: T6 from north.

| | Tree Species | | | Measurements | | | Crown (m) | | | | Tree Condition | | | | | | | Value | | | Management | |
|---|---|---|---|---|---|---|---|---|---|---|---|---|---|---|---|---|---|---|---|---|---|---|
| T6 | Norway Maple | Acer platanoides | Early-mature | 14 | 1 | 450 | No | 1.5 | 7 | 7 | 5.5 | 5.5 | No visual defects | Single stemmed. Slight lean. Old pruning wounds. Stubs. Tight union | Old pruning wounds. Minor deadwood | Slight lean northeast. On banking. | Good | Good | >40 yrs | Moderate | B | No works required in current site context |

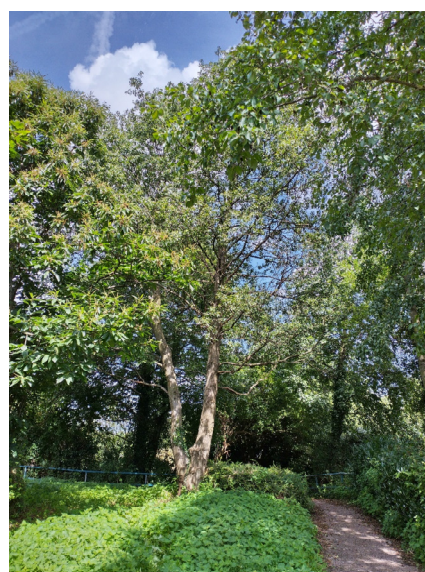
Photo 6: T71 from south.

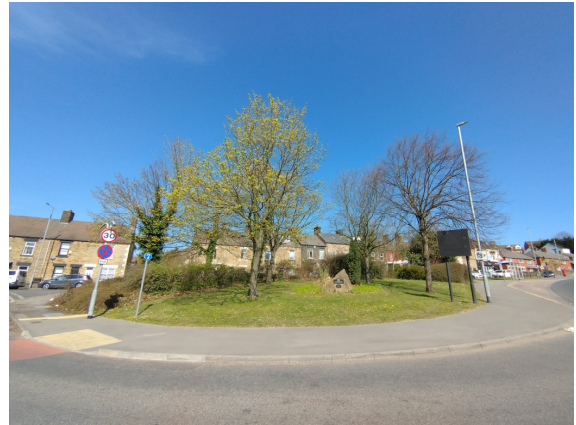
Photo 2: T153 to T156 from west.

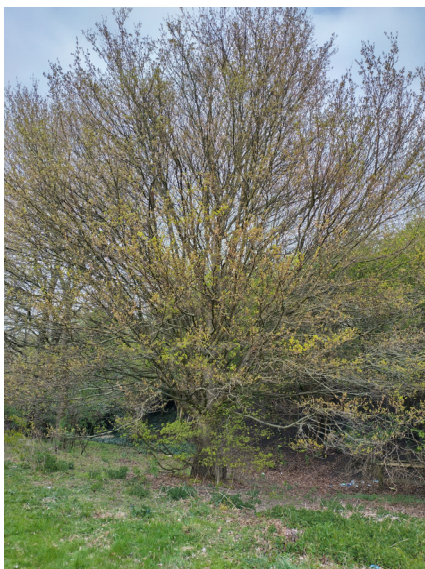
Photo 3: T226 from south

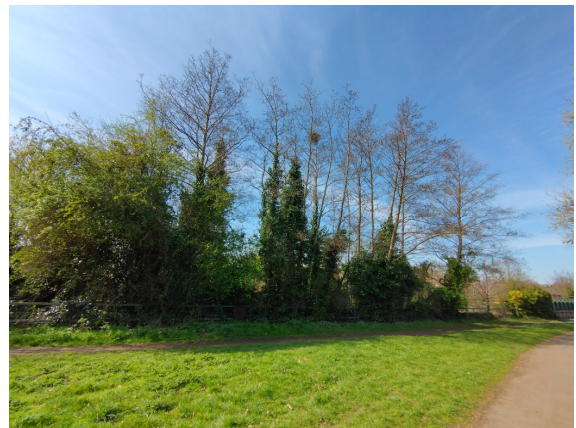
Photo 4: G77 from southeast.

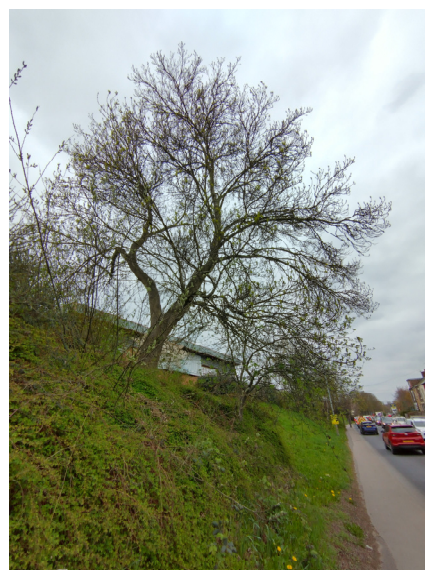
Photo 6: T242 from south.

- 3.2.28 T63, T123, T172, T109 and T244 all show significant signs of ill health or decline, and it is recommended that these be removed regardless of development.
